***Federal Railroad Administration  
Office of Railroad Safety  
Accident and Analysis Branch***

***Accident Investigation Report  
HQ-2017-1209***

***Union Pacific Railroad Company (UP)  
Ohlman, IL  
June 14, 2017***

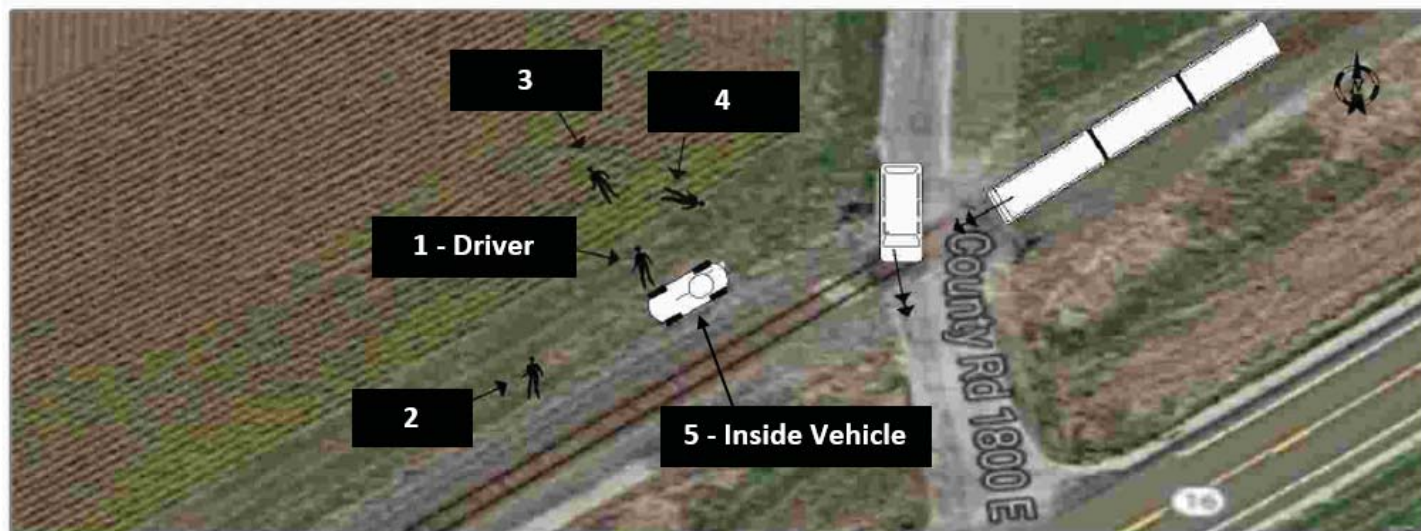
Accident Sketch (Derived From IL State Police Sketch)

A 2009 Chrysler Town & Country passenger van (struck vehicle) with a driver and four passengers was approaching the crossing from the north. Per statements given by the train crew, the vehicle appeared to be slowing to stop for the train, and then began to accelerate into the crossing, and into the path of the train, and was struck.

From the point of impact, the struck vehicle was thrown airborne and struck the top of the yield and cross-buck sign. The vehicle then overturned and came to rest on the passenger's side facing southwest. The driver and three passengers were ejected from the vehicle. The three passengers were pronounced deceased on the scene. The driver of the vehicle was transported by Pana Ambulance to Pana Community Hospital and then airlifted to St. Louis University Hospital and pronounced deceased at approximately 11:06 p.m. The other occupant of the vehicle was air-lifted to Barnes Jewish Hospital and later succumbed to injuries and pronounced deceased.

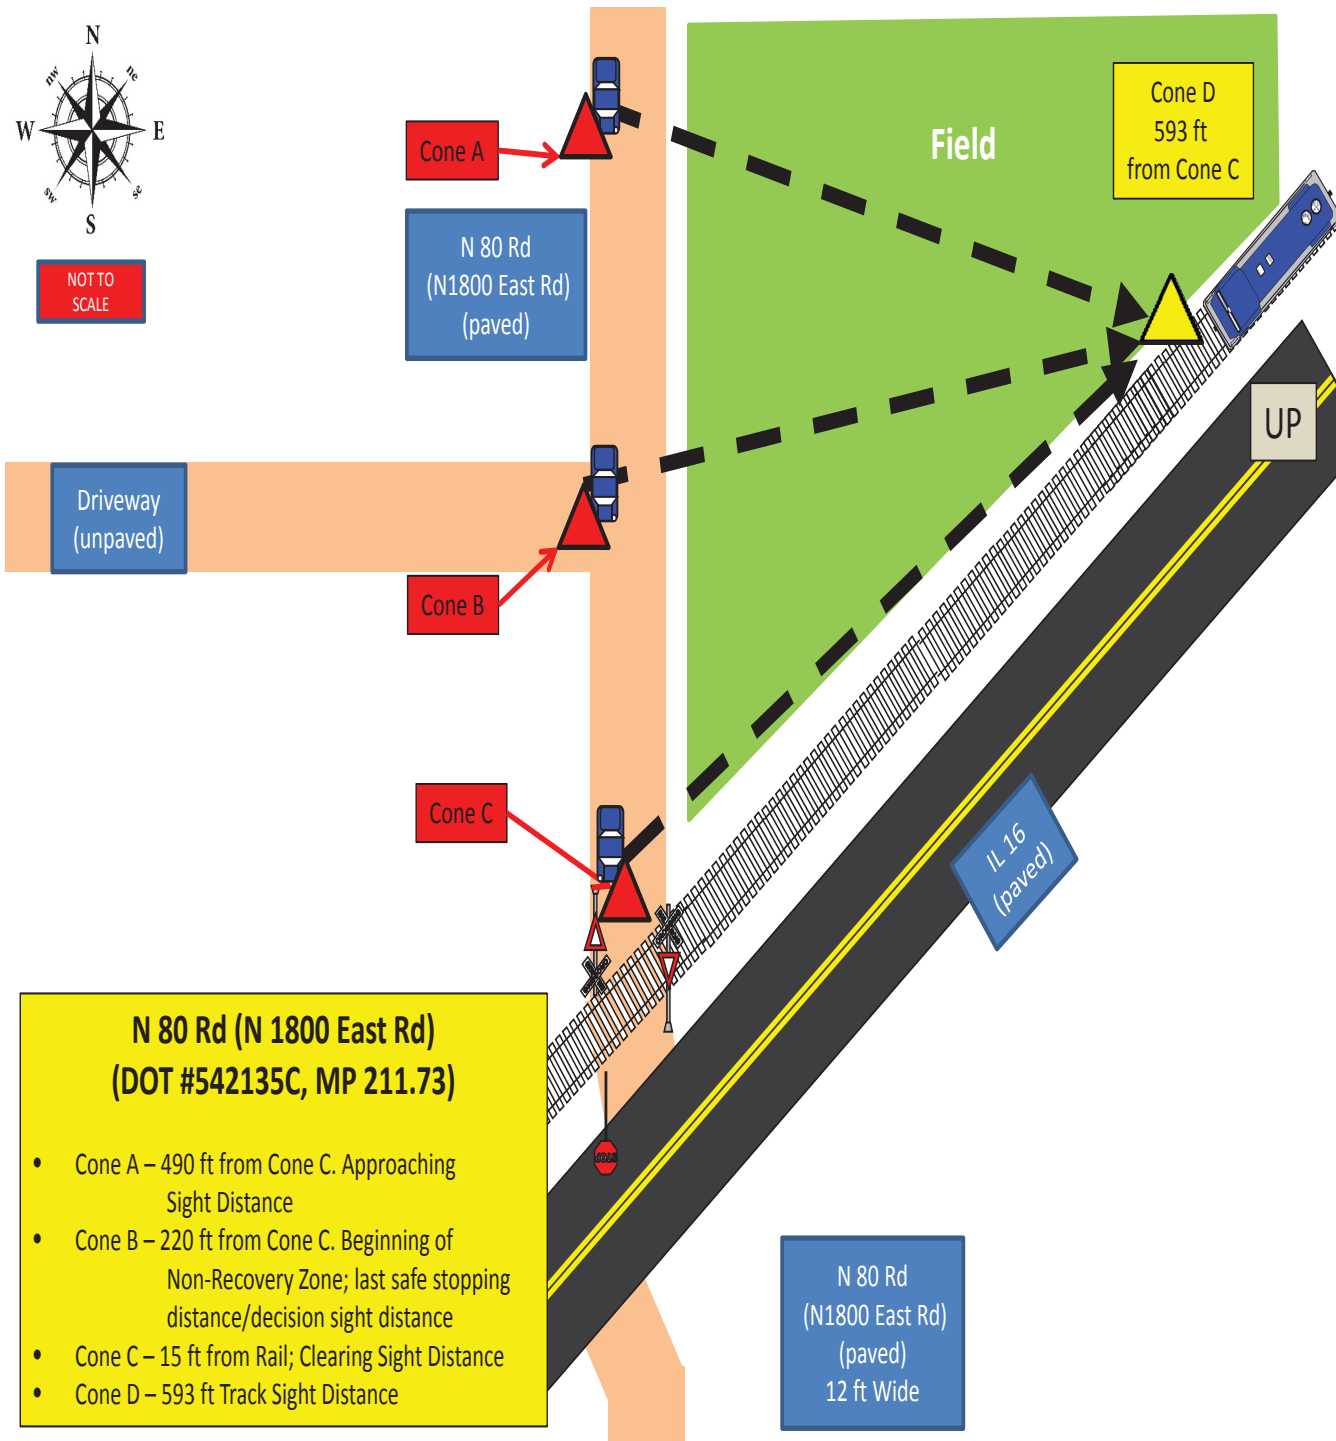
Pana, IL FRA Sight Distance Sketch

Analysis - Highway-Rail Grade Crossing: The highway-rail crossing at grade is equipped with yield signs and cross-buck signs. There is no advance warning sign posted at the crossing. There are no pavement markings within 100 feet of the crossing. A sight distance evaluation was conducted of the crossing in accordance with the method described in the Federal Highway Administration's Railroad-Highway Grade Crossing Handbook (revised Second Edition, 2007). Based on a highway speed limit of 30 mph, with a motor vehicle speed of 5 mph (on impact), and a 15-foot safe zone (Cone C) from the nearest rail, the beginning of the approach zone for this crossing was determined to be 490 feet (Cone A), with a point of nonrecovery beginning at 220 feet (Cone B). For a train speed of 48 mph, the distance along the railroad from crossing was determined to be 593 feet (Cone D). The actual sight visibility triangle was measured from the first point, at which the vehicle operator had an unobstructed line of sight from the vehicle to the front of the train. This point was determined to be 490 feet. There was no vegetation on the northeast side of the grade crossing, the direction from which the train was approaching.

Conclusion: The crossing, decision, approach, and clearing sight distances were clear and visible.

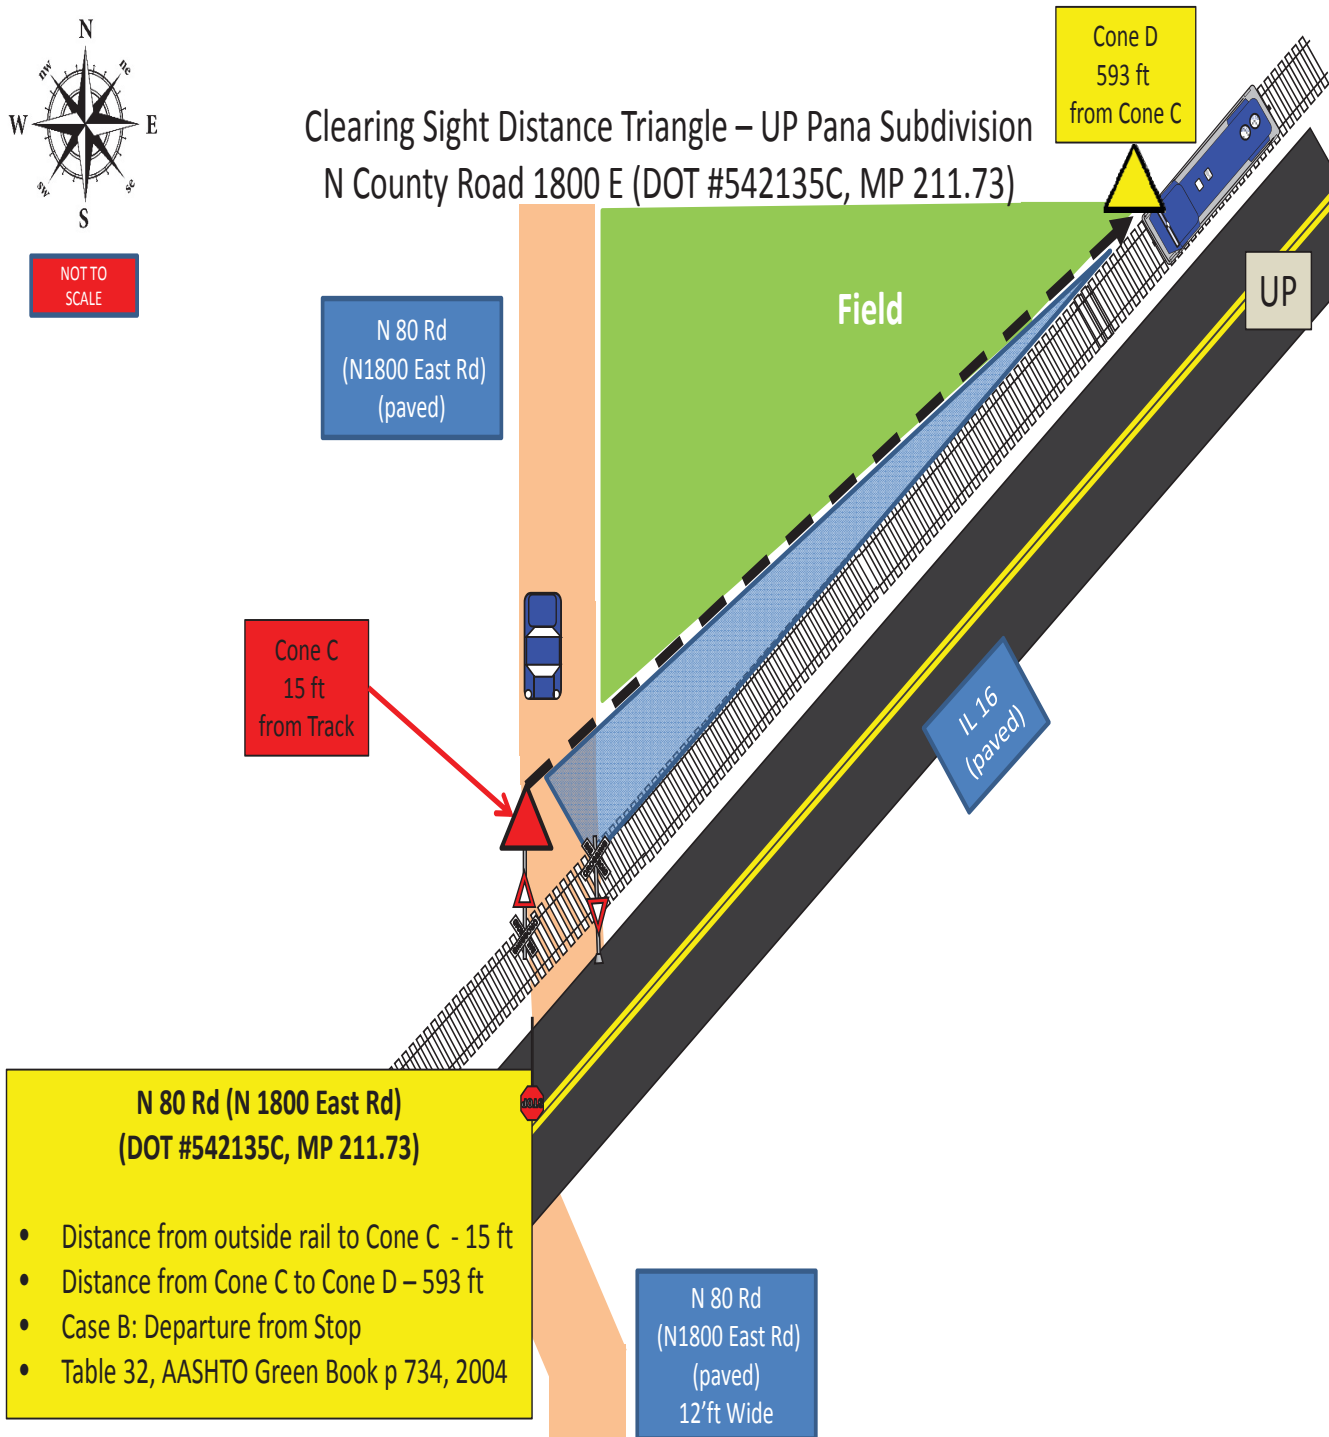
### Clearing Sight Distance Triangle – UP Pana Subdivision N County Road 1800 E (DOT #542135C, MP 211.73)

- Distance from outside rail to Cone C - 15 ft
- Distance from Cone C to Cone D - 593 ft
- Case B: Departure from Stop
- Table 32, AASHTO Green Book p 734, 2004
