***Federal Railroad Administration
Office of Railroad Safety
Accident and Analysis Branch***

***Accident Investigation Report
HQ-2017-1223***

***Montana Rail Link (MRL)
Heron, MT
August 13, 2017***

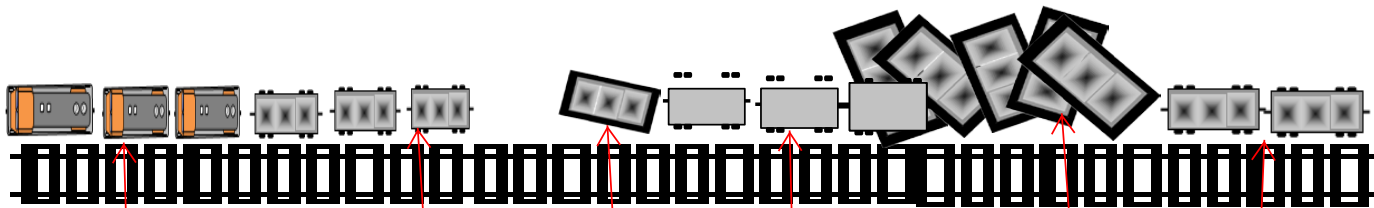
HQ-2017-1223 Sketch

3 degree, 30 minute curve on single main track on a 0.47% ascending grade

PGEX 724
PGEX 720
GEMX 5180
On their side part of the derailment

29 Railcars
Cars 8 – 37 of the train consist derailed laying accordion style

DLRX 60305
upright part of the derailment
