***Federal Railroad Administration
Office of Railroad Safety
Accident and Analysis Branch***

***Accident Investigation Report
HQ-2017-1224***

***Union Pacific Railroad Company (UP)
Morrison, MO
August 15, 2017***

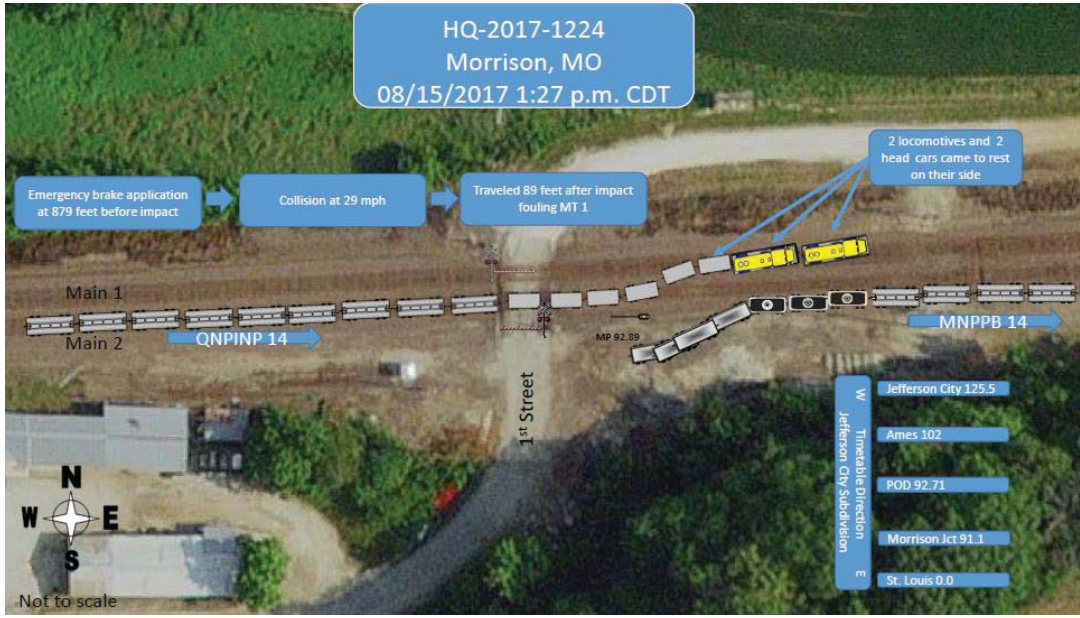
Sketch

On August 15, 2017, at 1:27 p.m., CDT, an eastbound Union Pacific Railroad (UP), mixed-freight train operating under Train QNPINP 14 (Train 1), struck the rear-end of a standing UP mixed-freight train operating under Train MNPPB 14 (Train 2). The rear-end collision occurred on UP's St. Louis Area Service Unit, Jefferson City Subdivision at Milepost (MP) 92.71, near the town of Morrison, Missouri, on Main Track No. 2. The method of operation is a Centralized Traffic Control double main track. Train 1, consisted of two lead locomotives, one distributed power unit (DPU), 82 loads, and 47 empty cars. Train 1 contained 11809 trailing tons and was 8213 feet long. Train 1 struck the rear of a stopped Train 2.

Due to the collision, the two lead locomotives and three cars from Train 1, and the rear 13 cars of Train 2, were derailed. There was no release of hazardous materials due to the collision.
