***Federal Railroad Administration  
Office of Railroad Safety  
Accident and Analysis Branch***

***Accident Investigation Report  
HQ-2017-1196***

***Union Pacific Railroad Company (UP)  
Malakoff, TX  
March 29, 2017***

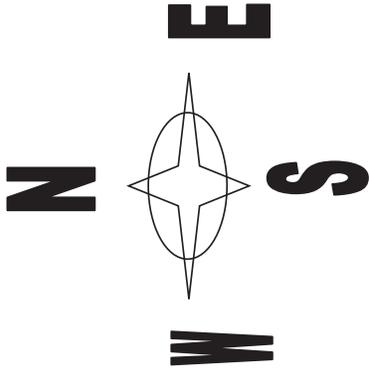
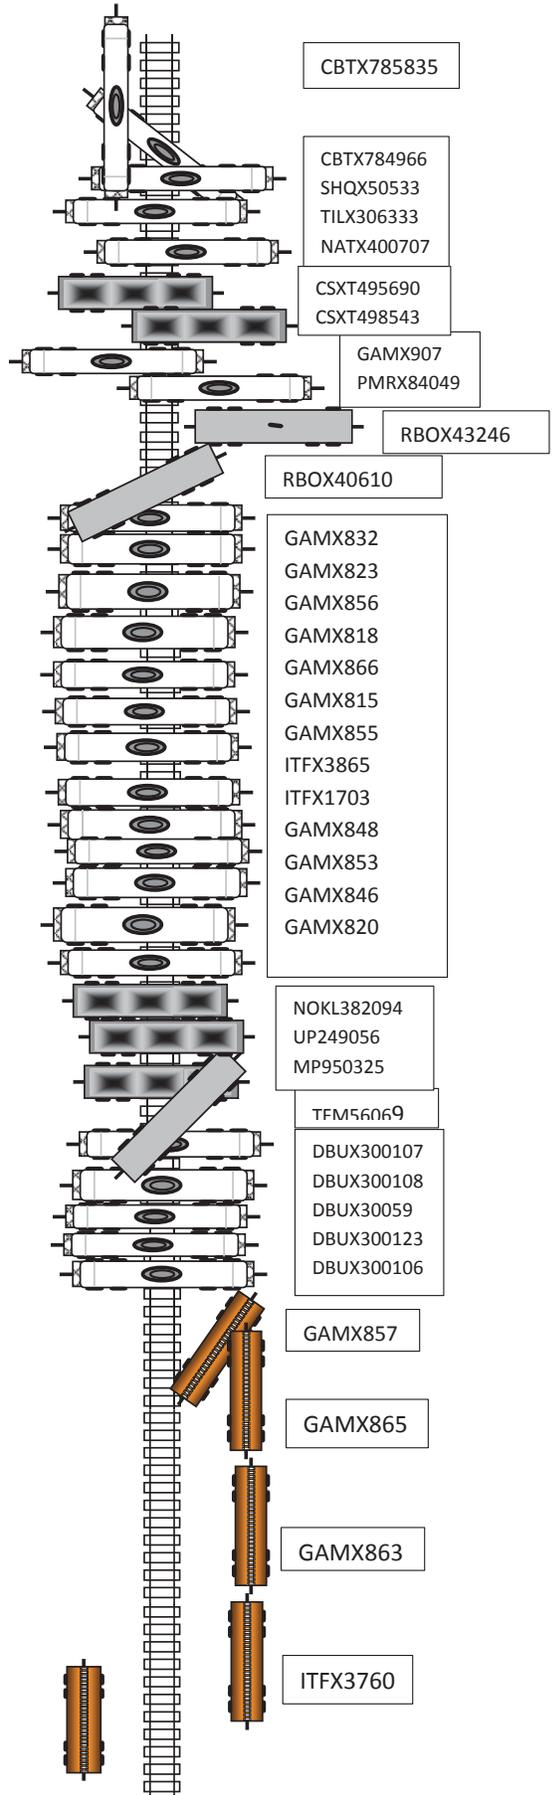
Accident Sketch

MPBMX-28  
126 LOADS  
6 EMPTY  
15603 TONS  
7479 FEET LONG

38 CARS DERAILED  
37 LOADS  
1 EMPTY  
LINE 75 - 112
