***Federal Railroad Administration
Office of Railroad Safety
Accident and Analysis Branch***

***Accident Investigation Report
HQ-2017-1231***

***CSX Transportation (CSX)
Atlanta, GA
October 5, 2017***

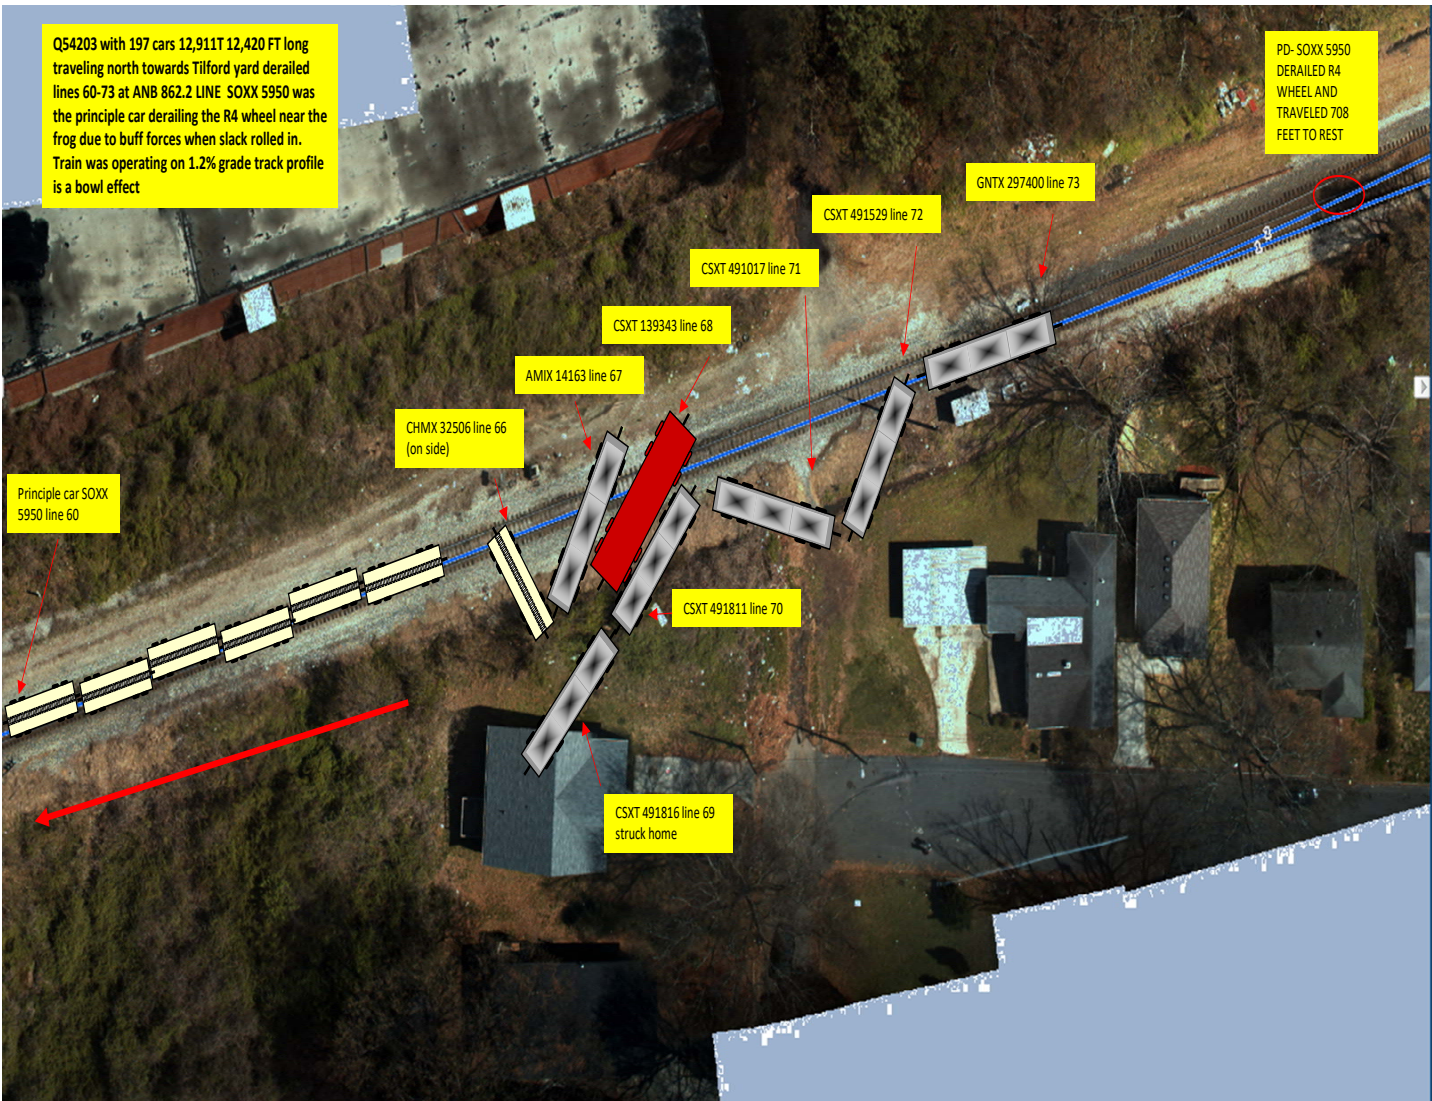
Sketch

The point of derailment (POD) was located in the turnout at South Bellwood. Cars positioned 60 through 73 derailed as follows:
