***Federal Railroad Administration
Office of Railroad Safety
Accident and Analysis Branch***

***Accident Investigation Report
HQ-2017-1204***

***Union Pacific Railroad Company (UP)
Mason City, IA
May 18, 2017***

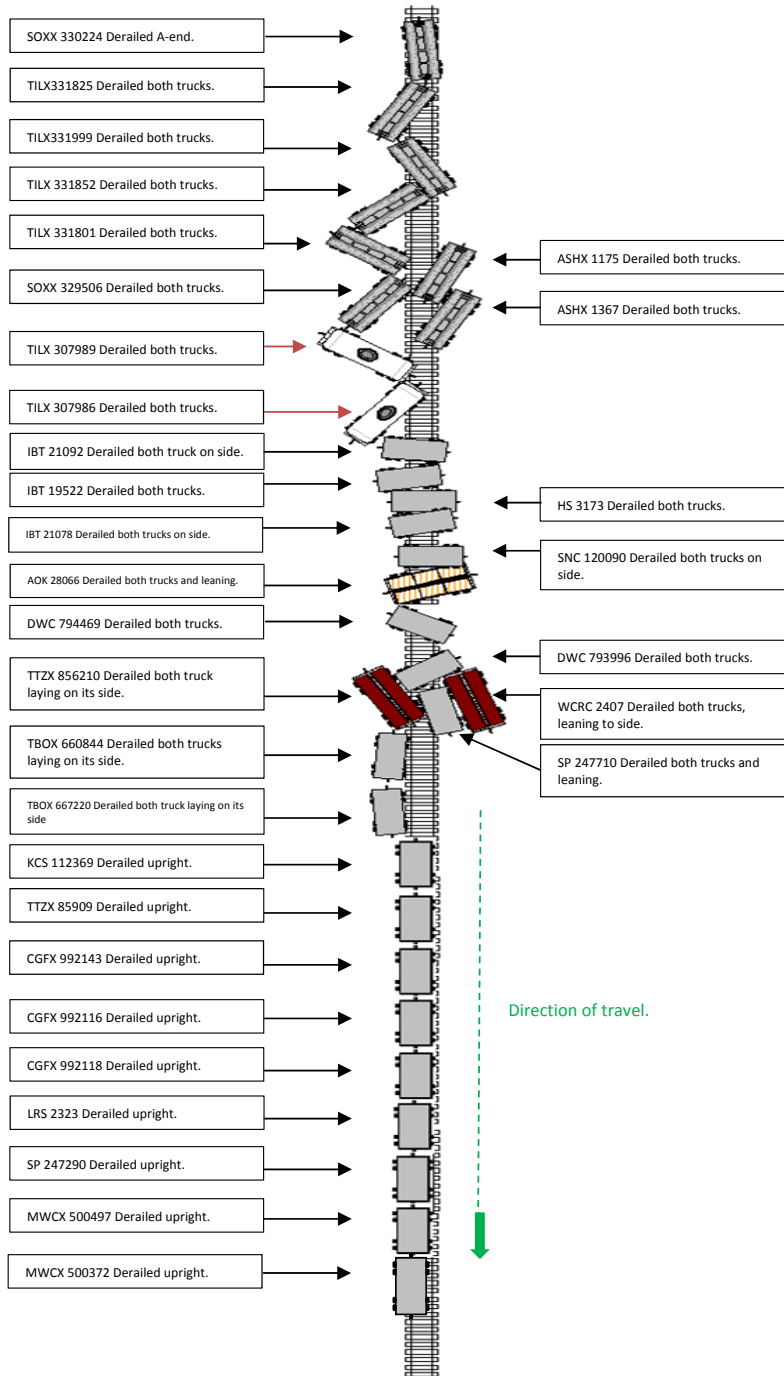
Sketch - HQ-2017-1204 Sketch

On May 18, 2017, at 11:30 a.m., CDT, a southbound Union Pacific Railroad (UP) train derailed. The derailment occurred near Mason City, Iowa, at milepost (MP) 184.27, on the single main track of the Twin Cities Service Unit, Iowa Area, Mason City Subdivision.

Train Symbol MSSNP 18 consisted of 5 locomotives, 121 loads, and 25 empties. The train was traveling at a recorded speed of 33 mph when it experienced an undesired emergency brake application. A total of 32 cars derailed, including 2 hazardous materials cars. The derailed cars were the 87th through the 118th cars from the head-end of the train. The train crew reported having an uneventful trip prior to that point.

Conclusion: FRA determined excessive buff force on the empty cars mid-train was the primary cause of this derailment.

In response to derailment prevention analysis of the train, UP has established a new block and placement requirement that requires the placement of these EOCC cars (loads and empties) at the rear of the trains. By doing this, it substantially reduces the risk of derailment of similar large trains operating over undulating territory.
