***Federal Railroad Administration
Office of Railroad Safety
Accident and Analysis Branch***

***Accident Investigation Report
HQ-2018-1262***

***BNSF Railway (BNSF)
Oswego, Montana
Saturday, April 7, 2018***

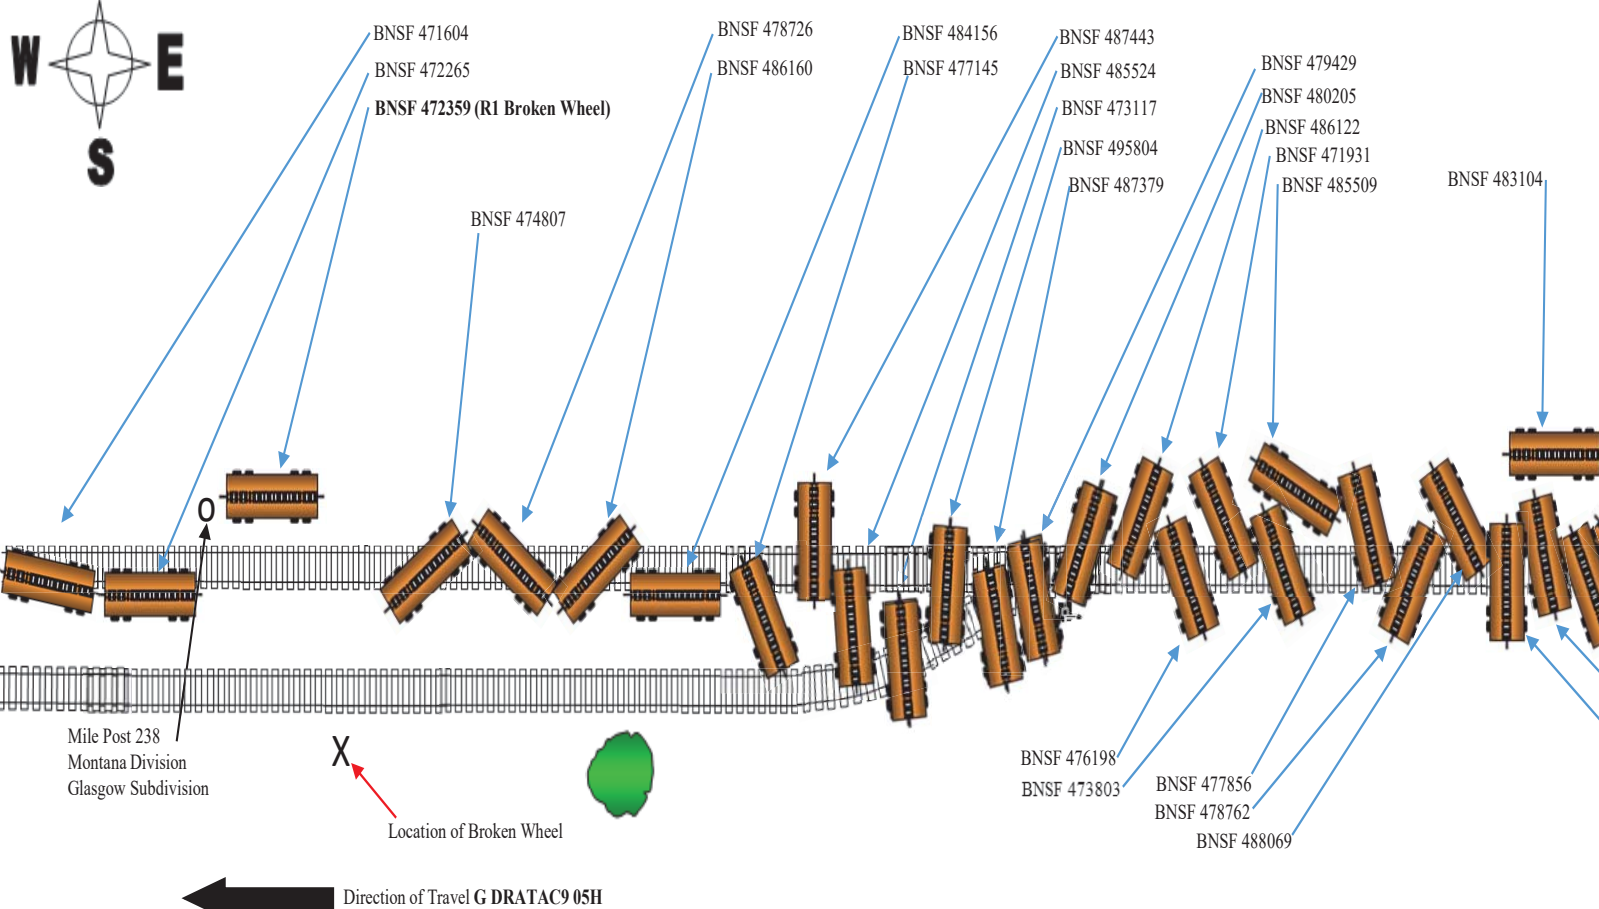
Sketch - HQ-2018-1262 Sketch

The point of derailment was later determined to have occurred at MP 237.1 with the ensuing pile-up occurring at MP 237.8.
