***Federal Railroad Administration
Office of Railroad Safety
Accident and Analysis Branch***

***Accident Investigation Report
HQ-2018-1263***

***Union Pacific Railroad (UP)
Monahans, Texas
Wednesday, April 18, 2018***

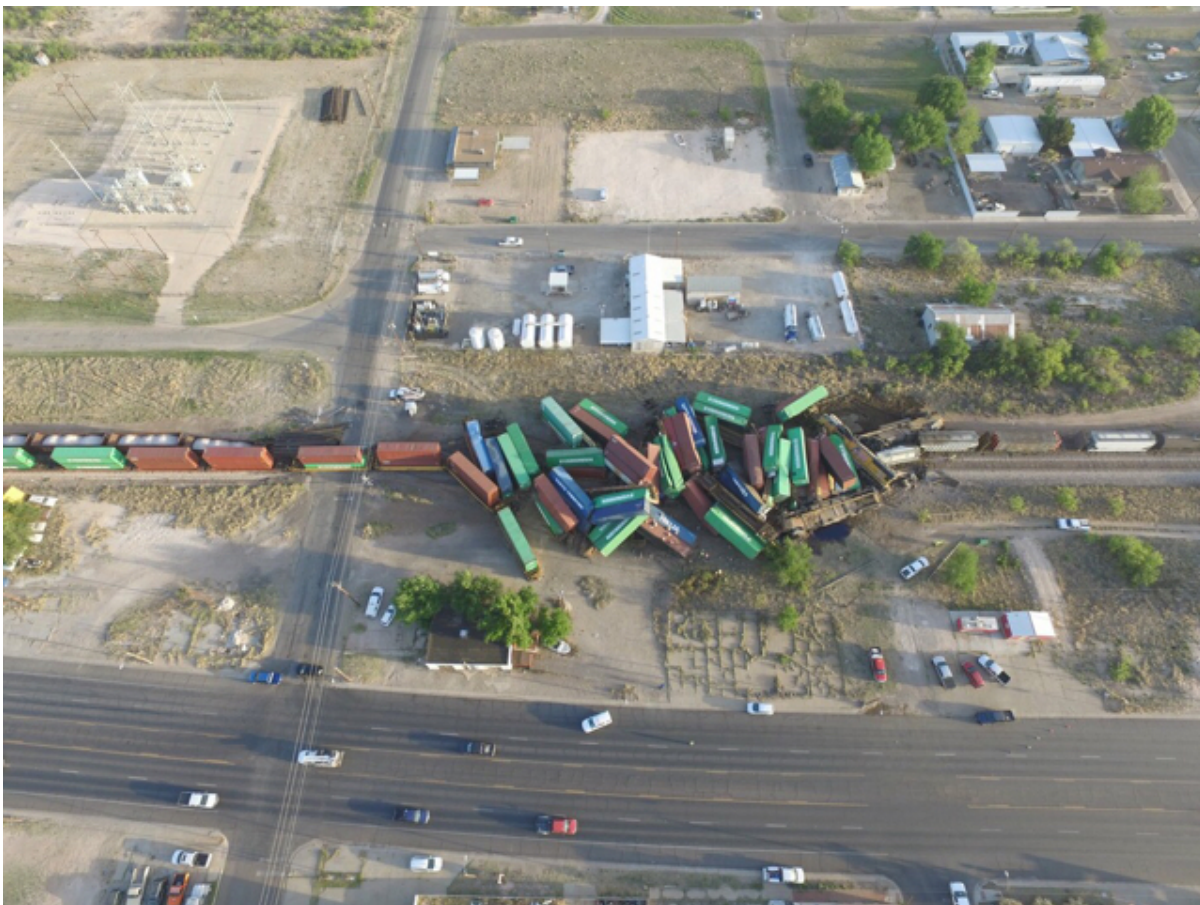
Sketch - Aerial View

HQ-2018-1263
Drone still shot provided by Union Pacific Railroad

Aerial View of Union Pacific Railroad Monahans Texas Derailment
