***Federal Railroad Administration
Office of Railroad Safety
Accident and Analysis Branch***

***Accident Investigation Report
HQ-2017-1194***

***Union Pacific Railroad Company (UP)
Graettinger, IA
March 10, 2017***

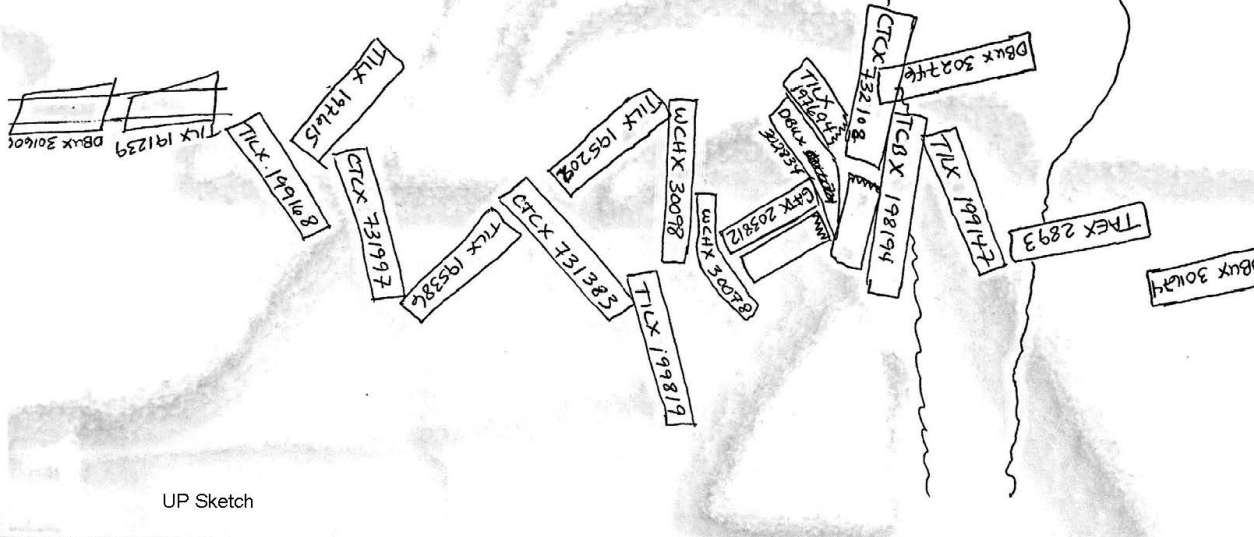
UP Sketch

* There were no signals, switches, grade crossings or other structures besides the destroyed Jack Creek bridge in the area of the derailment.

[1] Car TAEX 2909 is represented in the accident sketch as GATX 203812. This is due to the only visible markings due to the damage to the car were the top stencil that was not covered when the car ownership changed and the car was re-stenciled. This car was built by GATX in 2007 and sold to Anderson Company in 2015 when it was re-stenciled to TAEX 2909. All required stencil markings and AEI tags were correctly TAEX 2909, but damaged and unreadable in the accident.
