***Federal Railroad Administration
Office of Railroad Safety
Accident and Analysis Branch***

***Accident Investigation Report
HQ-2018-1253***

***Norfolk Southern (NS)
Attica, NY
February 15, 2018***

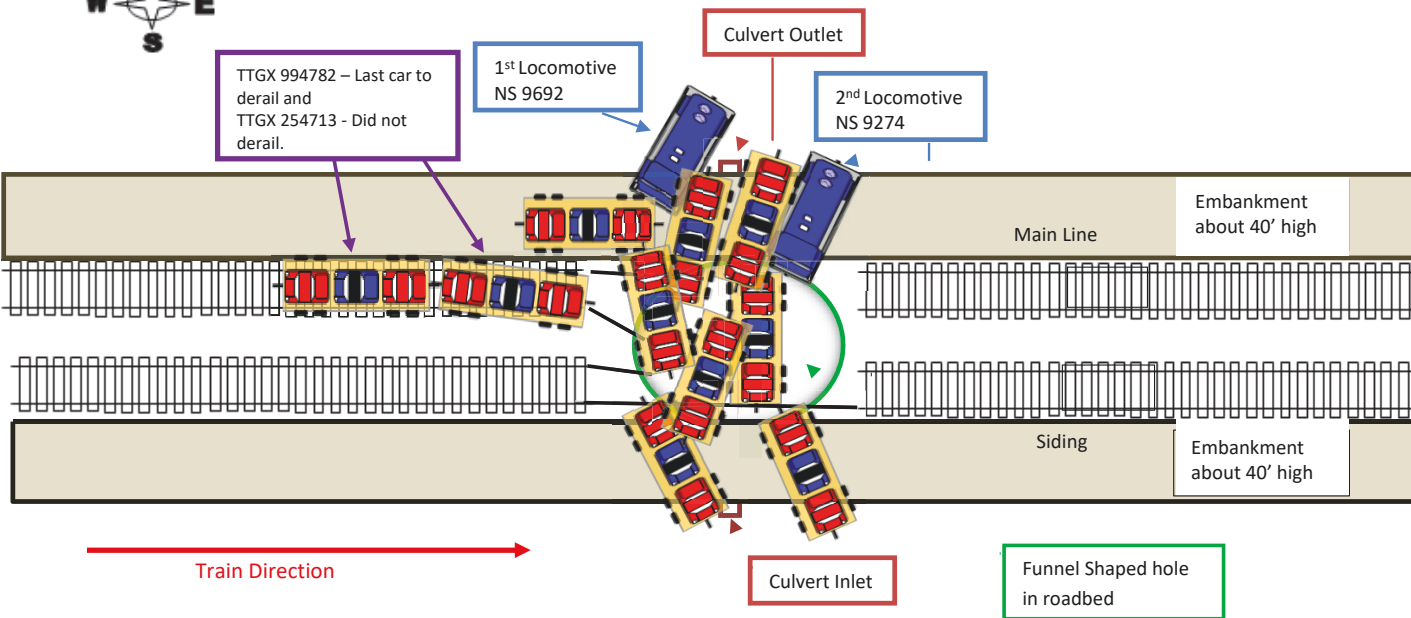
Sketch - Up-dated Sketch

NS MP SR390.67 on Southern Tier in Attica, NY. First nine cars which derailed:

1. TTXG 964643
2. TTXG 995031
3. TTXG 988455
4. TTXG 852922
5. TTXG 971708
6. TTXG 985838
7. TTXG 158434
8. TTXG 985731
9. TTXG 994782
10. TTXG 254713 – Did not derail
