FULL-SCALE SHELL IMPACT TEST OF A DOT-111 TANK CAR

On October 30, 2018, the Federal Railroad Administration (FRA) conducted a full-scale shell impact test of a DOT-111A100W (DOT-111) tank car meeting voluntary industry standard CPC-1232 at the Transportation Technology Center (TTC) in Pueblo, CO. The shell of the car was struck at its mid-length by a 297,000-pound ram car equipped with a 12-inch by 12-inch impactor. [Figure 1](#) shows the tank car in its pre-test position against the impact wall at TTC.

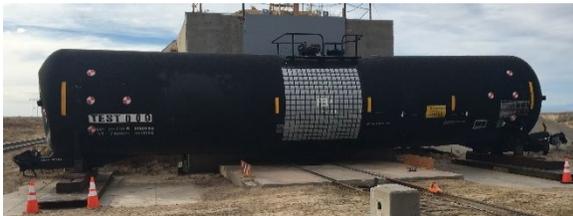
Figure 1. Pre-test Photo of DOT-111 Tank Car

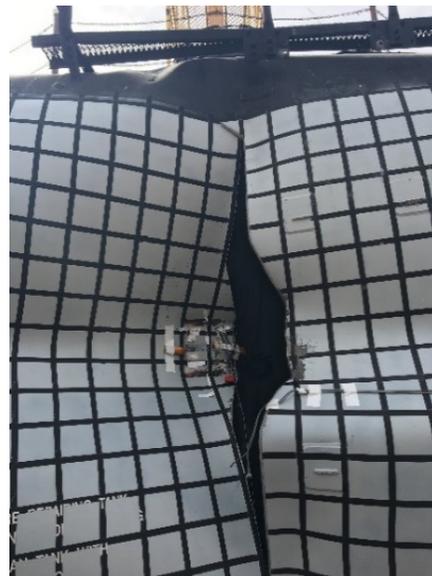
The tank was punctured after an indentation of ~57 inches, at a peak force of ~900,000 pounds. Review of the test measurements showed that the impactor slowed to approximately 0.5 mph when puncture occurred, confirming the model prediction that an impact speed of 13.9 mph only slightly exceeds the speed necessary to

puncture this tank car. [Figure 2](#) shows the punctured tank car shell. The puncture initiated under a corner of the impactor and ran vertically along a circumferential weld seam.

Figure 2. Post-test Photo of the Punctured Shell

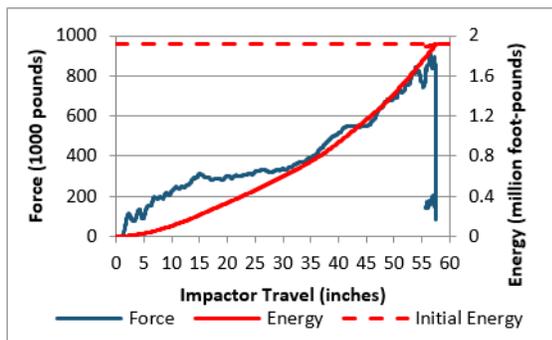
The impact occurred at 13.9 mph and resulted in puncture of the tank. The force-displacement and energy-displacement results from the test are shown in Figure 4, as well as the initial kinetic energy of the ram. These results are taken from the average of the five longitudinal accelerometers on the ram car. A CFC-60 filter was used on these results. From this graph, it is apparent the impactor's energy nearly dissipated at the time of puncture and that the impactor rebounded from the tank after puncture.

Figure 4. Test Force- and Energy-displacement Results at 13.9 mph

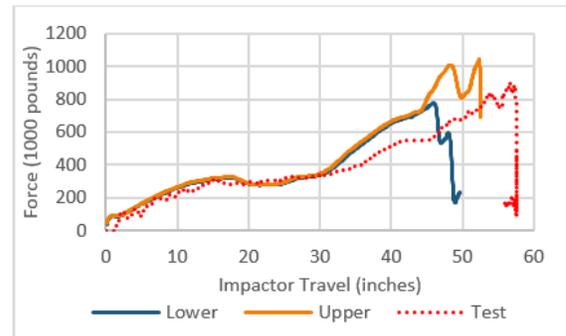
The force-displacement results from the test and from the pre-test FE model, run at 14 mph, are compared to one another in Figure 5. The model was run with two different estimated tank shell materials: (1) lower represents a lower-bound estimate for strength and ductility, and (2) upper represents an upper-bound estimate on strength and ductility. The two pre-test FE models' results both predicted puncture at 14 mph, which is consistent with the test result. Each pre-test FE model exhibits qualitative agreement with the test measurements, but the FE results estimated a stiffer response after roughly 30 inches of indentation.

Figure 5. Pre-test FEA (14 mph) and Test (13.9 mph) Force-displacement Results

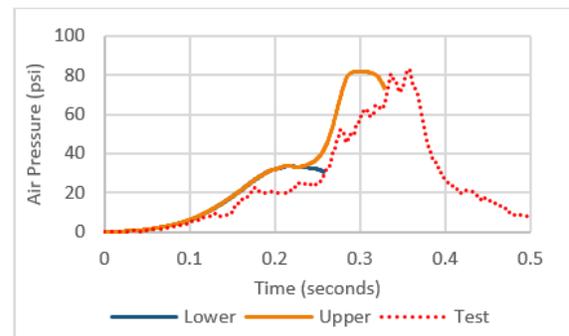
The average air pressures in the pre-test FE models are compared to the average air pressure measured during the test in Figure 6. Overall, the models exhibited a qualitatively similar response to the test measurements, but the air pressure increased more gradually in the test than in the models subsequent to 0.1 seconds.

Figure 6. FEA and Test Average Air Pressure Results
