***Federal Railroad Administration
Office of Railroad Safety
Accident and Analysis Branch***

***Accident Investigation Report
HQ-2018-1279***

***Norfolk Southern Railway (NS) Derailment
Eden, Alabama
July 5, 2018***

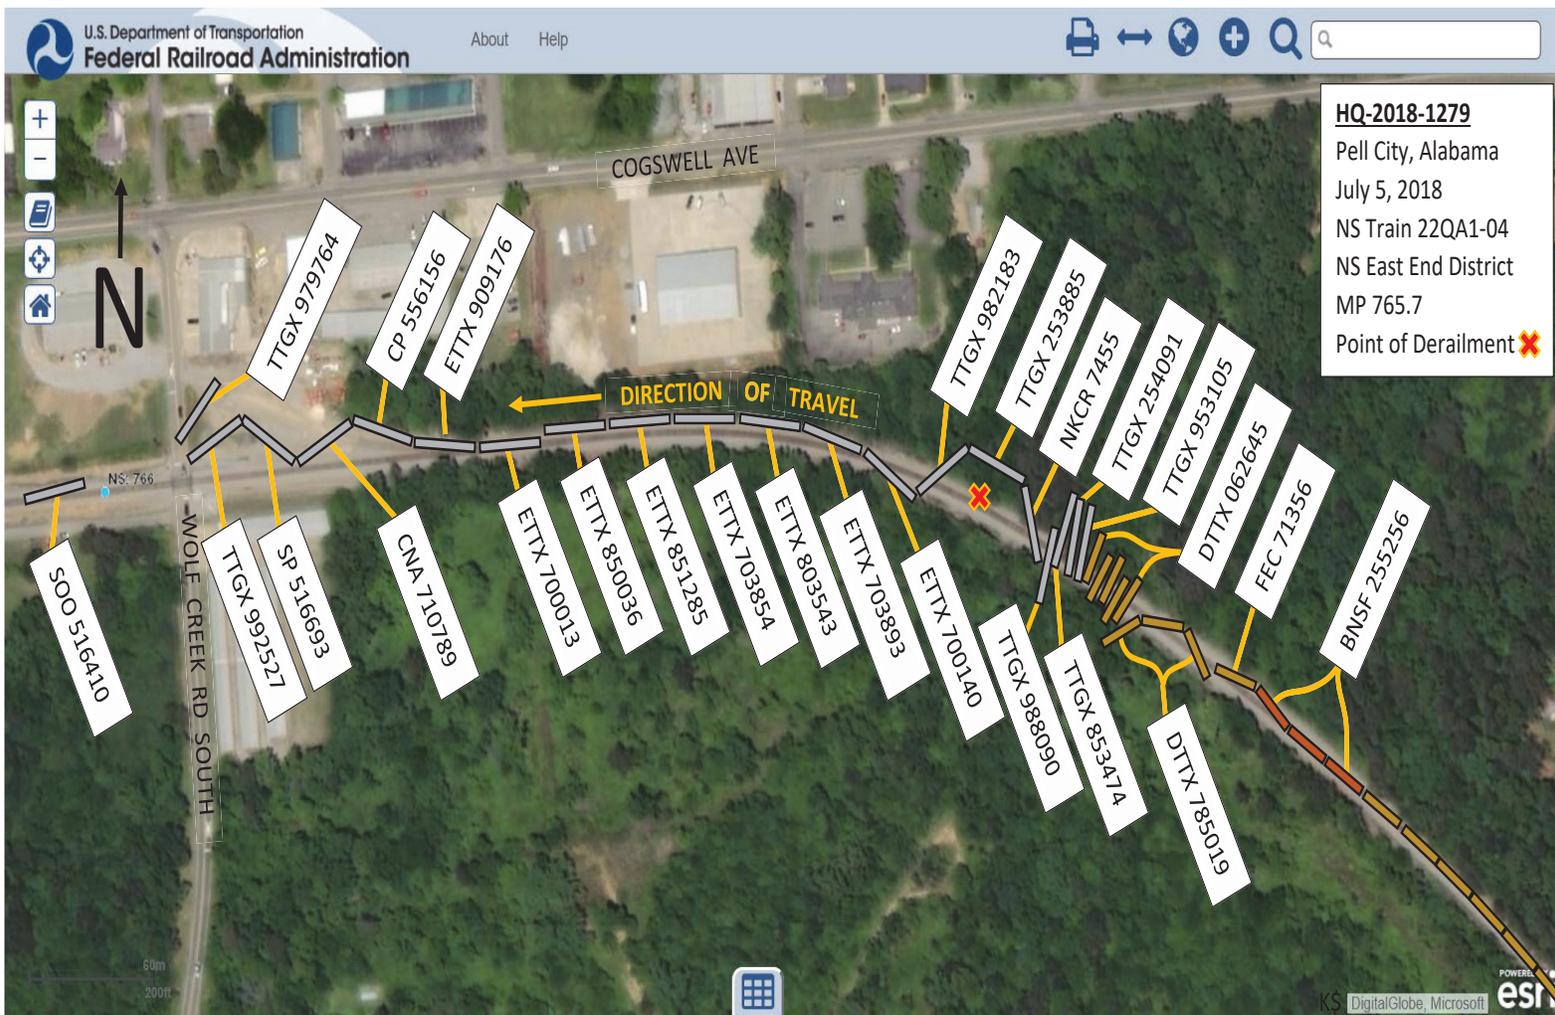
HQ-2018-1279
Sketch - Page 1 of 1

The Conductor, NS Road Foreman, and other railroad personnel assessed the scene and discovered 25 cars derailed at MP 765.65 in a general pile-up. The derailed cars, consist lines 41 to 65, consisted of 14 empty auto racks, 7 loaded auto racks, and 4 intermodal cars. The derailed intermodal cars were 3-unit articulated cars totaling 12 wells. Train 1 was operating on single main track in ABS territory on a clear signal, at a recorded speed of 40 mph and in light dynamic braking on a descending grade.
