***Federal Railroad Administration
Office of Railroad Safety
Accident and Analysis Branch***

***Accident Investigation Report
HQ-2016-1141***

***BNSF Railway Company (BNSF)
Panhandle, TX
June 28, 2016***

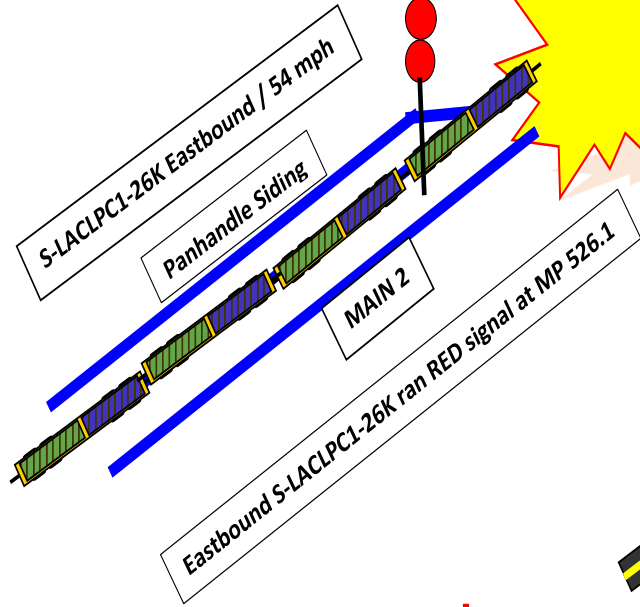
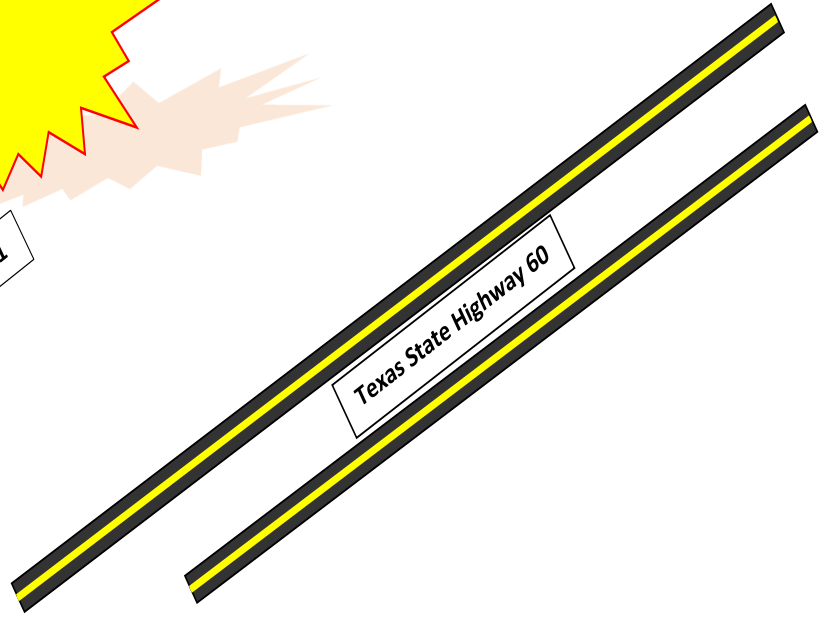
Panhandle Sketch

BNSF Panhandle, TX Train Collision – June 28, 2016
MP 525.4 Panhandle Sub
NOT TO SCALE

Q = 5 Locomotives & 3 Freight Cars Derailed
S = 3 Locomotives & 10 Freight Cars Derailed
Massive Fire

Westbound Q-CHISBD6-27L was lined to enter siding at MP 526.1
