***Federal Railroad Administration  
Office of Railroad Safety  
Accident and Analysis Branch***

***Accident Investigation Report  
HQ-2018-1249***

***Amtrak (ATK)  
Crozet, VA  
January 31, 2018***

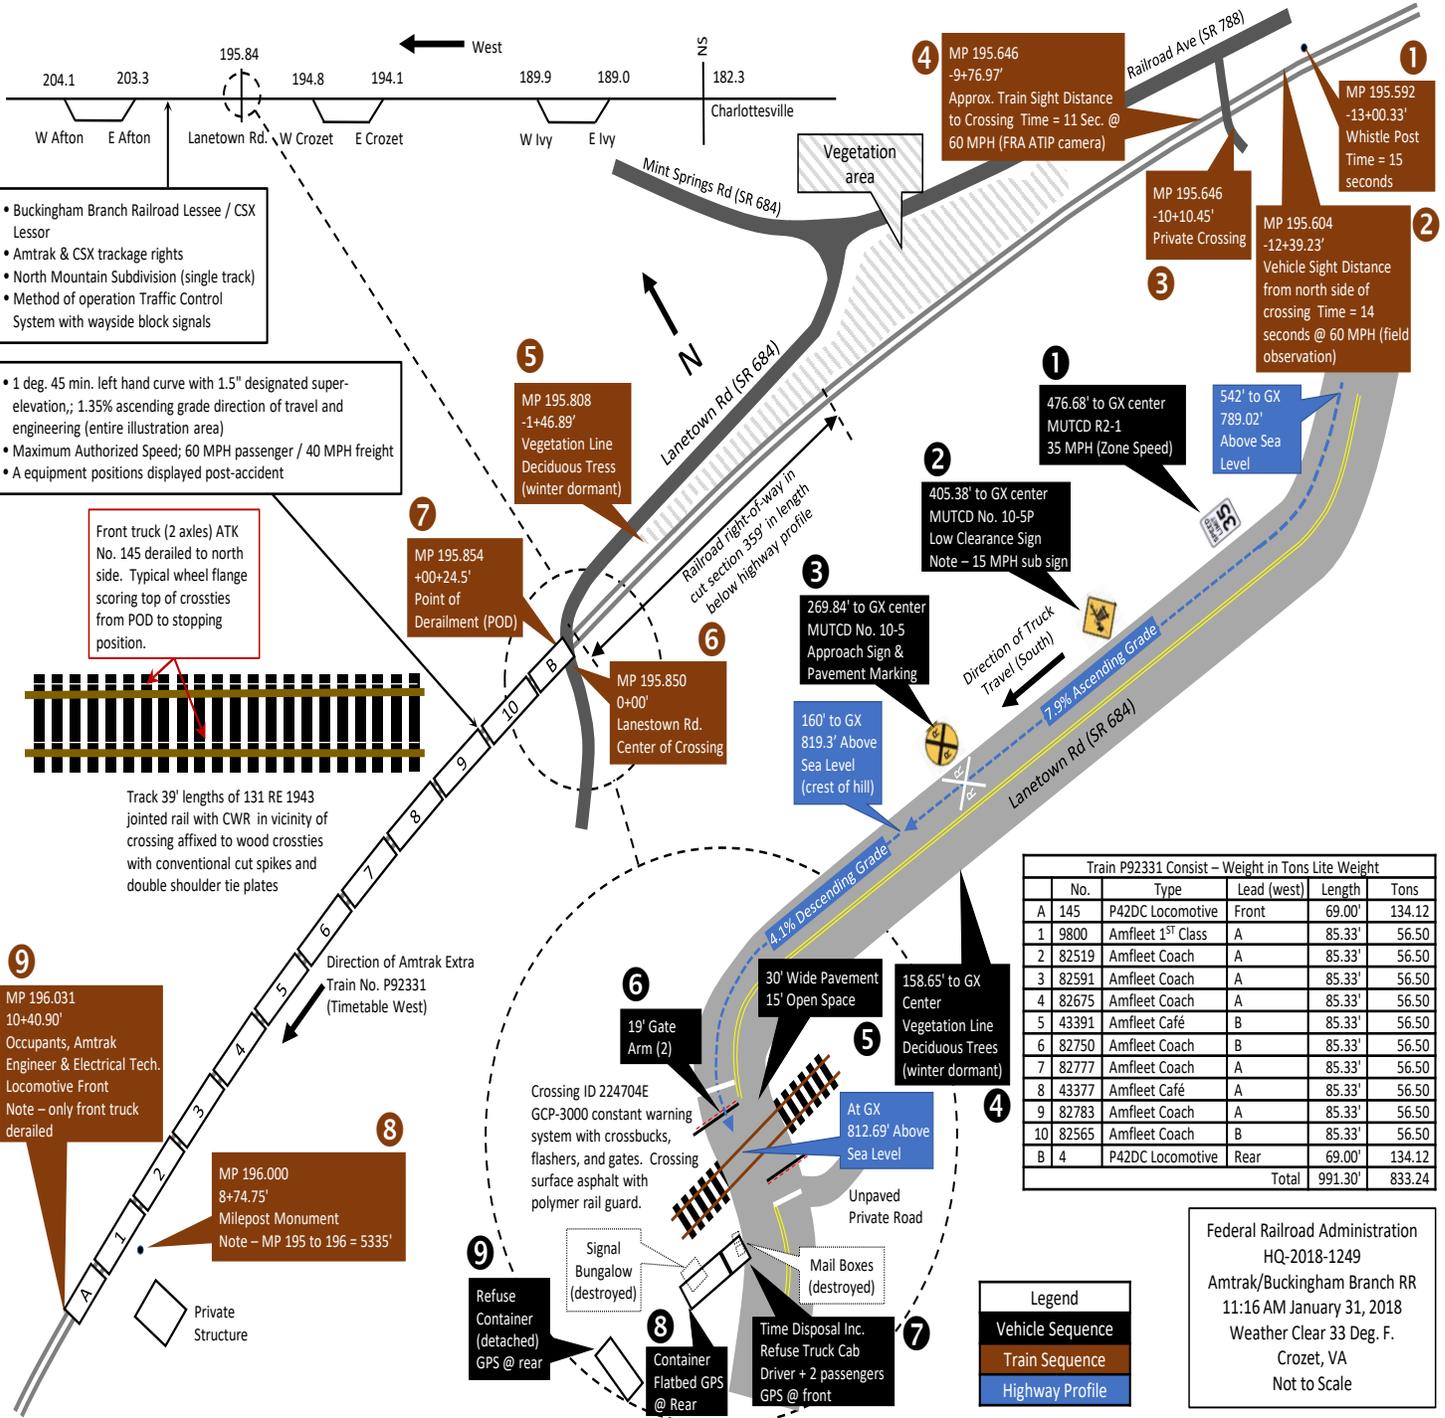
Sketch - Accident Sketch

Front truck (2 axes) ATK No. 145 derailed to north side. Typical wheel flange scoring top of crossties from POD to stopping position.

MP 196.031  
10+40.90'  
Occupants, Amtrak Engineer & Electrical Tech. Locomotive Front  
Note - only front truck derailed
