***Federal Railroad Administration
Office of Railroad Safety
Accident and Analysis Branch***

***Accident Investigation Report
HQ-2018-1265***

***CSX Transportation (CSX) Derailment
Lebanon Junction, Kentucky
May 1, 2018***

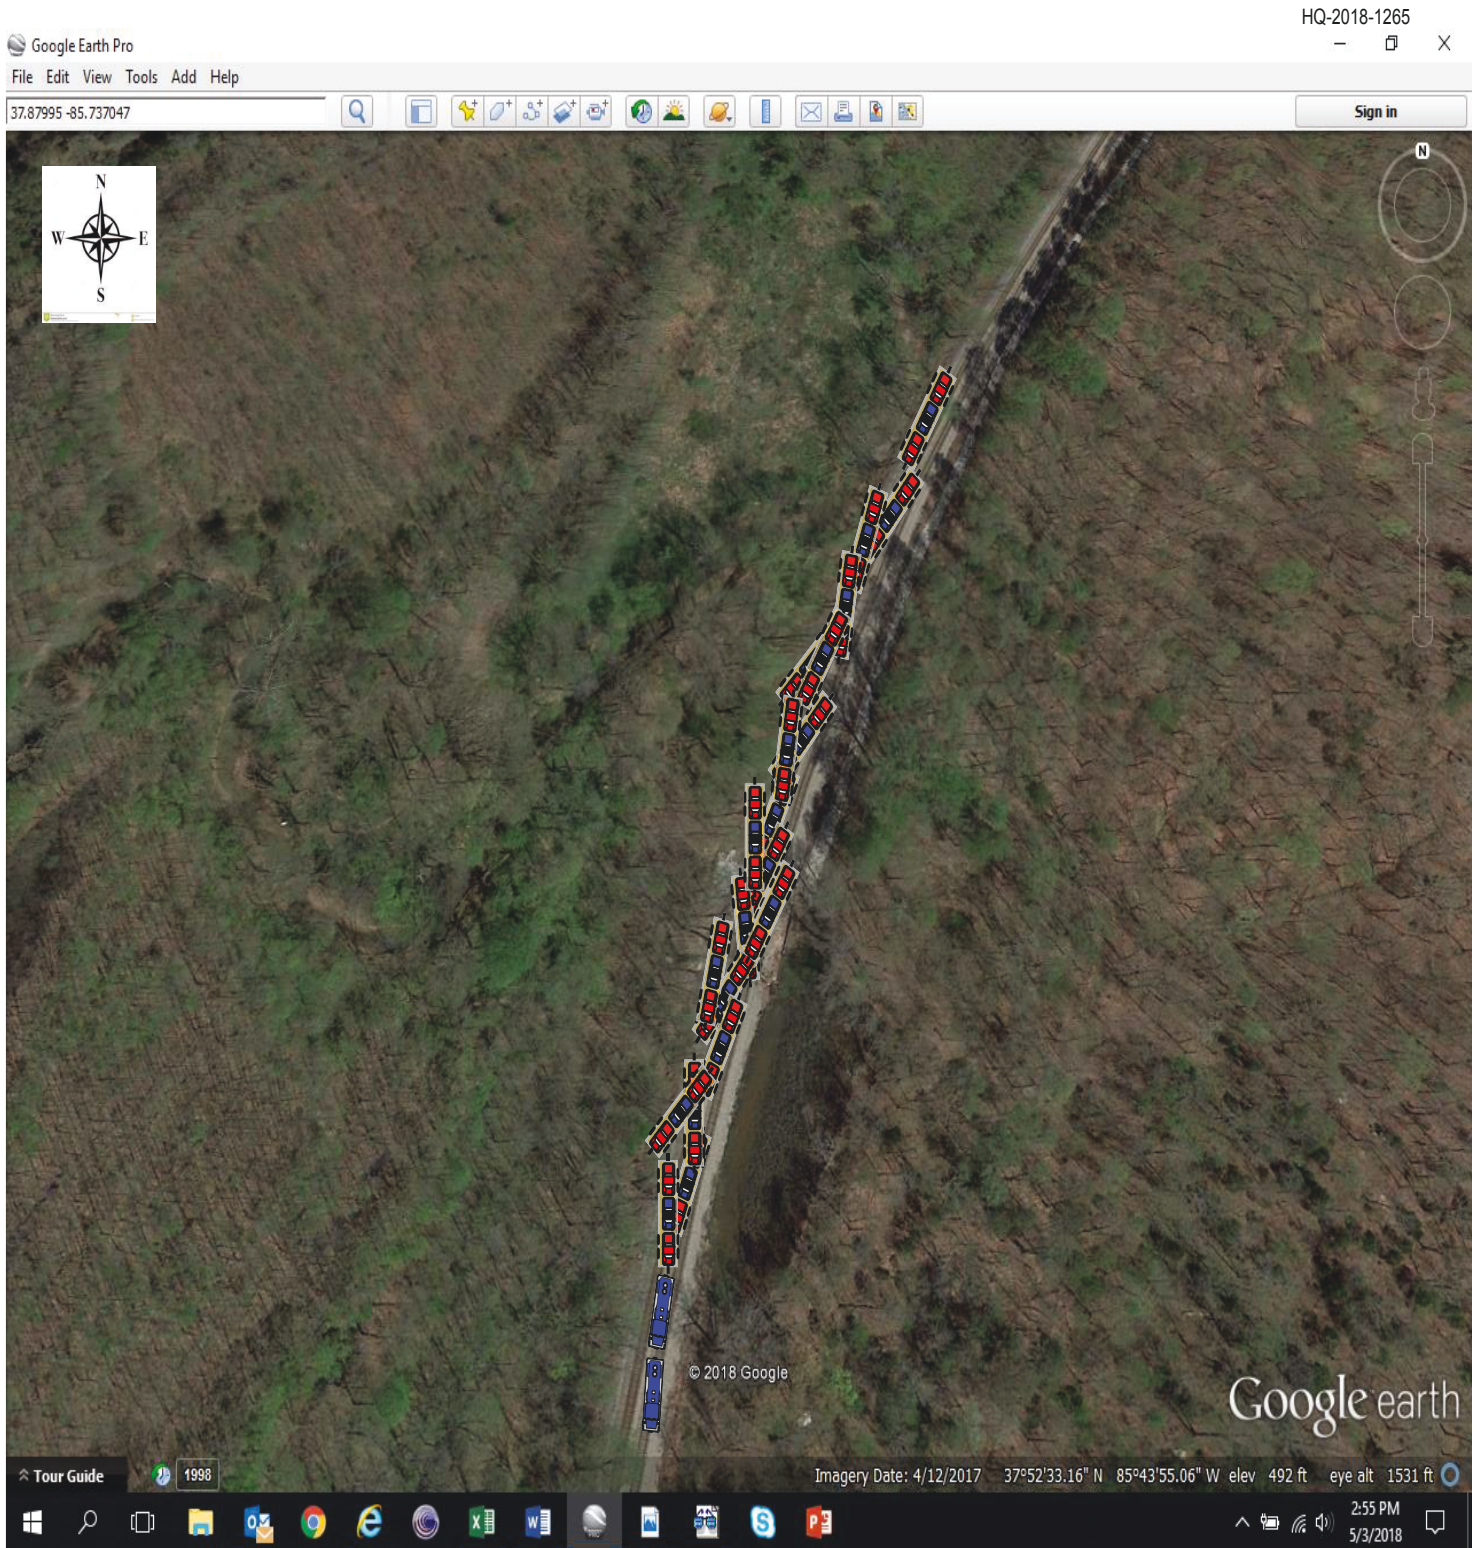
Sketch - Sketch

The accident occurred on the CSX Louisville Division, Mainline Subdivision, at Milepost (MP) 00026.7, on main track Number 1, near the town of Lebanon Junction, Kentucky. The Mainline Subdivision runs geographic northeast and southwest, and timetable direction is south. Timetable direction will be used throughout this report. The method of operation for this subdivision is Centralized Traffic Control, with a Positive Train Control (PTC) overlay. Beginning at MP 00026.0, there are two main tracks identified, from west to east, as Main Track 1 and Main Track 2. The maximum authorized speed for the Mainline Subdivision is 60 mph, and there were no active speed restrictions in effect. Both Main Tracks have a descending 0.03-percent grade, and are tangent from MP 00026.0 until a 2-degree, left hand curve at about MP 00026.6, and then become tangent again at MP 00027.0. A culvert runs beneath the track at about MP 00026.7.

At approximately 3:21 p.m., EDT, Train 1 approached MP 00026.7 operating in throttle notch 6 as the train speed increased to 57 mph when the crew noticed a severe track misalignment ahead. The Engineer did not have enough time to make any changes to the controls due to the limited sight distance. As Train 1's locomotives traversed the track misalignment, they derailed and rolled onto their left side, with the head 19 cars derailed in a general pileup. The event recorder on the lead locomotive indicates Train 1 came to a complete stop at 3:21:55 p.m., EDT.
