***Federal Railroad Administration  
Office of Railroad Safety  
Accident and Analysis Branch***

***Accident Investigation Report  
HQ-2018-1266***

***BNSF Railway Company (BNSF)  
Saginaw, Texas  
Wednesday, May 2, 2018***

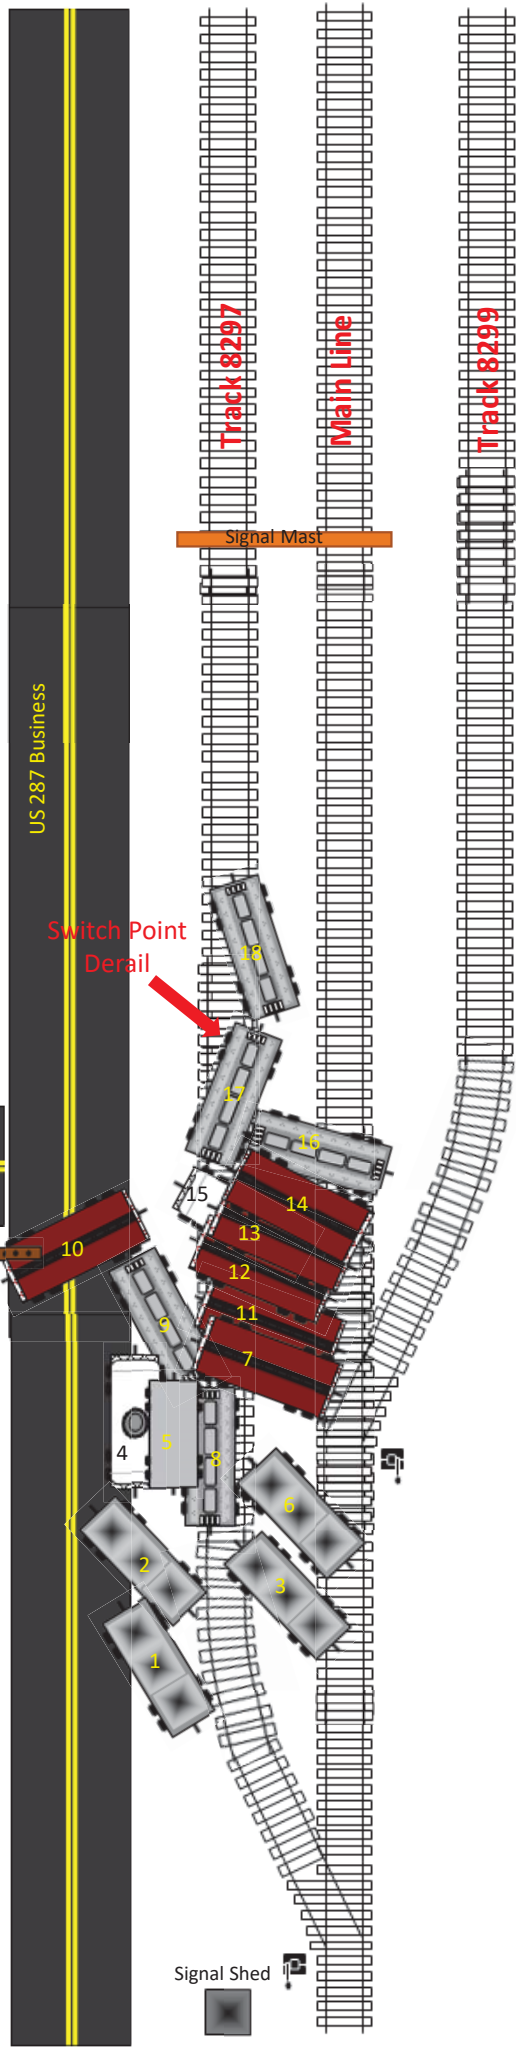
# Final Railcar Resting Position

- 1 – BN 575509 On It's Side
- 2 – BN 954133 On It's Side
- 3 – BN 551423 On It's Side
- 4 – FHRX 649548 On It's Top
- 5 – BN 57556
- 6 – ATSF 85877
- 7 – ATSF 81786
- 8 – EQUX 620178 On It's Side
- 9 – EQUX 621478 On It's Side
- 10 – DWC 627739
- 11 – WC 37985
- 12 – LW 880071
- 13 – COER 875165
- 14 – TTX 862468
- 15 – GATX 3930 On It's Side
- 16 – CITX 200391
- 17 – EQUX 13625
- 18 – CITX 200307

Eighteen of the 41 rail cars derailed. Cars 1 through 3, 8, 9, and 15 derailed and rolled onto their side. Car four completely rolled over, resting on its top. Cars 5 through 7, 10 through 14, and 16 through 18 derailed and remained upright. Cars 19 through 41 did not derail.
