***Federal Railroad Administration
Office of Railroad Safety
Accident and Analysis Branch***

***Accident Investigation Report
HQ-2018-1269***

***CSX Derailment
Alexandria, Virginia
May 19, 2018***

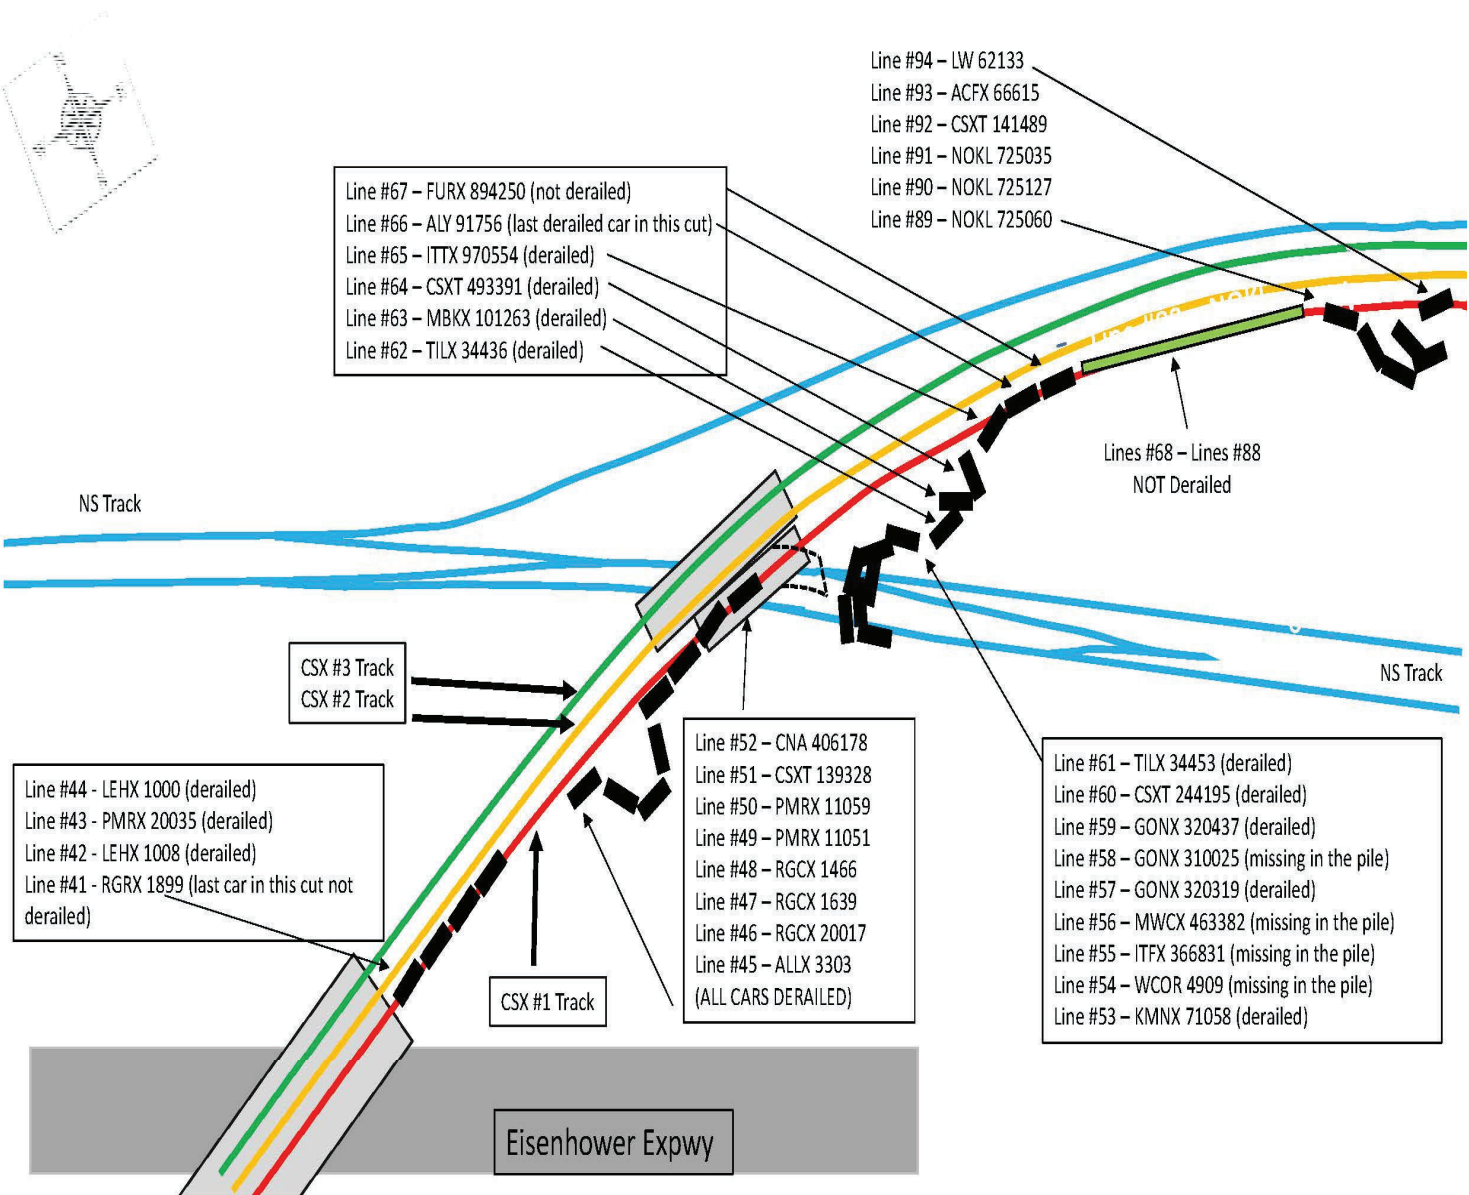
Sketch - Accident Sketch

The derailment occurred at MP CFP102.9 at a subgrade fill failure due to the excessive rain in the area. The point of derailment is 238 feet north of the bridge on Main Track 1 and about 60 feet south of the fill failure. The fill failure was limited to the east (field side) of Main Track 1, causing it to suddenly, and severely, warp under movement.
