***Federal Railroad Administration  
Office of Railroad Safety  
Accident and Analysis Branch***

***Accident Investigation Report  
HQ-2018-1277***

***CN Rear-End Collision  
Weirgor, Wisconsin  
June 16, 2018***

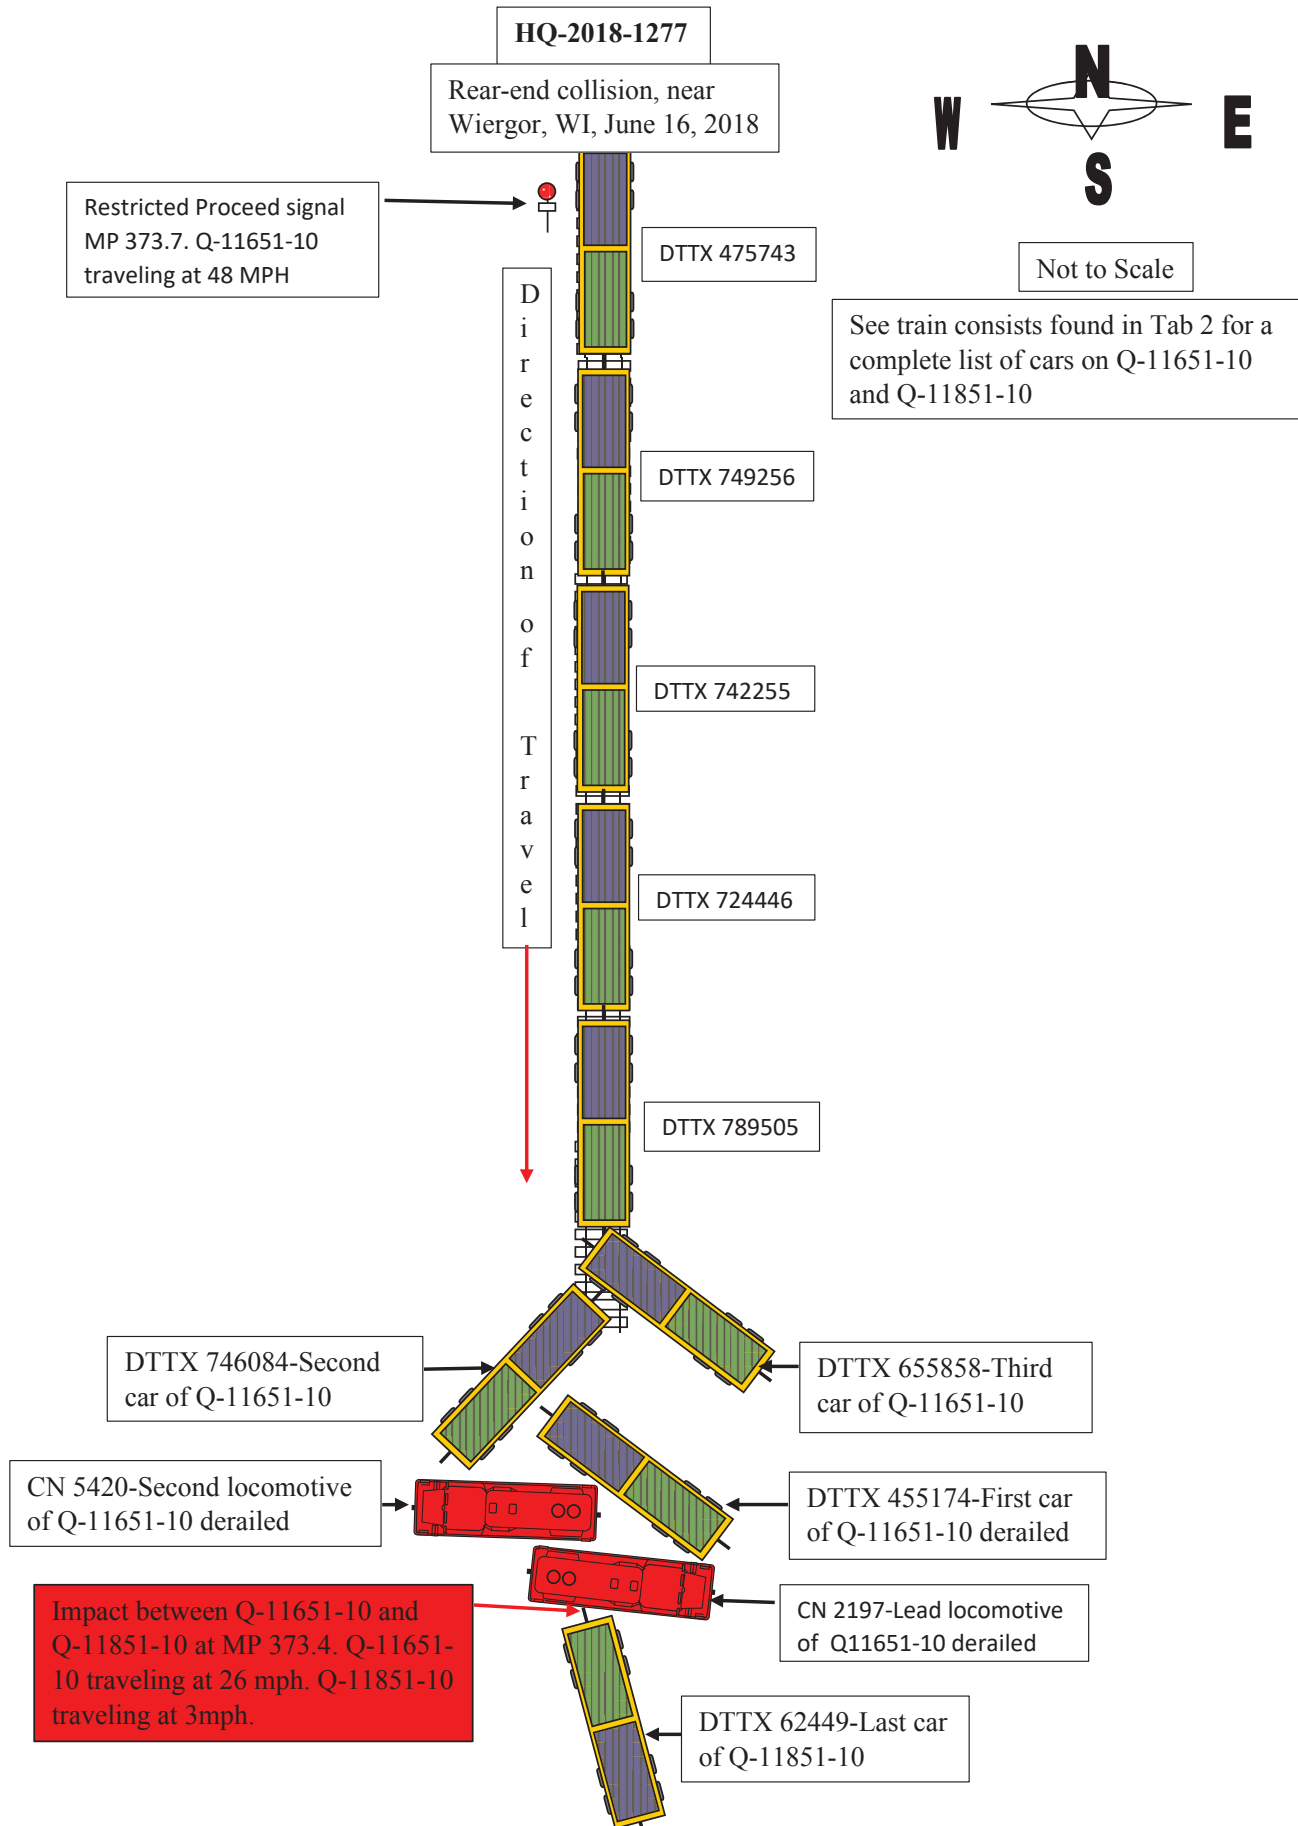
Sketch - Accident Sketch

At impact, the lead locomotive on Train 1 rode up on top of the last car of Train 2 and fell over on its side. The second locomotive followed the lead locomotive on top of the rear car in Train 2, and fell the opposite direction on its side. The three lead cars on Train 1 derailed upright, as did the last car on Train 2. The last car on Train 2 was a five-well intermodal car, and only the one rear well derailed. Both locomotives on Train 1 ruptured their fuel tanks and caught fire, which spread to the first two cars of Train 1 and the last car of train 2. The Train 1 crew crawled out of the lead locomotive through the door on the front of the engine. Both crew members recalled crawling through thick smoke and flames as they exited. Both crew members exited the engine and stayed on the same side of the track as they made their way toward the head end of Train 2, and the highway-grade crossing at Applebee Road.
