***Federal Railroad Administration  
Office of Railroad Safety  
Accident and Analysis Branch***

***Accident Investigation Report  
HQ-2019-1318***

***Union Pacific (UP) Highway-Rail Grade Crossing Accident  
Athens, Texas  
January 25, 2019***

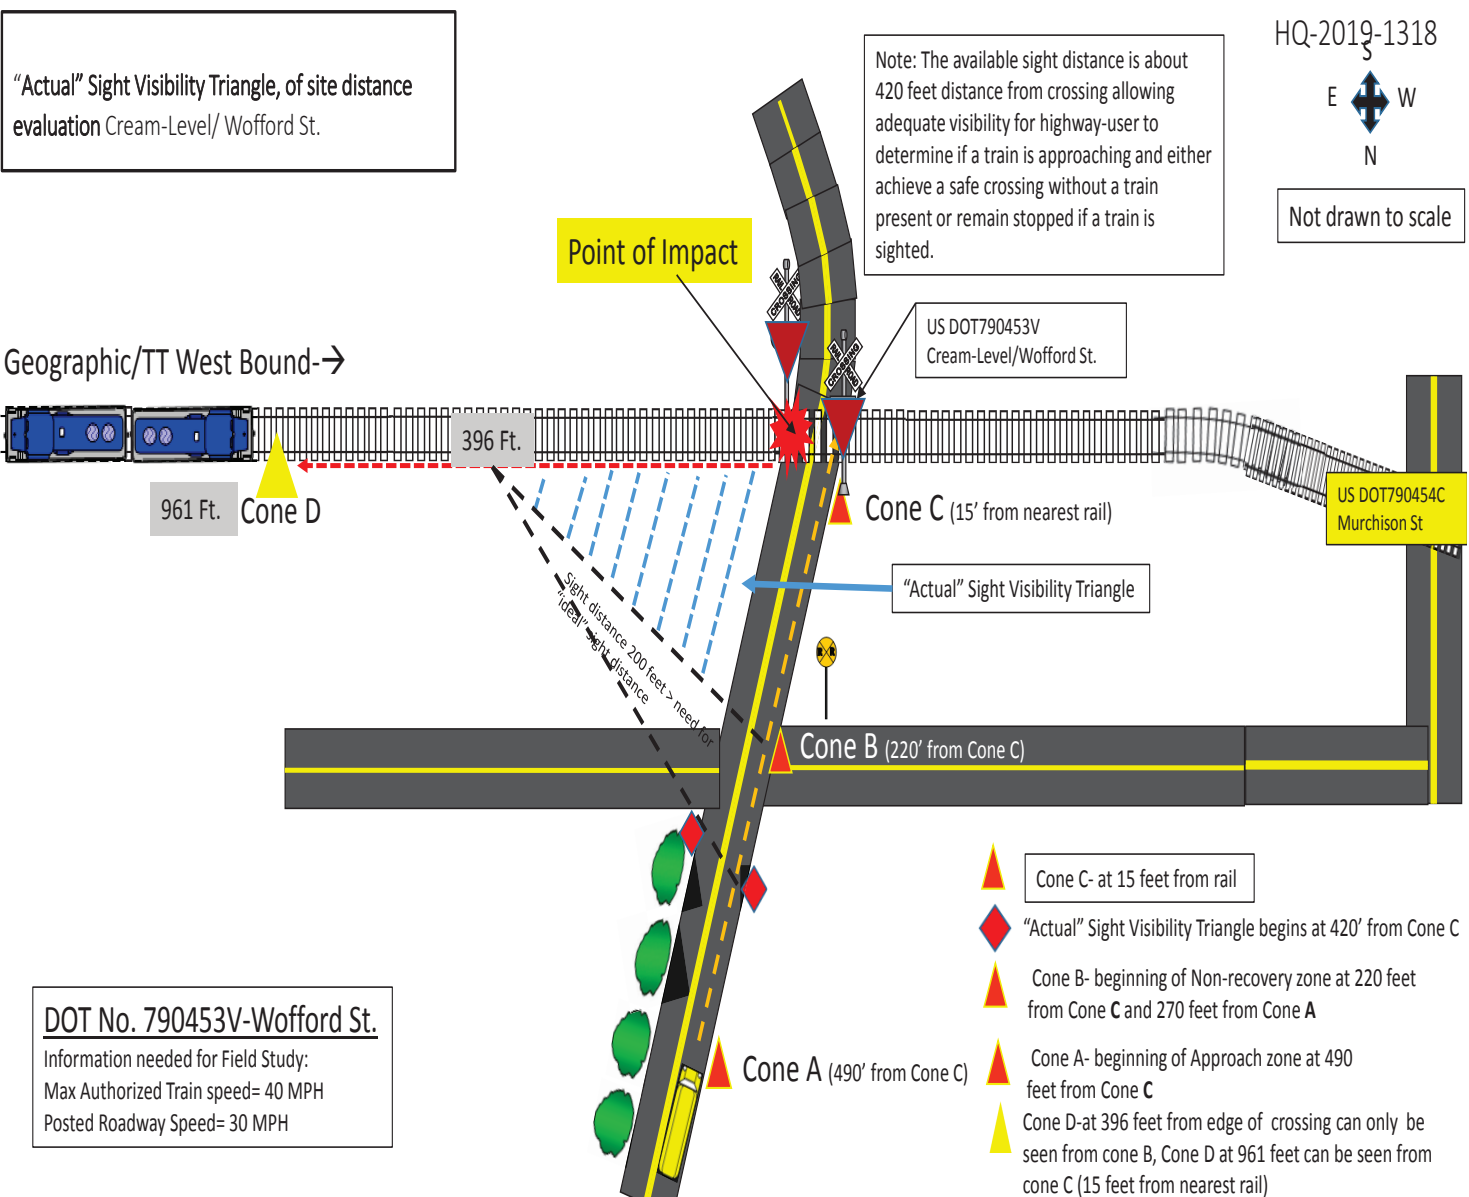
Sketch - Sketch

Clearing Sight Distance of 961 feet was available at this crossing. From a stopped position at Cone C, there is adequate visibility to see Cone D. This evaluation indicates that from a stopped position, the operator of a vehicle such as a long-wheel base school bus, had adequate sight distance of 961 feet down the tracks. Had Train 1 been farther than 961 feet from the crossing, at a train speed of 40 miles per hour, the school bus driver would have had enough time to safely cross the tracks before Train 1's arrival. This was not the case in this collision. Based on time-stamped still photos from the locomotive's

Forward Image Camera, the bus began moving about five seconds prior to impact. At this point, Train 1 was traveling 38 miles per hour and was in the final 300 feet of the approach when the bus moved into the crossing. This evaluation indicates that sight-distance at this crossing was not a factor in the collision.
