**Federal Railroad
Administration**

**Office of Railroad Safety
Summary Report**

Collision of Amtrak Train P09103 and CSX Train F77703

Cayce, South Carolina

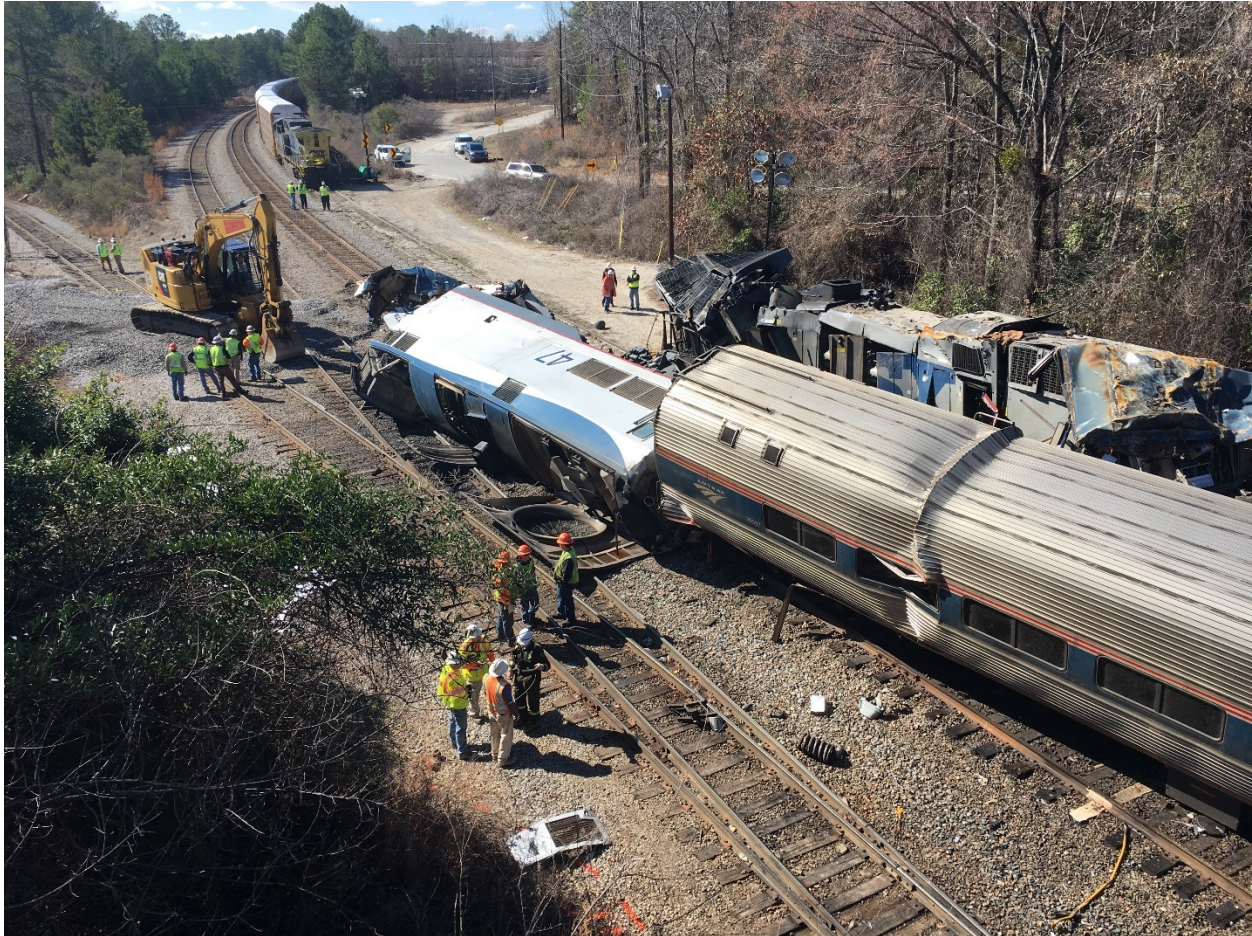
Figure 1: Accident Site

Train 2 collided head-on with Train 1 at 2:27:27 a.m., still traveling 50 mph. (See Figure 1: Accident Site) ATK 47 overrode CSXT 130, with the nose and operating cab of ATK 47 folding completely under its deck. ATK 47 then rolled over on its left side and off CSXT 130 coming to rest on its side about 150 feet from the point of impact. The first coach car, ATK 25037, followed ATK 47 atop CSXT 130 before also rolling to the left and on its side. It experienced buckling in the roof and partial loss to the occupant volume in the front third of the car. The second coach car, ATK 25072, derailed the lead trucks coming to rest upright. The third coach car, ATK 25020, did not derail. The café car, ATK 28002, buckled over 90-degrees in the

middle into a “V” shape. The two sleeper cars, ATK 62012 and ATK 62008, and the baggage car, ATK 61048, all derailed and came to rest upright.

Train 1 was shoved back 15 feet from the impact. The collision posts of CSXT 130 were sheared off as ATK 47 overrode the locomotive, but none of the cars or locomotives from Train 1 were derailed.

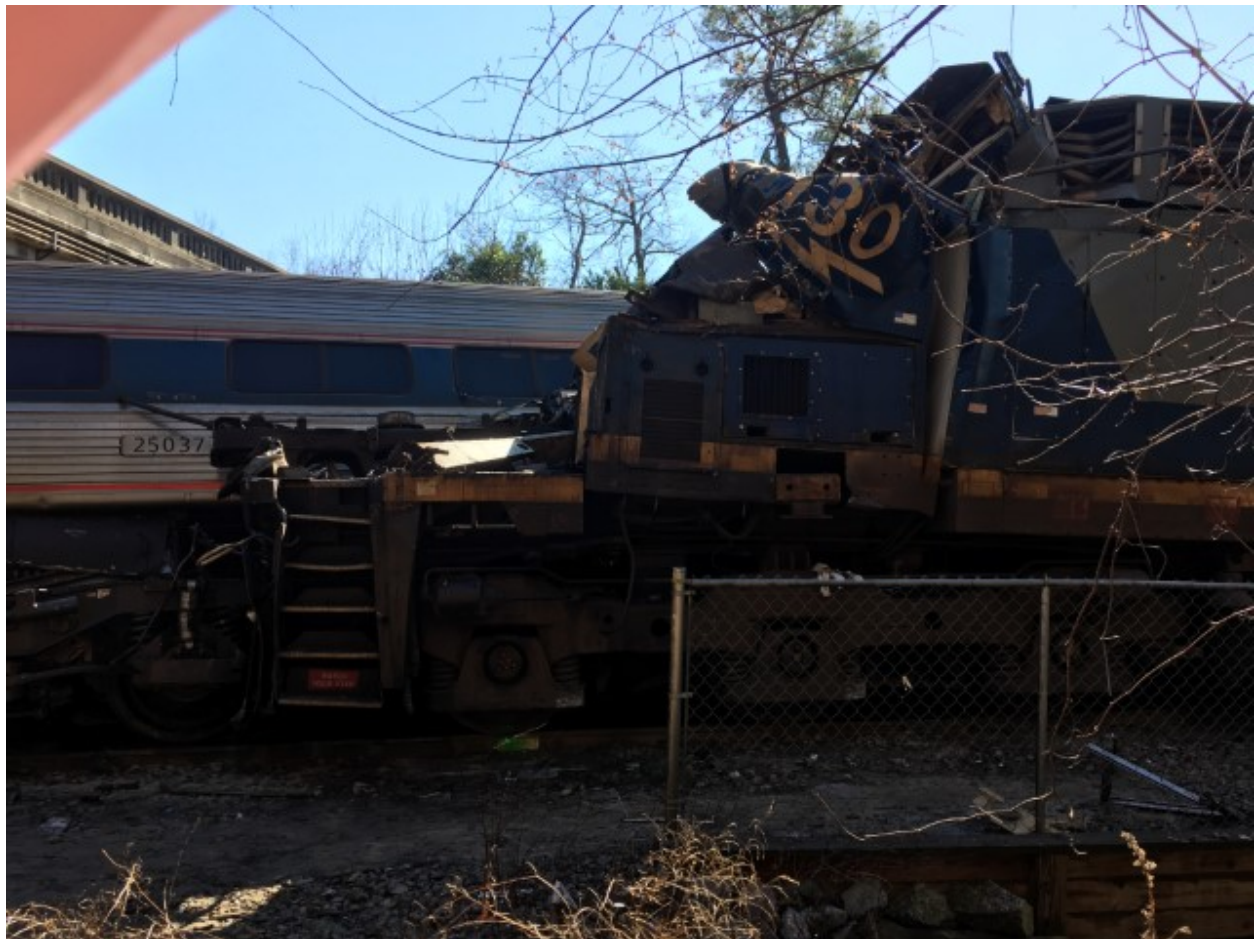
Figure 2: CSXT 130

In the accident, the lead locomotive of Train 1, CSXT 130, experienced a total loss of survival space. (See Figure 2: CSXT 130) The collision posts of CSXT 130 were displaced and found resting horizontally on the deck, sheared off at the floor. The cab structure of CSXT 130 was removed, resulting in a cleared deck, and the truck bolster from the first coach car in Train 2 was found on the deck. Both stairways of CSXT 130 were compressed, and the car body displaced rearward.

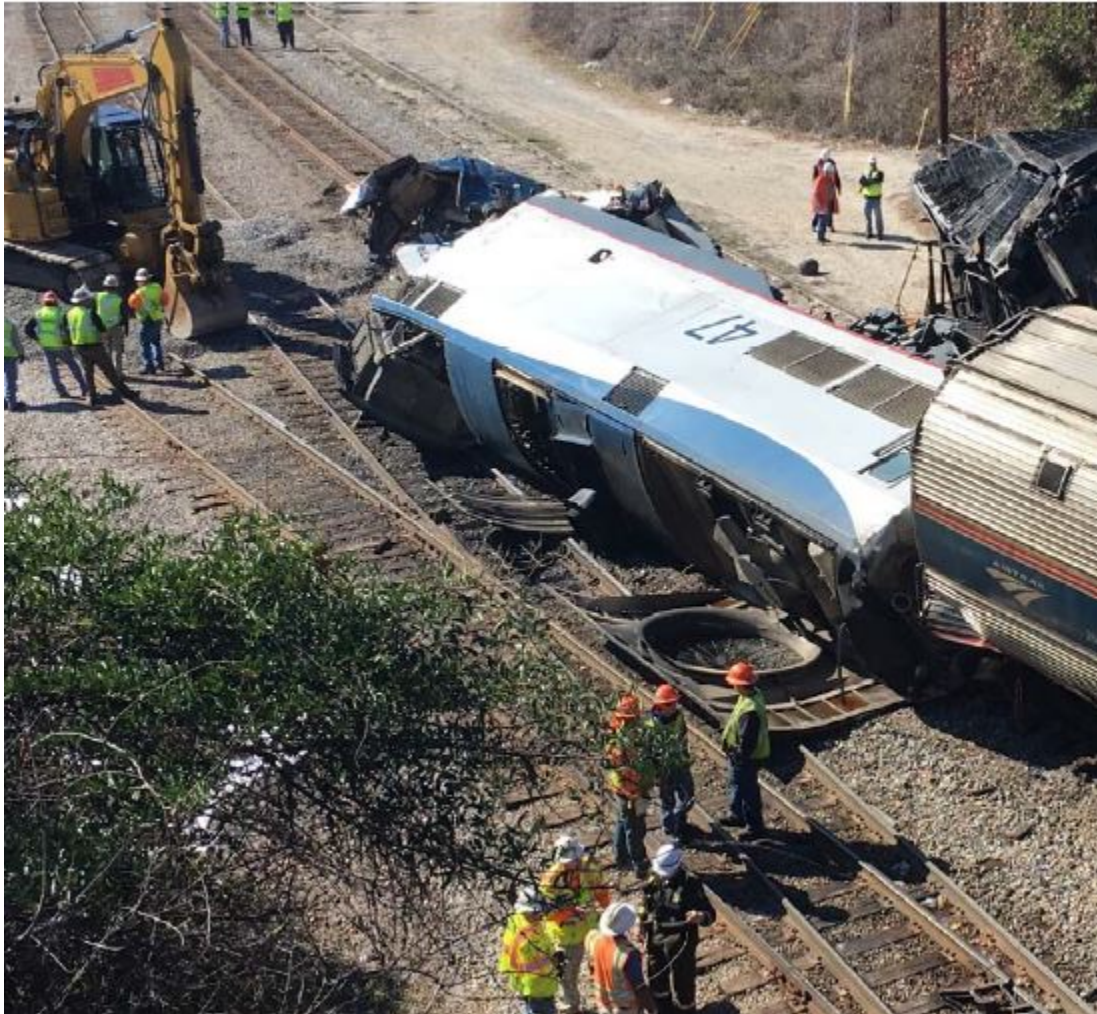
Figure 3: ATK 47

The lead locomotive of Train 2, ATK 47, also experienced a total loss of survival space. (See Figure 3: ATK 47) The front end of the locomotive crushed and bent to the right, penetrating the cab compartment. The locomotive deck folded 180-degrees underneath the locomotive so the lead coupler was facing the opposite direction of travel. The fuel tank on ATK 47 ruptured, and the locomotive toppled over onto the left side.

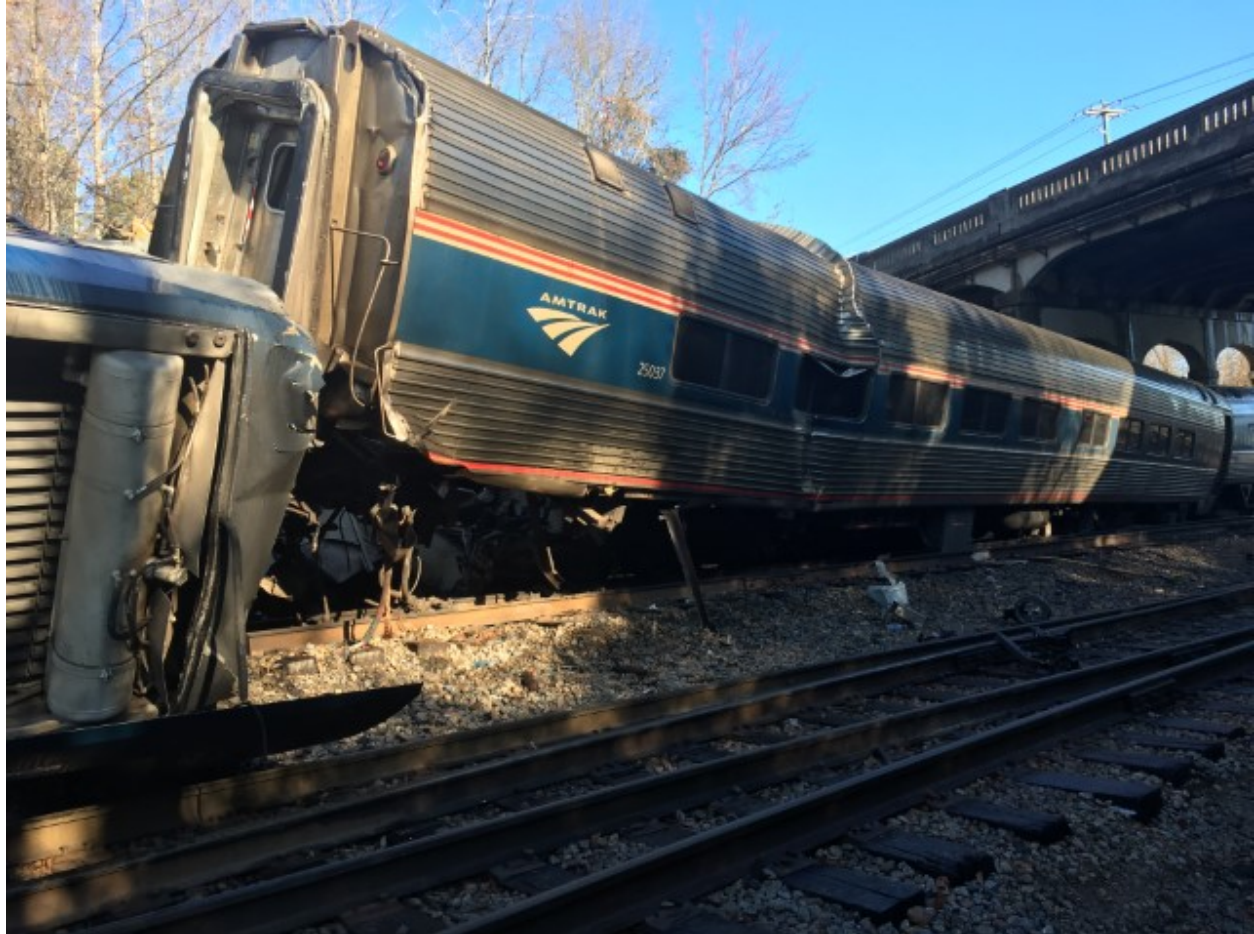
Figure 4: ATK 25037

Passenger car ATK 25037 was unoccupied. The lead truck assembly disconnected from the car body, and the truck bolster was detached and found on the deck of CSXT 130. A sharp buckle was found around the circumference of the car near the second window from the leading end of the car, causing the displacement of the window and the ceiling and luggage rack falling to headrest level. (See Figure 4: ATK 25037)

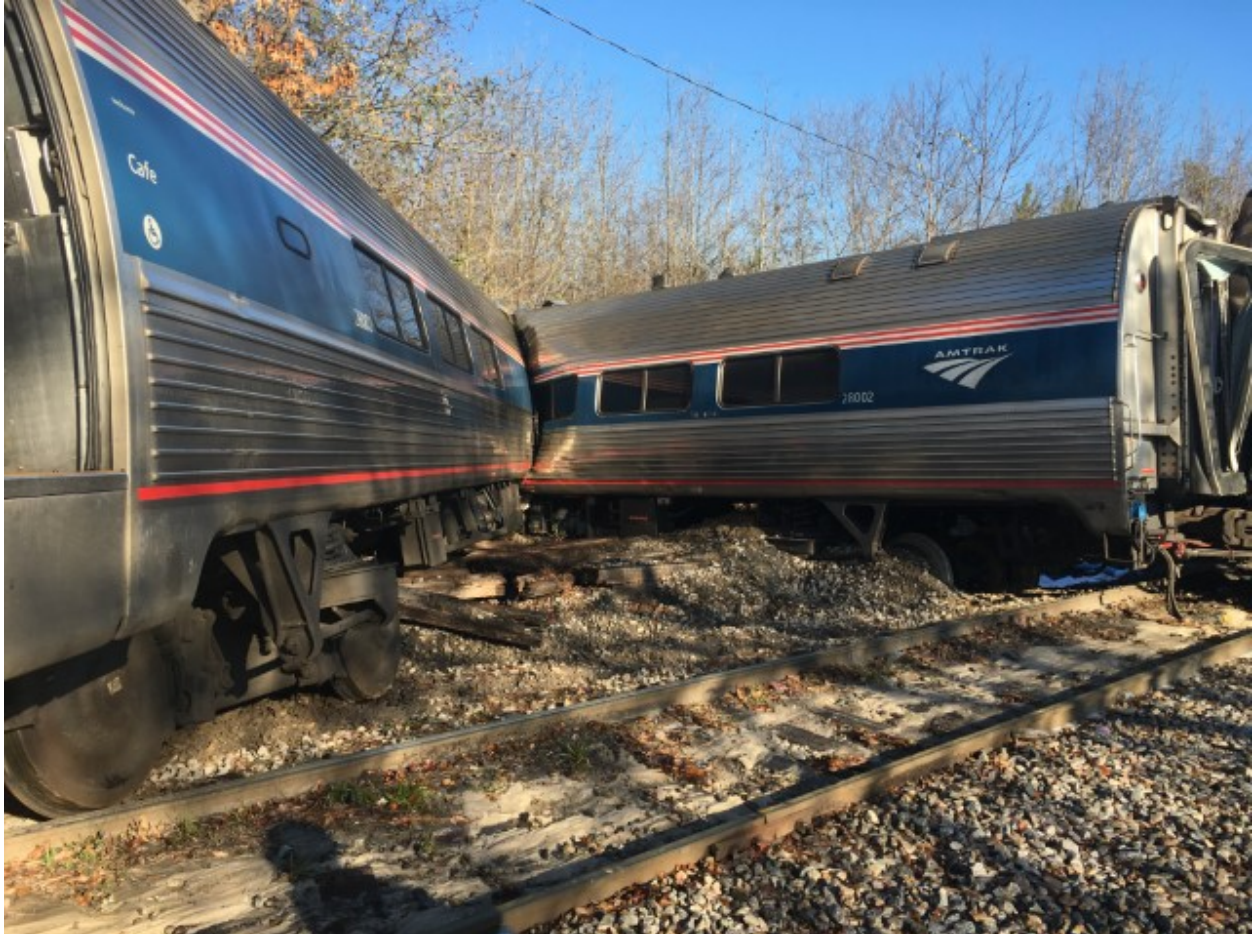
Figure 5: ATK 28002

Café car ATK 28002 was occupied by the Assistant Conductor and one passenger. The car experienced complete structure failure near the fourth window from the leading end. The car came to rest in a “V” shape with a large opening at the apex. (See Figure 5: ATK 28002) The floor of the car deformed upward near the middle of the car, where the car was broken in half, which resulted in the loss of survival space.

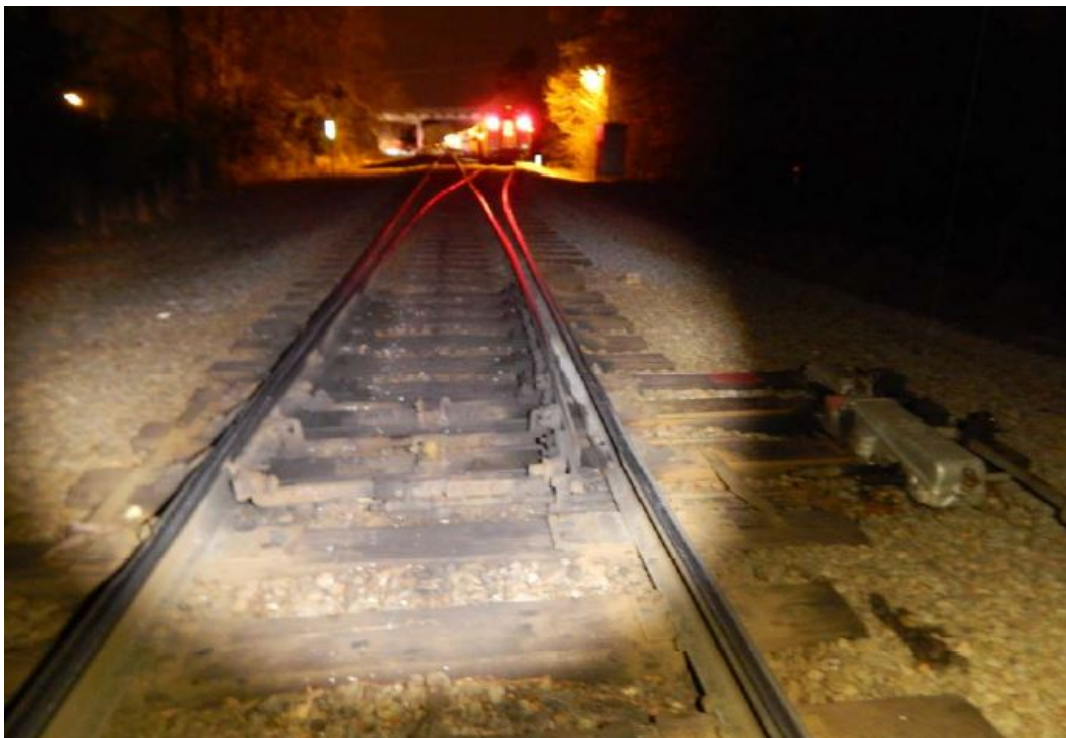
Figure 6: Switch Entering Silica Storage Track

A post-accident inspection of the switch located at MP S 366.9 was completed. No damage occurred to the switch or the equipped electric lock. The switch was found locked in the reverse position, lined into the storage track, with a switch lock.

The Train 1 Conductor failed to properly align the switch at MP S 366.9 for the main line prior to releasing his track authority, as required by Title 49 CFR § 218.105(d)(1).

FRA determined the failure of the Train 1 crew to restore the switch at the north end of Silica storage track, MP S 366.9, was the probable cause of the accident. (See Figure 6: Switch Entering Silica Storage Track)
