U.S. Department
Of Transportation

**Federal Railroad
Administration**

Reply to Att. of: MP&E 01-02

Subject: **Guidance for Inspection for Locomotive Draft Gear Pocket Center Sill Connection Plate Cracks During Daily and 92-Day Periodic Inspections**

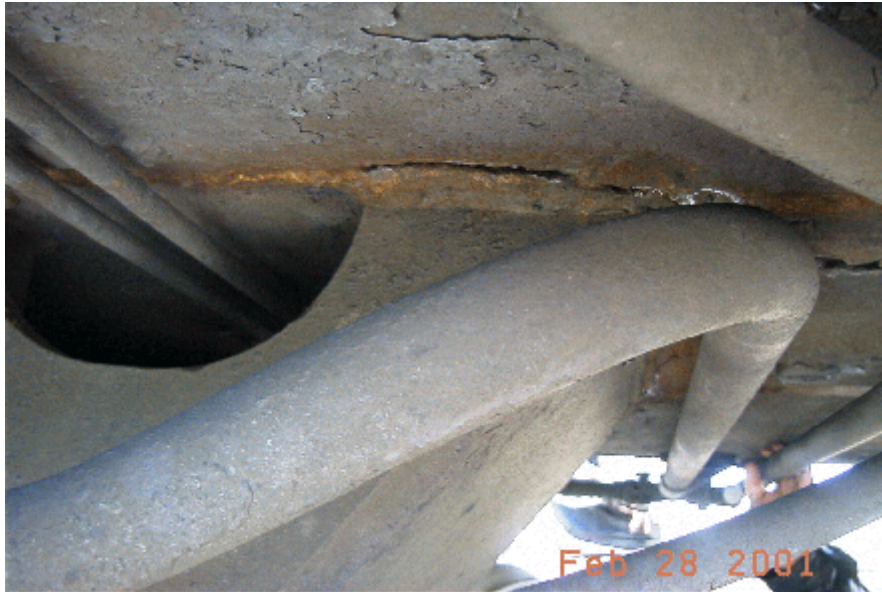
Recently, there have been a number of locomotives discovered with cracks in the center sill connection plate in the area where the draft pocket is secured to the under frame of the locomotive. These cracks are developing in the plate steel, not in the securement welds (see figures 1 & 2). When the cracking progresses far enough, the coupler face drops and the backside of the draft pocket is forced up between the center sills. Catastrophic failure results in separation of the draft unit from the locomotive (see figure 3).

Fig. # 1 Crack at the rear connection of the draft gear pocket extending past piping.

These cracks can be observed during the daily inspection, but are best seen when a locomotive is placed over an inspection pit or on raised track during the 92-day periodic inspection. At least two Class I railroads have issued additional instructions to do a better inspection of draft gear pocket the area during 92 day periodic inspection.

The current locomotive safety standard [49 CFR 229.23] requires "that at each periodic inspection a locomotive shall be positioned so that a person may safely inspect the entire underneath portion of the locomotive". It is at this time that a thorough visual inspection of the draft pocket area should be performed.

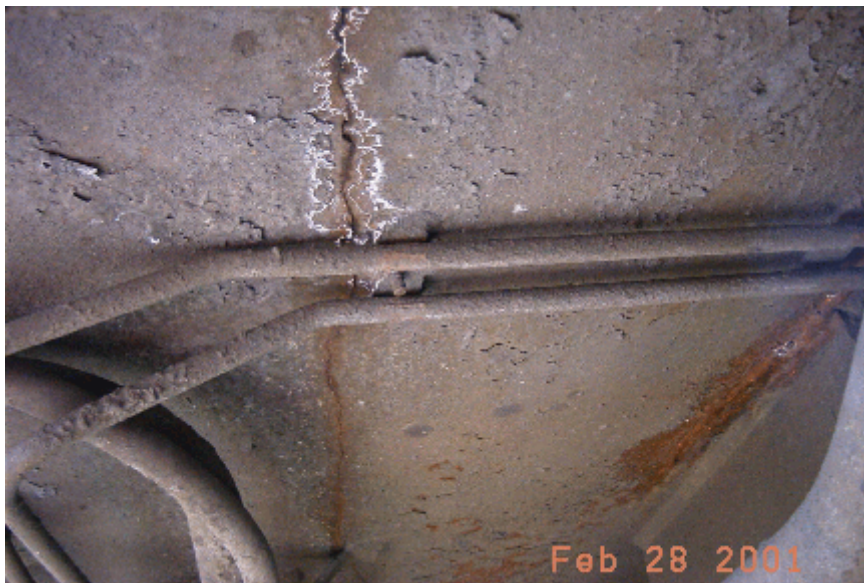
Fig. # 2 Crack in the connection plate along side draft gear pocket.

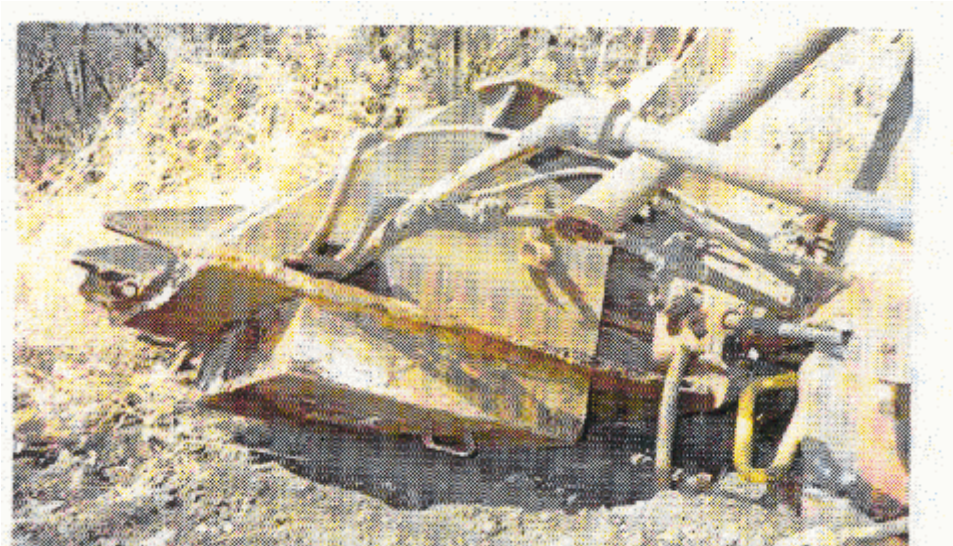
Fig. # 3. Catastrophic failure resulting in separation of the draft unit from the locomotive.
