**Federal Railroad
Administration**

Research Results

RR08-13
October 2008

Update: New Crosstie and Fastening System Test at the Facility for Accelerated Service Testing

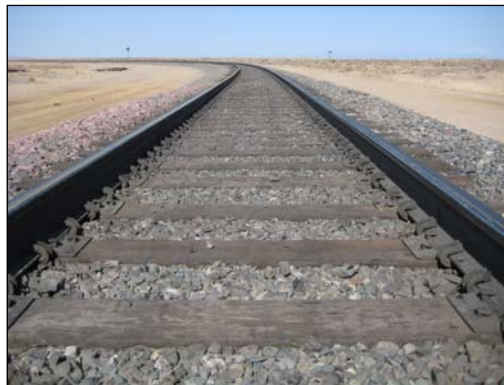
Figure 1. Southern Yellow Pine Crosstie Test Zone Installed at FAST

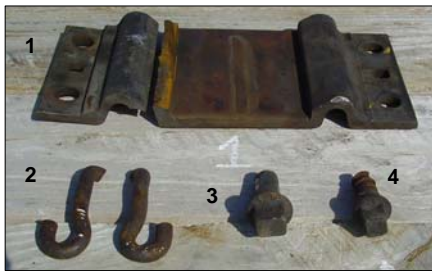
Broken screw spikes and tie plates (Figure 2) were a significant problem in Control Zone 1, where 44 percent of the tie plates had two or more broken LB&N Co. high-strength screw spikes and 14 percent of the Pandrol rolled steel tie plates fractured. A failure cycle may have been at work in this zone, where broken screw spikes contributed to the broken tie plates, which in turn led to more broken screw spikes. This type of tie plate, with its diagonally opposed e-clips, has a tendency to skew relative to the tie causing point loadings, which continue to result in increased plate fracture rates under HAL traffic at FAST.

Figure 2. Component Failure under HAL Traffic (1) Pandrol 16-in. Rolled Steel Tie Plate (2) NorFast Rail Clip (3) LB&N Co. High Strength Screw Spike (4) No. 5760 Screw Spike

When two of the four screw spikes break, the screw spike holes in the plate and tie become oblong. The plate then is free to skew, subjected to point loading, and ultimately breaks. The remaining screw spikes react against higher, per screw spike loads that are introduced by lateral translation of the plates, which may result in spots of weaker track gage, higher per-component loadings, and a higher stress state.

LB&N Co. submitted independent laboratory results to TTCI on a single broken screw spike sample. The report suggested problems related to rolling laps from the threading process and decarburization. LB&N Co. indicated these issues are continually addressed and improved in their manufacturing process.

TTCI's current maintenance procedure is to cut spike tie plates where two or more screw spikes have fractured inside the tie as a preliminary remedial action. After a number of plates have been cut spiked, those plates are replaced with different screw spike patterns to provide higher track strength. To avoid the track component failure cycle, it is best to eliminate remedial action and replace the plates with four new screw spikes.

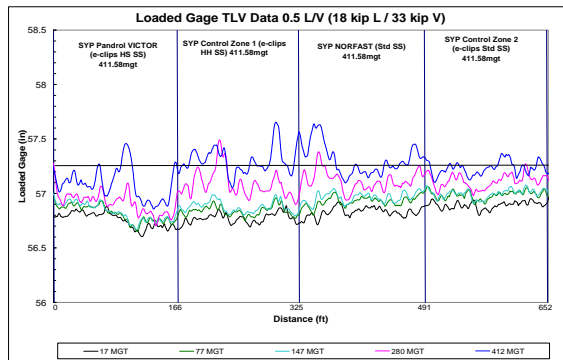
The track loading vehicle (TLV) was used to monitor track gage strength in the new test zones. Figure 3 shows the effect of HAL traffic on the loaded gage in the fastening system test zones. Six measurement cycles were taken under an applied 0.55 lateral/vertical (L/V) 18,000-/33,000-pound gage-spreading load at about 12 mph.

Figure 3. Fastening System Test Zones.

The initial average loaded gage measured in Control Zone 1 and in the NorFast test zone, after 17 MGT, was 56.77 and 56.83 inches. After 412 MGT of HAL traffic, the track gage exceeded 57.25 inches in more than 50 percent of each of the test zones under the dynamic gage spreading load of the TLV (degradation rates of 1/8 in/100 MGT to 3/16 in/100 MGT). This was likely a result of the high number of broken screw spikes in Control Zone 1 and the high number of screw spike uplift in the NorFast test zone.

Less than 10 percent of the Pandrol Victor test zone widened more than 57.25 inches, compared to almost 20 percent of Control Zone 2. The portion of the Pandrol Victor test zone that exceeded 57.25 inches, however, widened more (about 57.5 inches) than the widest portion of the control zone. This may have been due to the higher number of tie plates with more than two broken screw spikes in the Victor Zone (11 percent), as compared to Control Zone 2 (1 percent).
