**Locomotive Collision Test #9**  
**Freight Locomotive With a Strengthened Windshield Frame Impacting a High/Offset Intermodal Container**

# Test #9: Set-Up

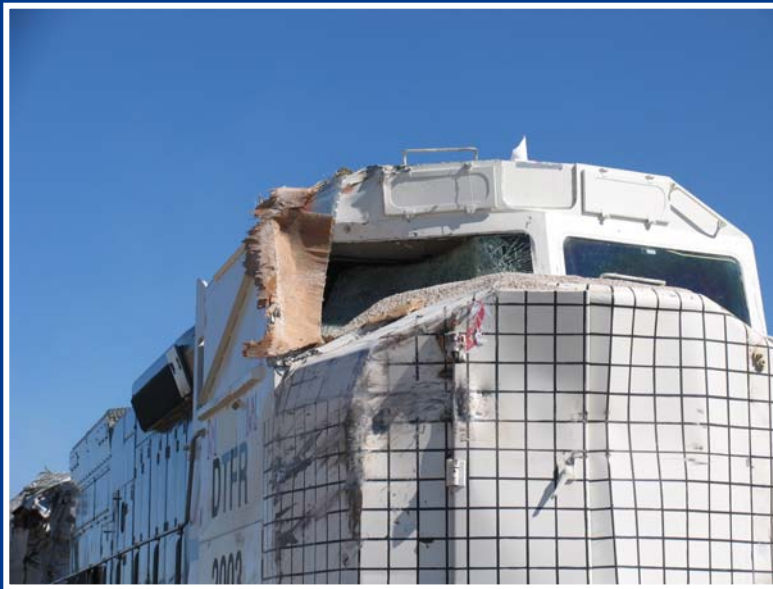
- Corner post and windshield frame remained intact
- Minor hood corner damage from initial container contact

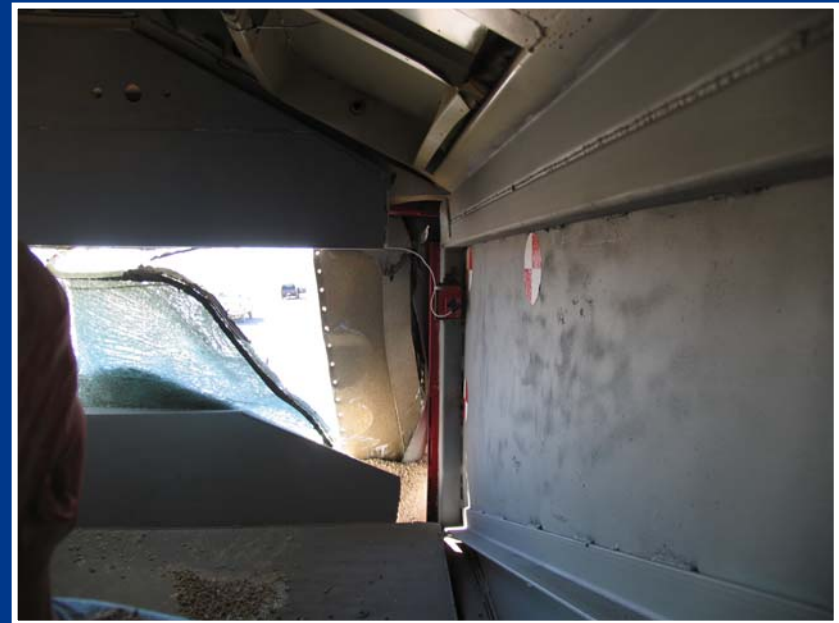
- Minor damage to cabin roof or side but w/minimal interior volume reduction

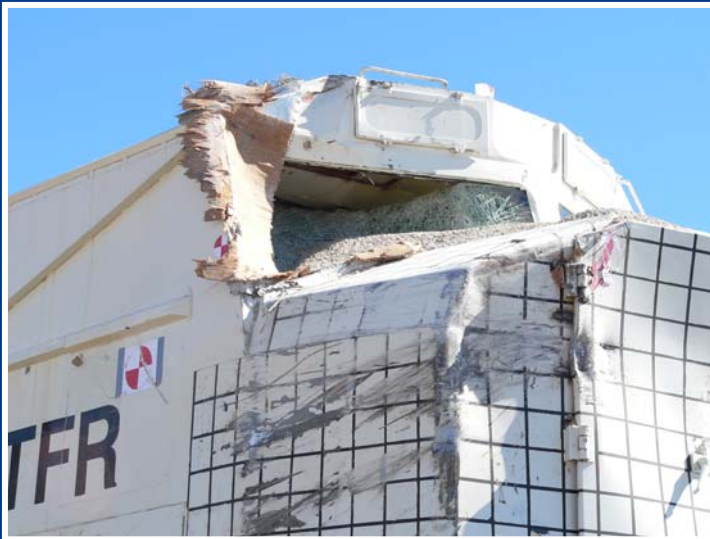
Test #9 – Strengthened Cab

- No significant roof or corner post failure; primarily outer roof skin and side wall deformations
- Inner added structure preserved cab volume (no intrusion)
- Corner post-windshield-roof connections intact

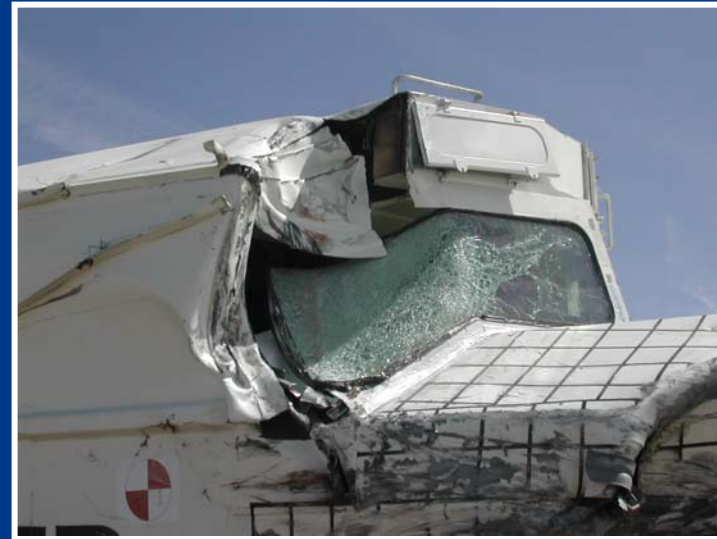
Test #6 – Unstrengthened Cab

- Collapse and tear of roof and corner post in impact zone
- Substantial cab volume reduction
- Container corner intrusion to crew compartment
- Inward side wall intrusion
