REPORT NO. FRA-OR&D 75-46

HAZARDOUS MATERIALS TANK CARS- EVALUATION OF TANK CAR SHELL CONSTRUCTION MATERIAL

G. E. Hicho
C. H. Brady

**Prepared For
DEPARTMENT OF TRANSPORTATION
FEDERAL RAILROAD ADMINISTRATION
Office of Research and Development
Washington, D.C. 20590**

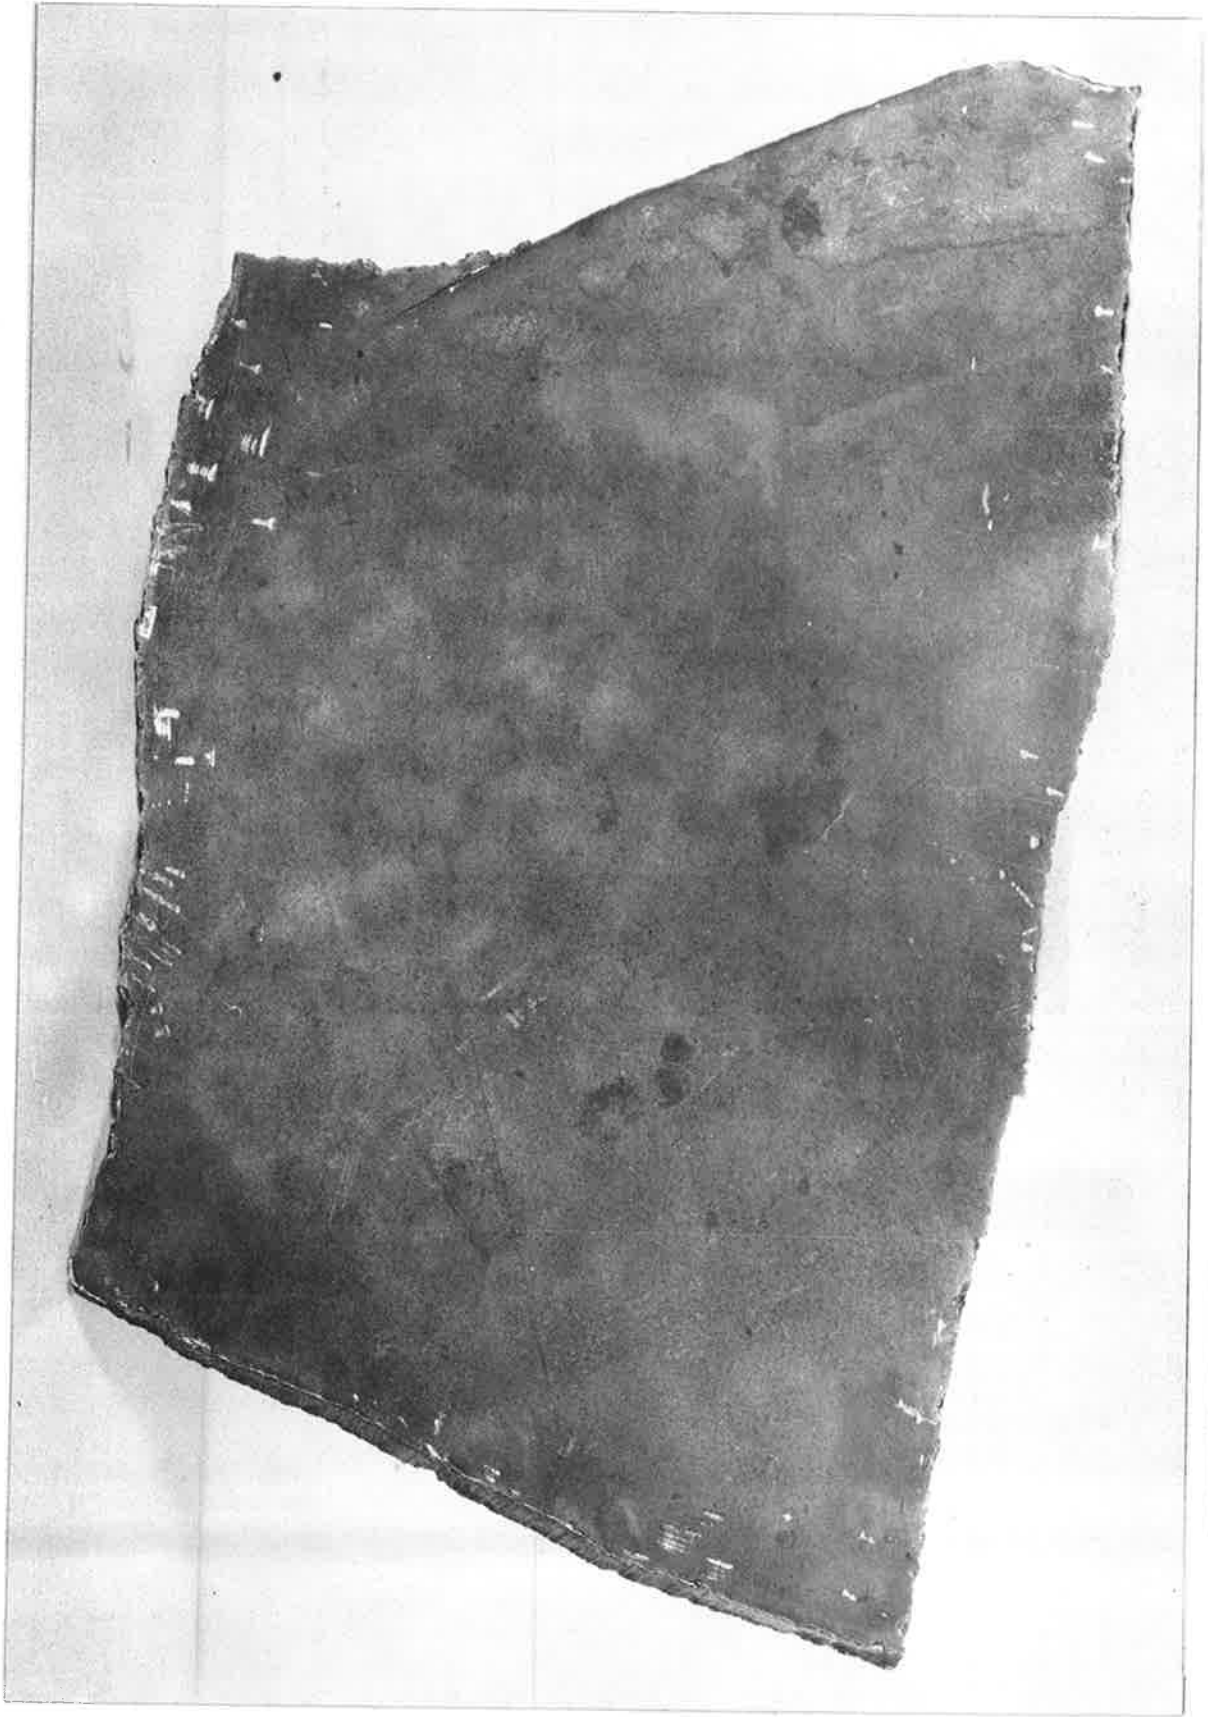
Figure 1. Photograph of the inside of a section of failed tank car plate in the as received condition. Fracture is located at right edge of photograph. X 1/3

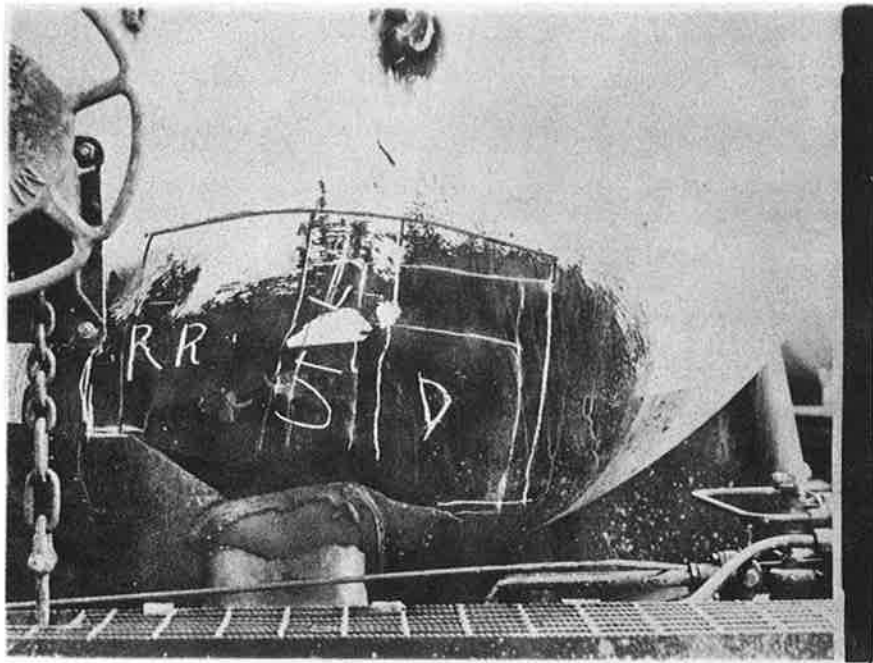
Material: The failed plate (identified as plate RR) was submitted to NBS by the Bureau of Railroad Safety, Federal Railroad Administration, Department of Transportation, for examination. The plate was approximately 11/16 inch thick and was reported to have been fabricated from a low carbon-high manganese steel. Figure 1 shows the steel plate (RR) in the as received condition with the fracture located along the right edge of the plate. Figure 2 shows the location of the failed plate (RR) in the damaged tank car.

Figure 2. Location of the submitted head plate portion "RR" in the damaged tank car.

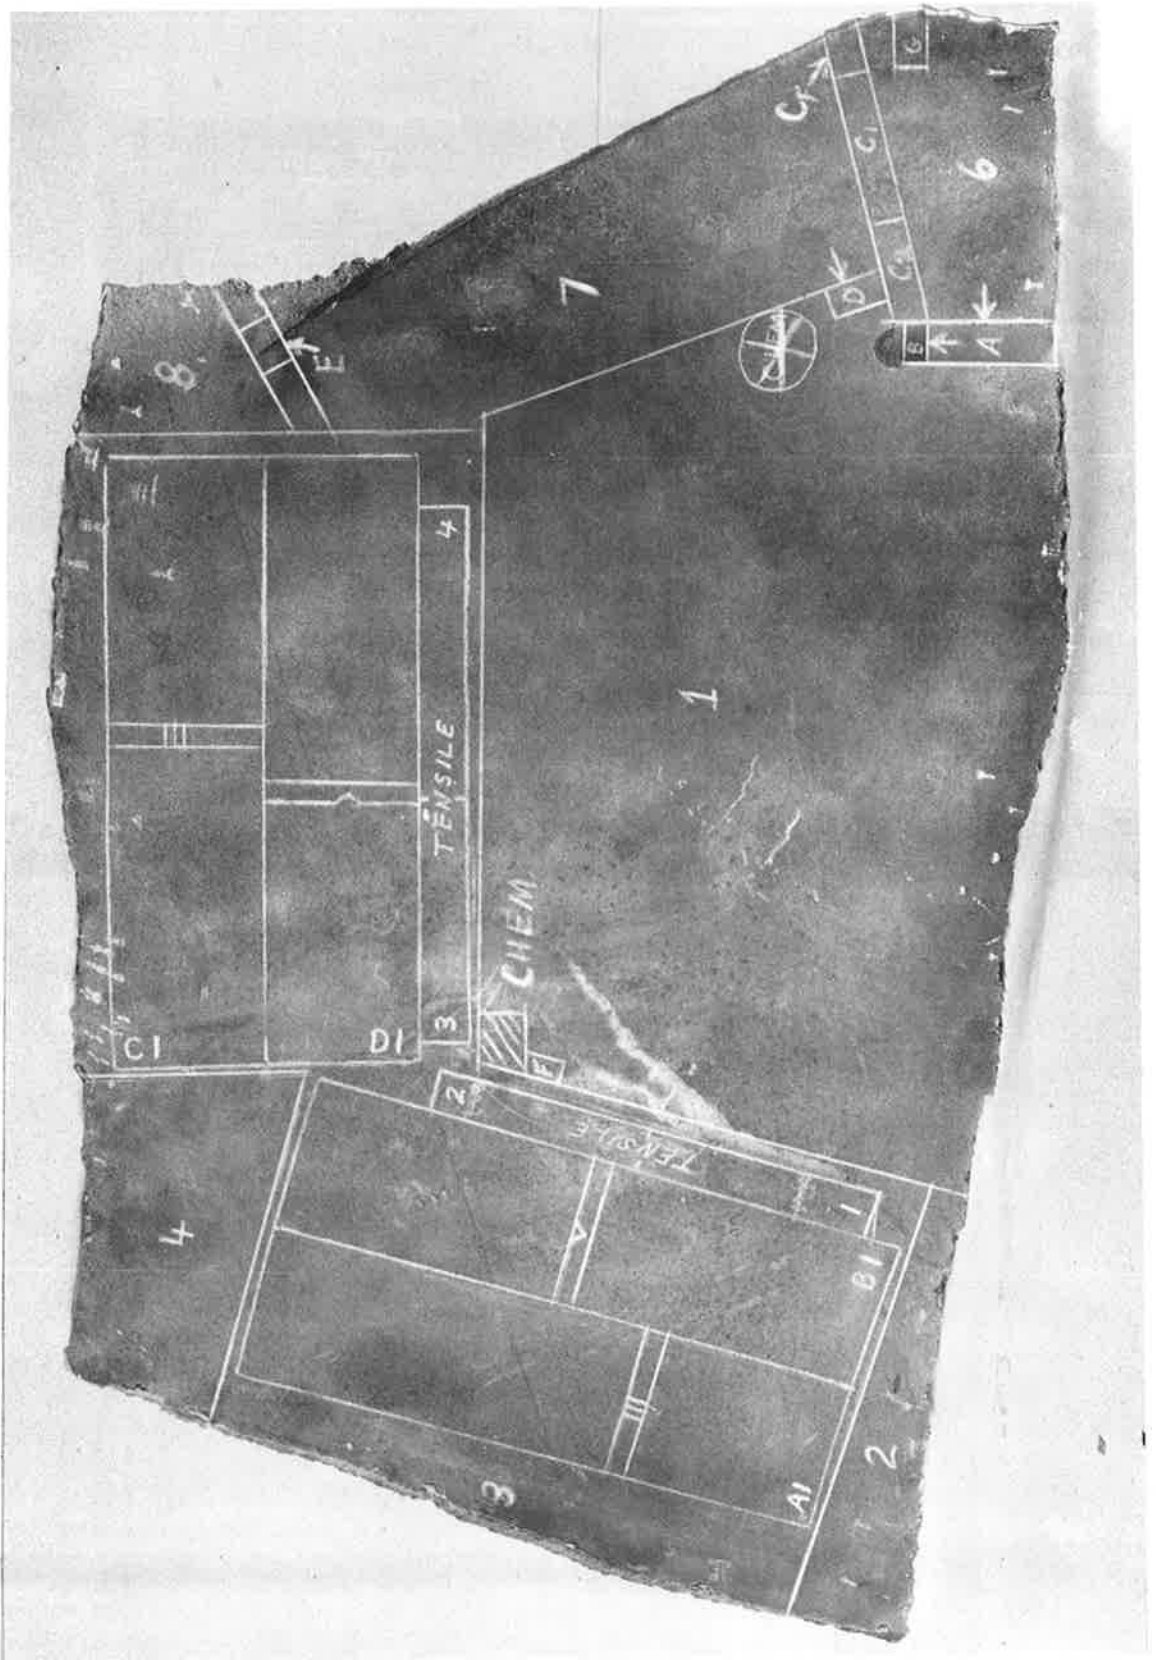
Examinations: Tensile, impact, and hardness tests were conducted on the plate. Tensile and impact specimens were taken in two directions approximately 90° to each other in order to establish whether directional properties existed. A chemical analysis and a complete metallographic examination were also performed on the submitted plate. The locations of the test samples used in this investigation are shown in figure 3.

Figure 3. Photograph of the failed plate showing the areas which were used for tensile, impact, and chemical examinations. The metallographic examinations were performed on areas A, B, C₁, C₂, C_F, D, E, F and G; the hardness tests were also performed on area A. X 1/3

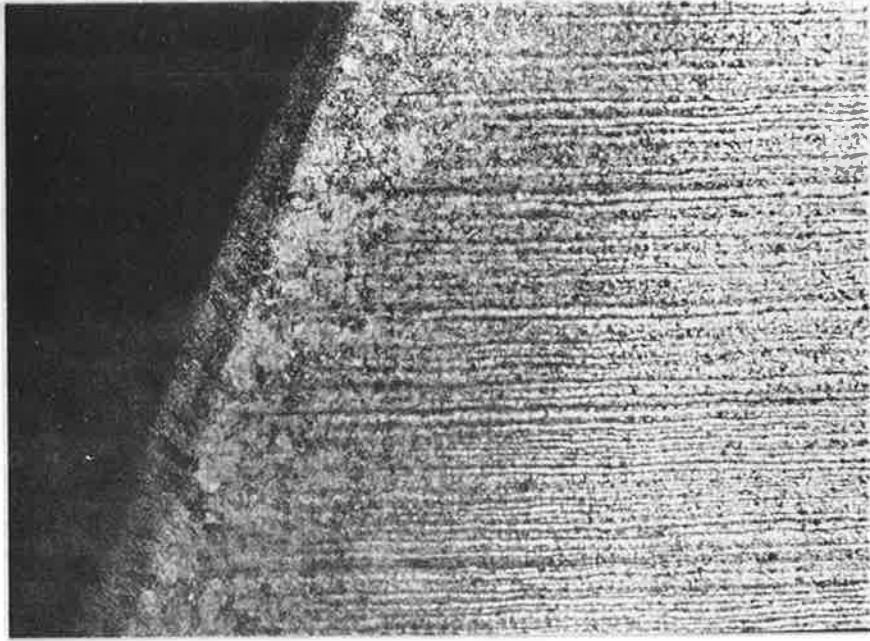
Hardness: Rockwell B hardness determinations were obtained on the plate (area A, figure 3) and are reported in Table 1. The hardness of the plate was relatively uniform with an average hardness of Rockwell B92. An investigation as to the effect of flame cutting on the hardness revealed that this effect extended to a depth of no greater than 0.1 inch. The microstructural changes (Fig. 4) that accompanied the flame cutting, occurred to a depth of approximately 0.04 inch.

Figure 4. Photomicrograph showing the effect of flame cutting on the structure of the plate. Picral etch. X 50

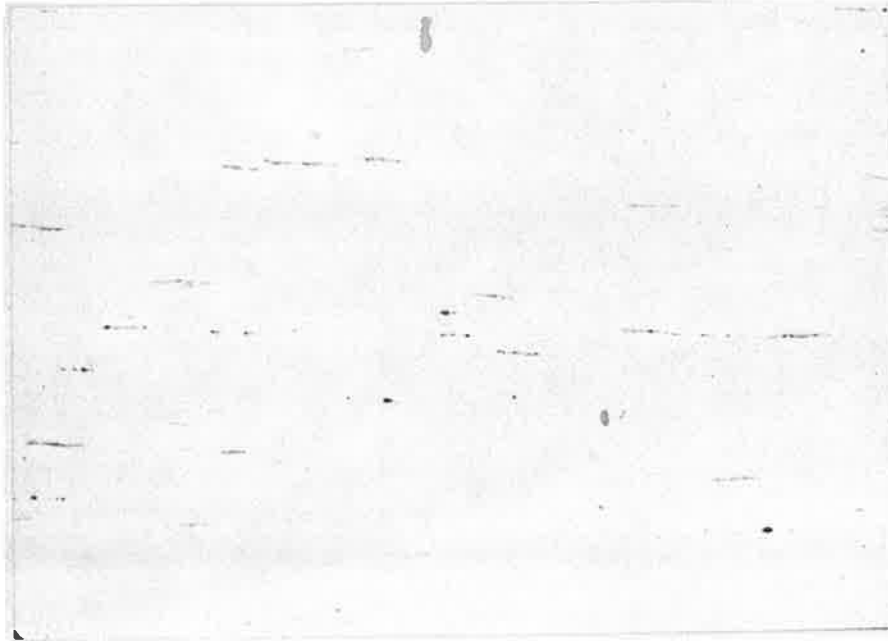
Metallographic Examination: The principal inclusions were found to be manganese sulfide. The approximate inclusion content was found from observations, at X 100, of several areas of the specimen. This inclusion content appears to be somewhat similar to those of sulfide type A, thin series 3 and 4 of figure 5 plate 1 of ASTM designation E-45.

Figure 5. Photomicrograph showing the sulfide inclusions in the plate. As polished. X 100

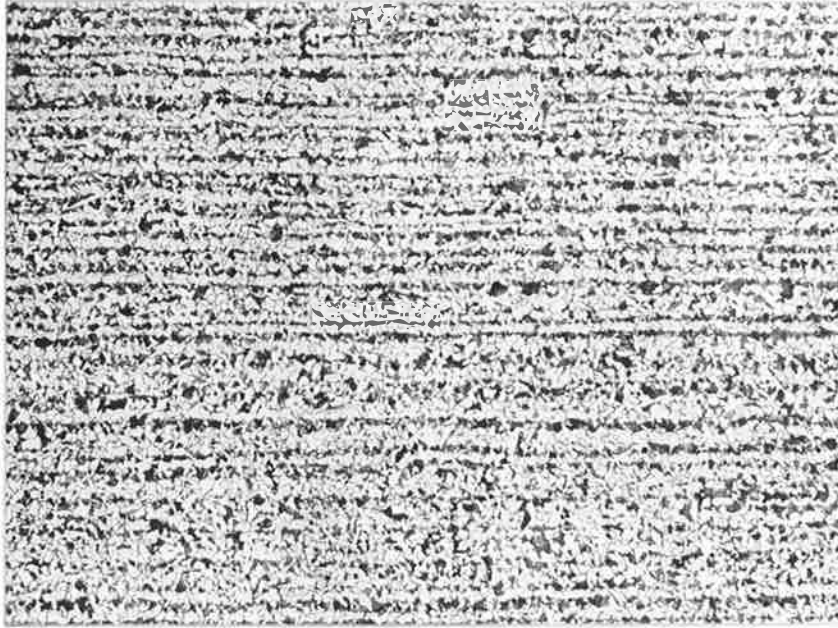
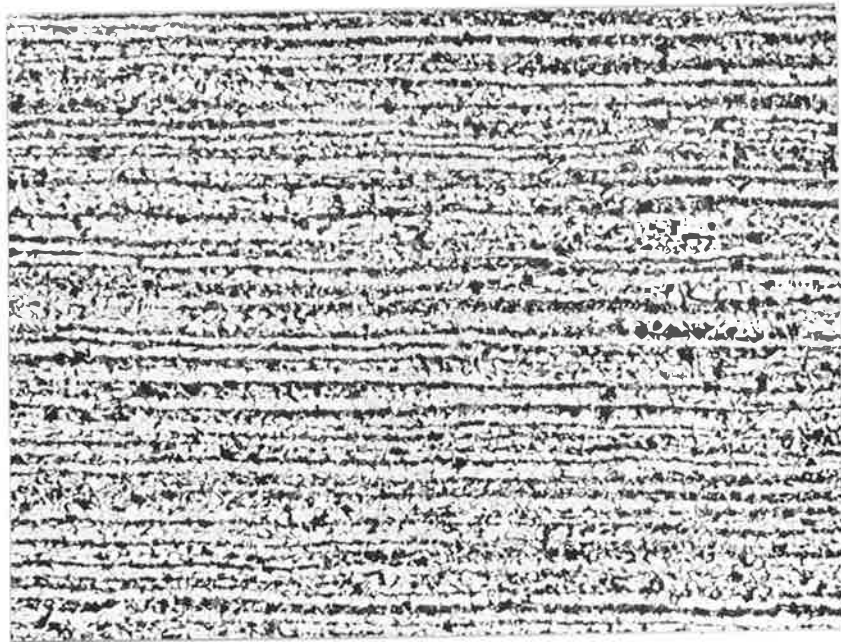
The grain size of the steel was determined, using the ASTM grain size method, to be ASTM grain size No. 8 and finer. A photomicrograph of the grain size (which meets the requirements for this steel) is shown in figure 6. Both figures 6 and 7 show that the material has a banded structure.

Figure 6. Photomicrograph of the banded structure of the plate. Picral etch. X 100

Figure 7. Photomicrograph of the banded structure of the plate. This photomicrograph was taken at about 90° to the photomicrograph shown in Figure 6. Picral etch. X 100

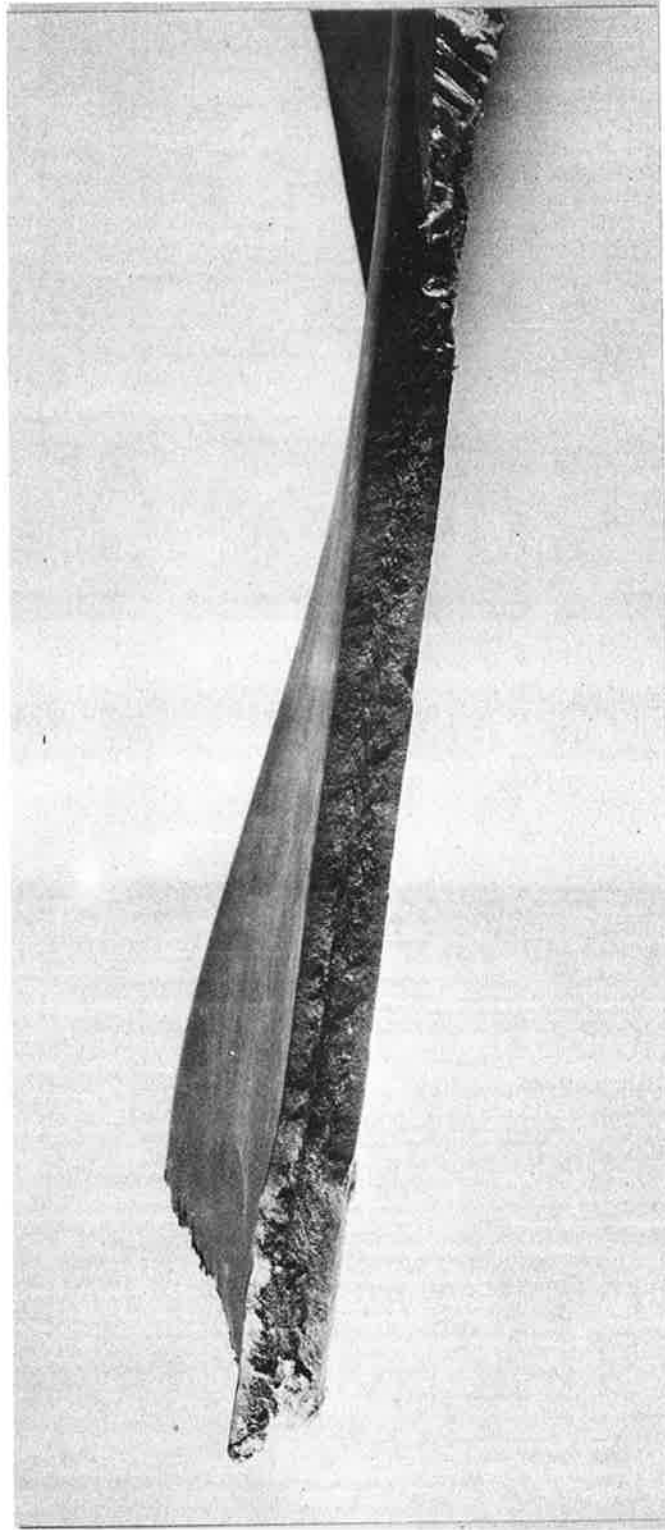
An examination of the fracture surface (Fig. 8) was made to determine the nature of the fracture. A cross-sectional view of the fracture surface at low magnification is shown in figure 9. The cross section is in the area designated C_F in figure 3. Figure 9 shows that the fracture surface has a complex shape. Two sections, of the surface, designated B and C in figure 9, are approximately normal to the surface, and another section, designated A in figure 9, is approximately parallel to the surface. In section A, the fracture appears to have been predominantly brittle in nature, and in this section the fracture surface is in the plane of the bands. The microstructure adjacent to the fracture is shown in figures 10, 11, 13 and 14. In section B, which is that portion of the fracture surface nearest the outside of the plate, the fracture appears to be both brittle and ductile in nature. Evidence of brittleness was found nearest section A, and evidence of deformation was found nearest the outside surface of the plate. A similar type situation was found in section C of the fractured surface. The fracture in this section was brittle nearest section A, but evidence of deformation was found as the inside surface of the plate was approached. The deformed areas at the fractured surface, both in sections B and C, indicate that this deformation probably occurred upon impact.

Figure 8. Photograph of the plate showing the fracture surface. X 1/2

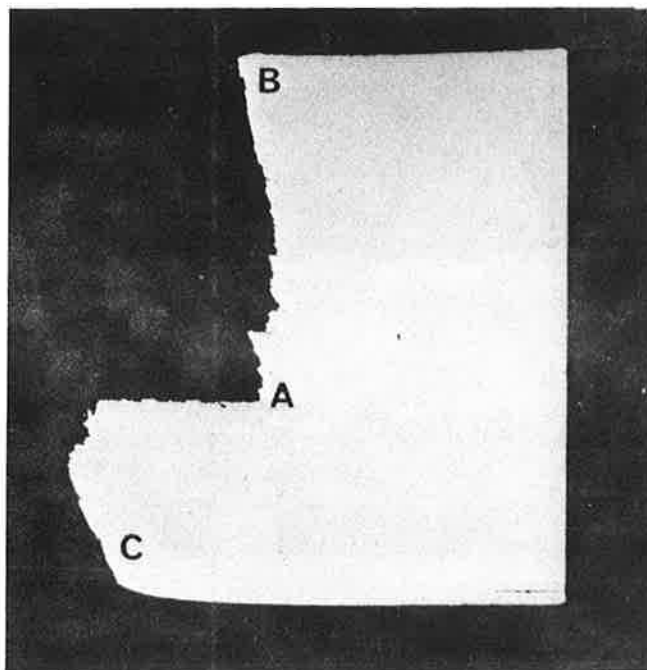
Figure 9. A thickness profile of the fracture area shown in Figure 12. A, brittle crack region; B, the outside surface of the plate; C, the inside surface of the plate.

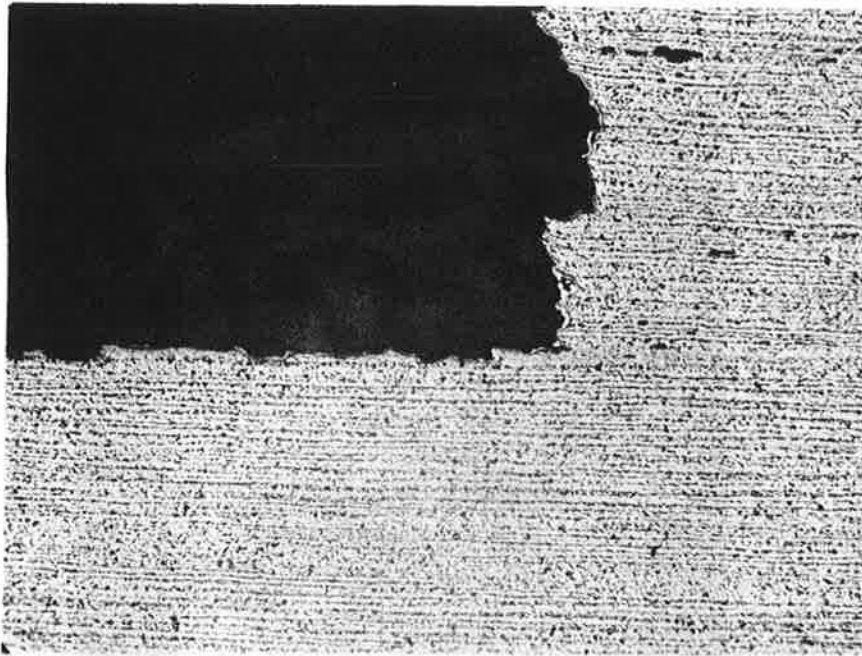
Figure 10. Microstructure at central section of the fracture (Area A, Figure 9). Part of fracture is parallel to the banded structure. Picral etch. X 40

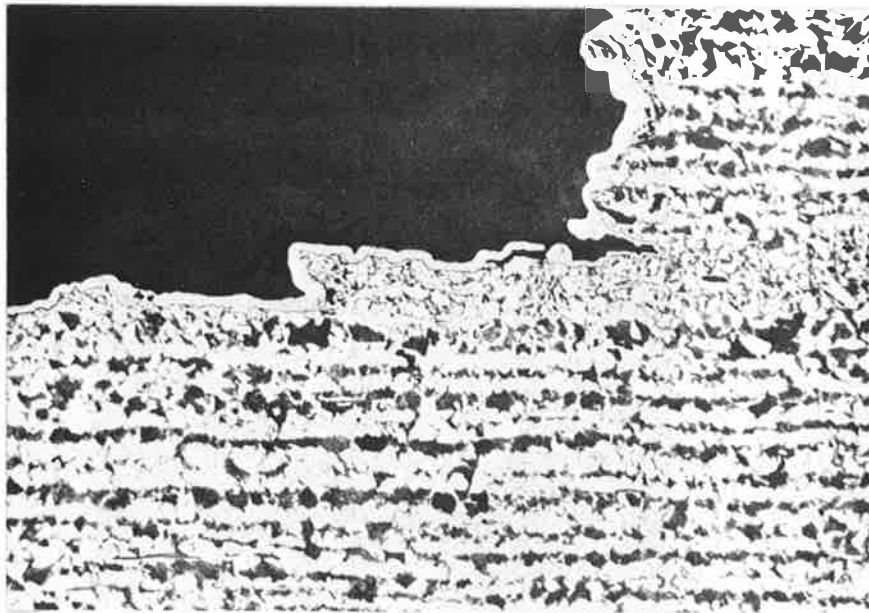
Figure 11. Microstructure adjacent to fracture path parallel to banded structure. Picral etch. X 240

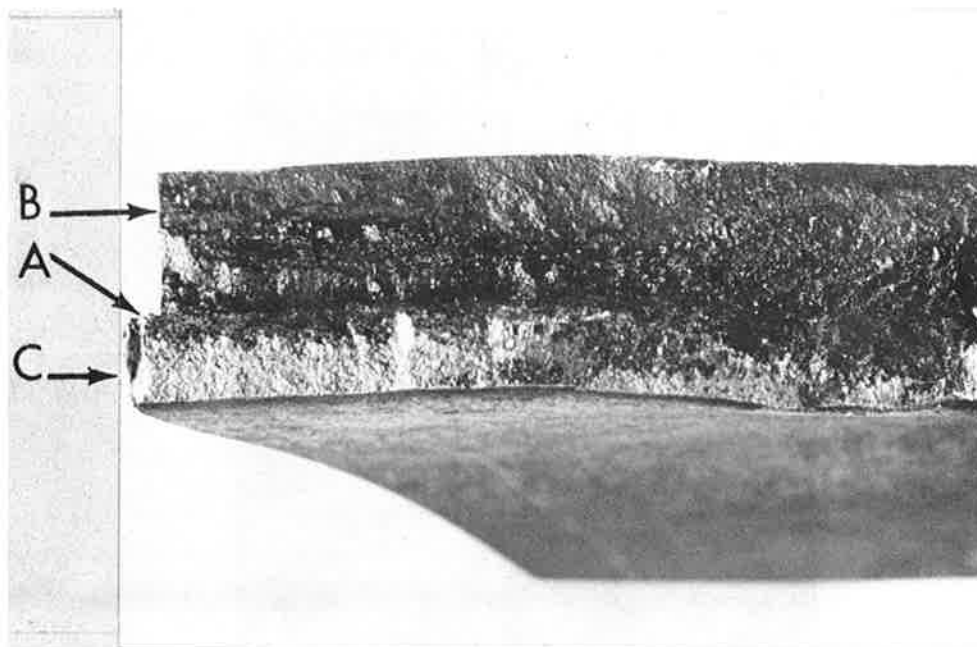
A surface view of the fracture surface discussed above is shown in figure 12. Portions of section B show distinct oxidation, the oxidized portions extending into the edge of, and onto, section A. These oxidized areas indicate that over some portions of the fracture surface, a crack extending into sections B and A existed sufficiently in advance of the final fracture for oxidation to occur. Figure 12, indicates, by contrast, that section C, the inner portion of the fracture surface, was bright and rust free when received, as were some portions of section B somewhat further removed from this area of examination.

Conclusions: The results of the observations indicated that a crack existed in the material for some time prior to failure. At impact, the crack extended to failure. The crack was mainly brittle with appreciable areas of ductile fracture present near the inner and outer surfaces of the plate.

Figure 12. Photograph of a part of the fracture surface. A, brittle crack region; B, outside surface of plate; C, inside surface of the plate. Dark areas are layers of oxide (rust). Lighter areas relatively free of rust. X 1 2/3

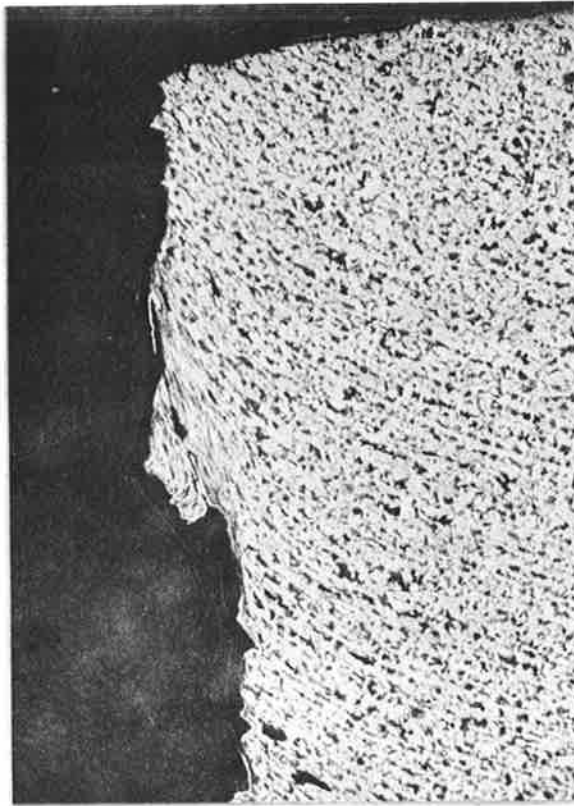
Figure 13. Microstructure at outside edge of the fracture (same area as Section B, Figure 12). Picral etch. X 100

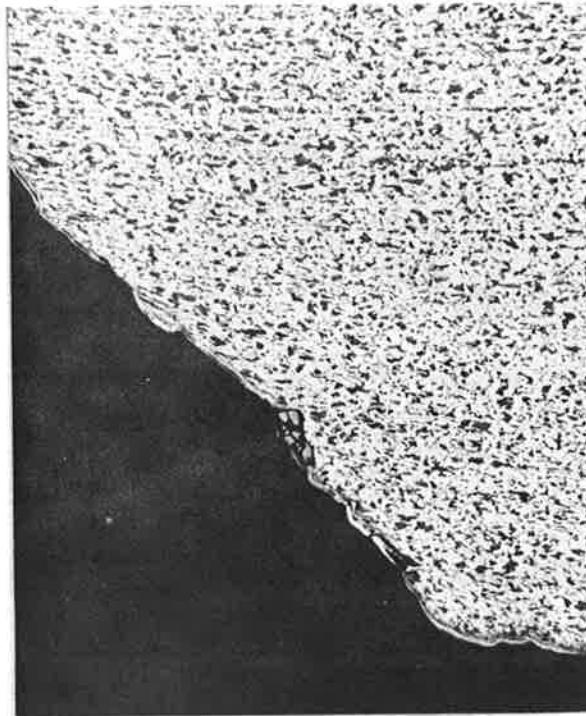
Figure 14. Microstructure at inside edge of the fracture (same area as Section C, Figure 12). Picral etch. X 100

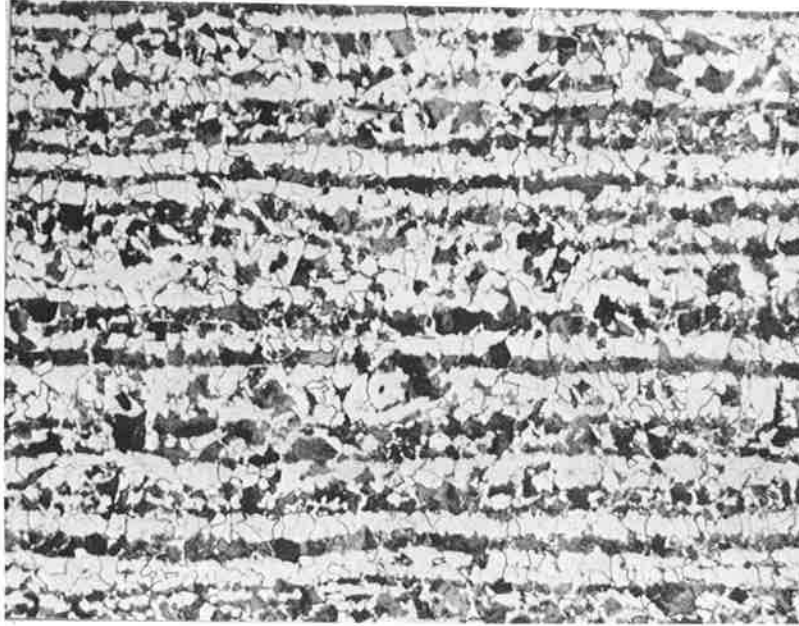
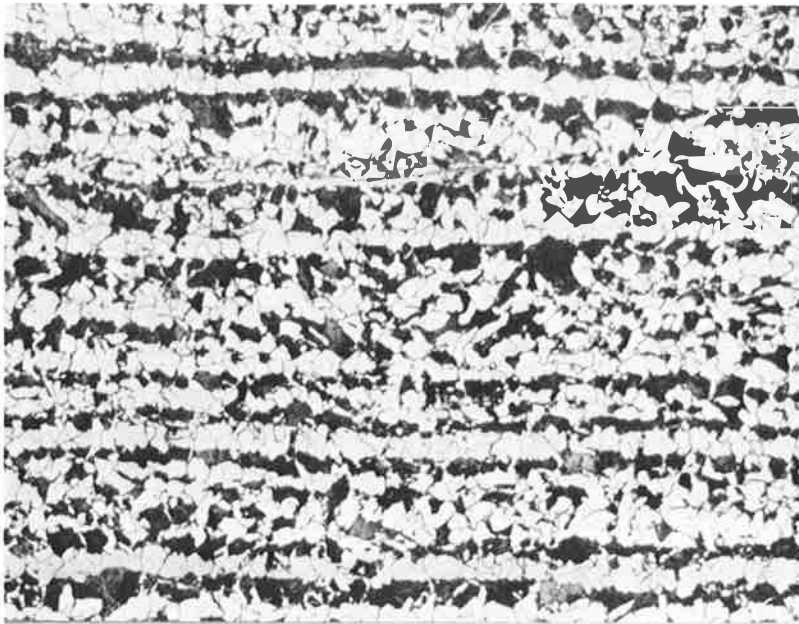
Micrographs (Figs. 15 and 16) of transverse sections of the plate, at right angles to each other, were examined in an attempt to ascertain a rolling direction. No definite conclusions could be made as to the direction of rolling from these micrographs, but further examinations indicated that the material had been cross-rolled.

Examination of the micrographs (Figs. 15 and 16) reveal that the bands consist mainly of ferrite (white areas) pearlite (black areas), and possibly some bainite (gray areas).

Banding is generally considered to be due to chemical segregation in the ingot while the molten steel is solidifying. The segregation may result from the variation of composition between the primary crystals of the dendrites and the interdendritic liquid. A light or medium degree of banding may or may not be harmful to the final product, in this case, the head plate. The banding, as present in this plate, may have some detrimental effect on the mechanical behavior of the plate, but more experimentation must be performed before a definite conclusion can be drawn.

Figure 15. Photomicrograph of the banded structure. Pearlitic structure (dark areas), possible a bainitic or martensitic structure (gray areas), and ferrite (white areas). Picral etch. X 240

Figure 16. Photomicrograph taken at 90° to the area shown in Figure 15. Picral etch. X 240

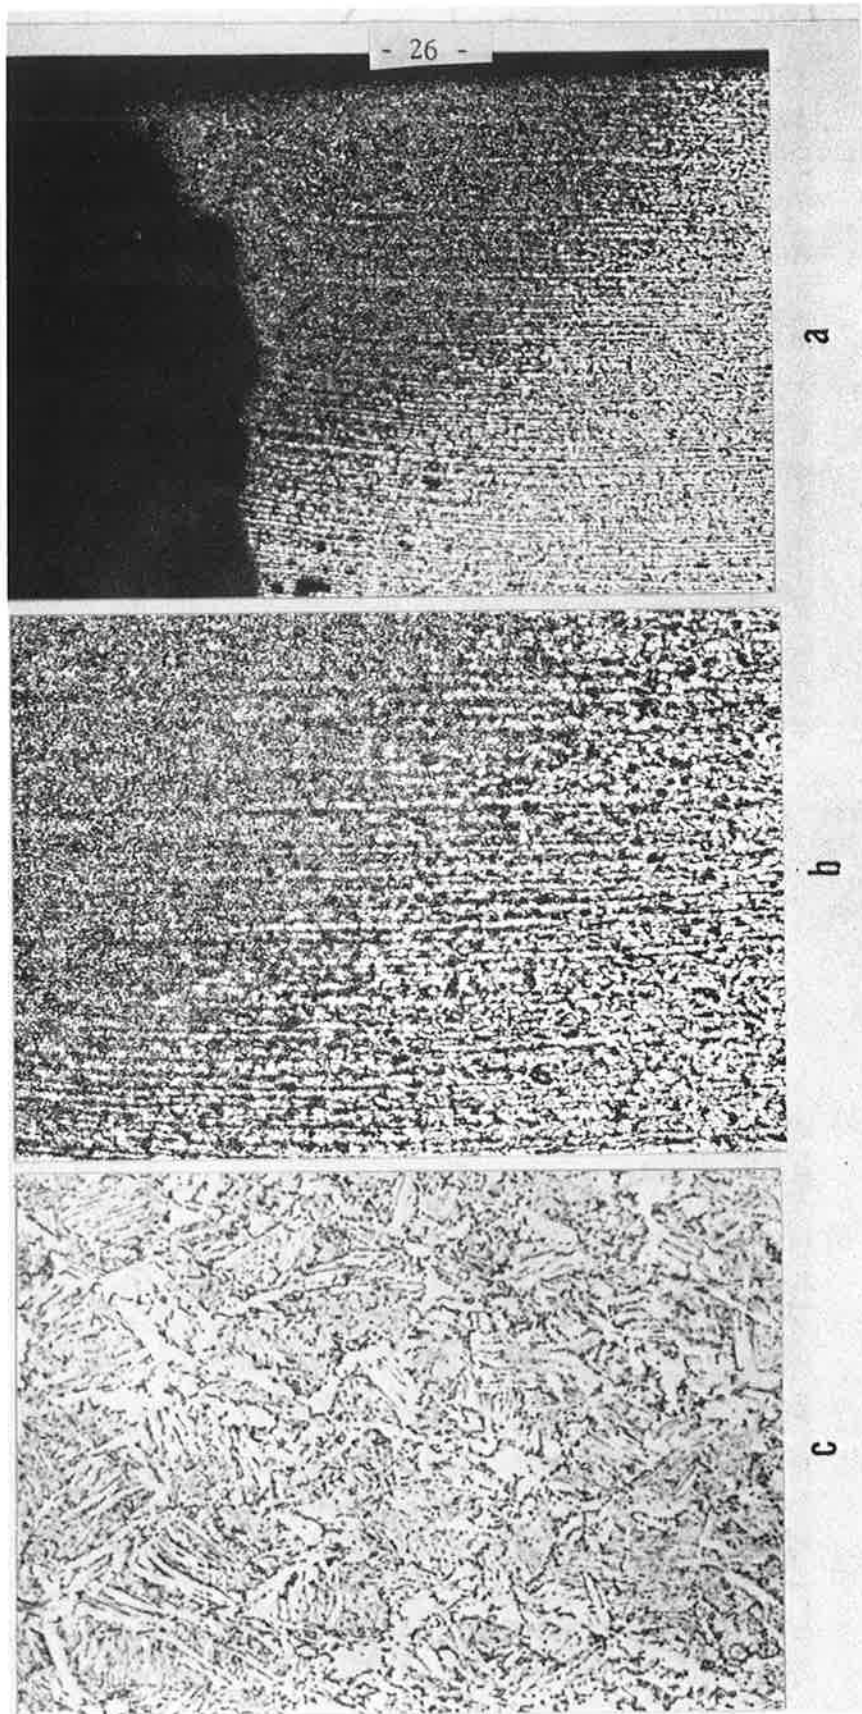
Area G in figure 3, a section in the vicinity of the welded stiffener plate, was examined. No weld material was seen but a heat affected zone was observed. Figure 17 (a) shows, at low magnification, the heat affected zone at the outside surface of the plate in the vicinity of the welded stiffener plate. Micrograph 17 (b), shows the change between the heat affected zone (dark area) and the parent material (light area). Micrograph 17 (c), reveals the microstructure of the heated zone to be mostly bainitic. The bainite appears to be a transformation product produced during the welding operation.

Figure 17. Photographs of an area near the outer surface and in the vicinity of the welded stiffener plate (area G, figure 3). Micrographs a, X 50, and b, X 100 show the heat affected zone and the parent material. Micrograph c, X 1200, of the heated zone reveals the bainitic structure. Picral etch.

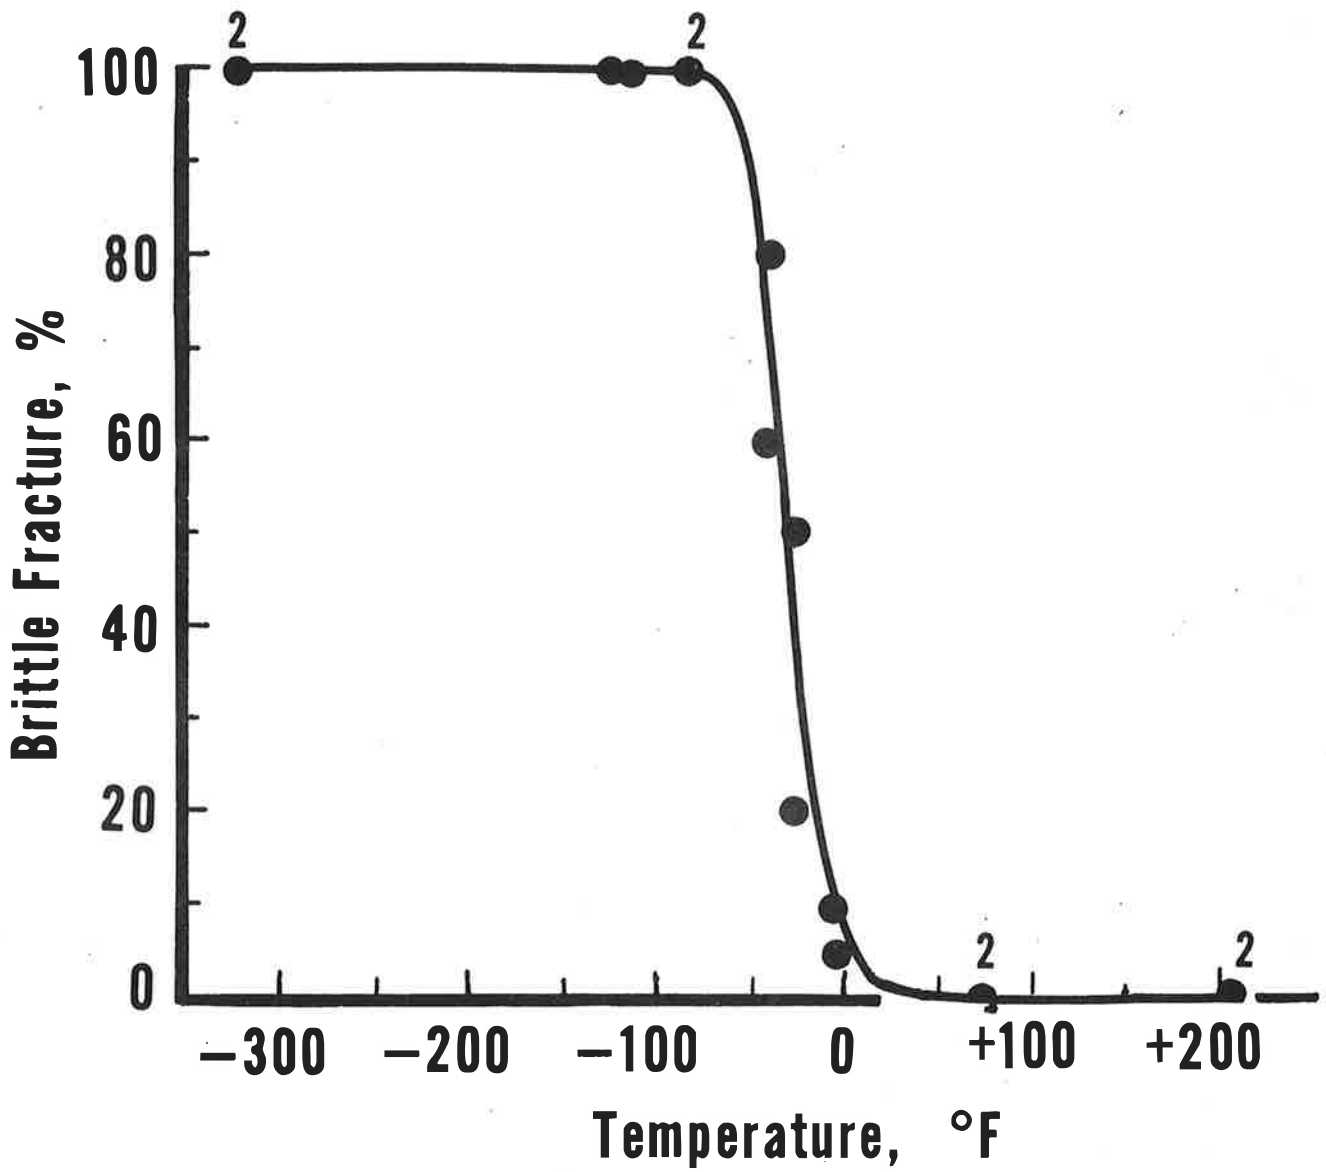
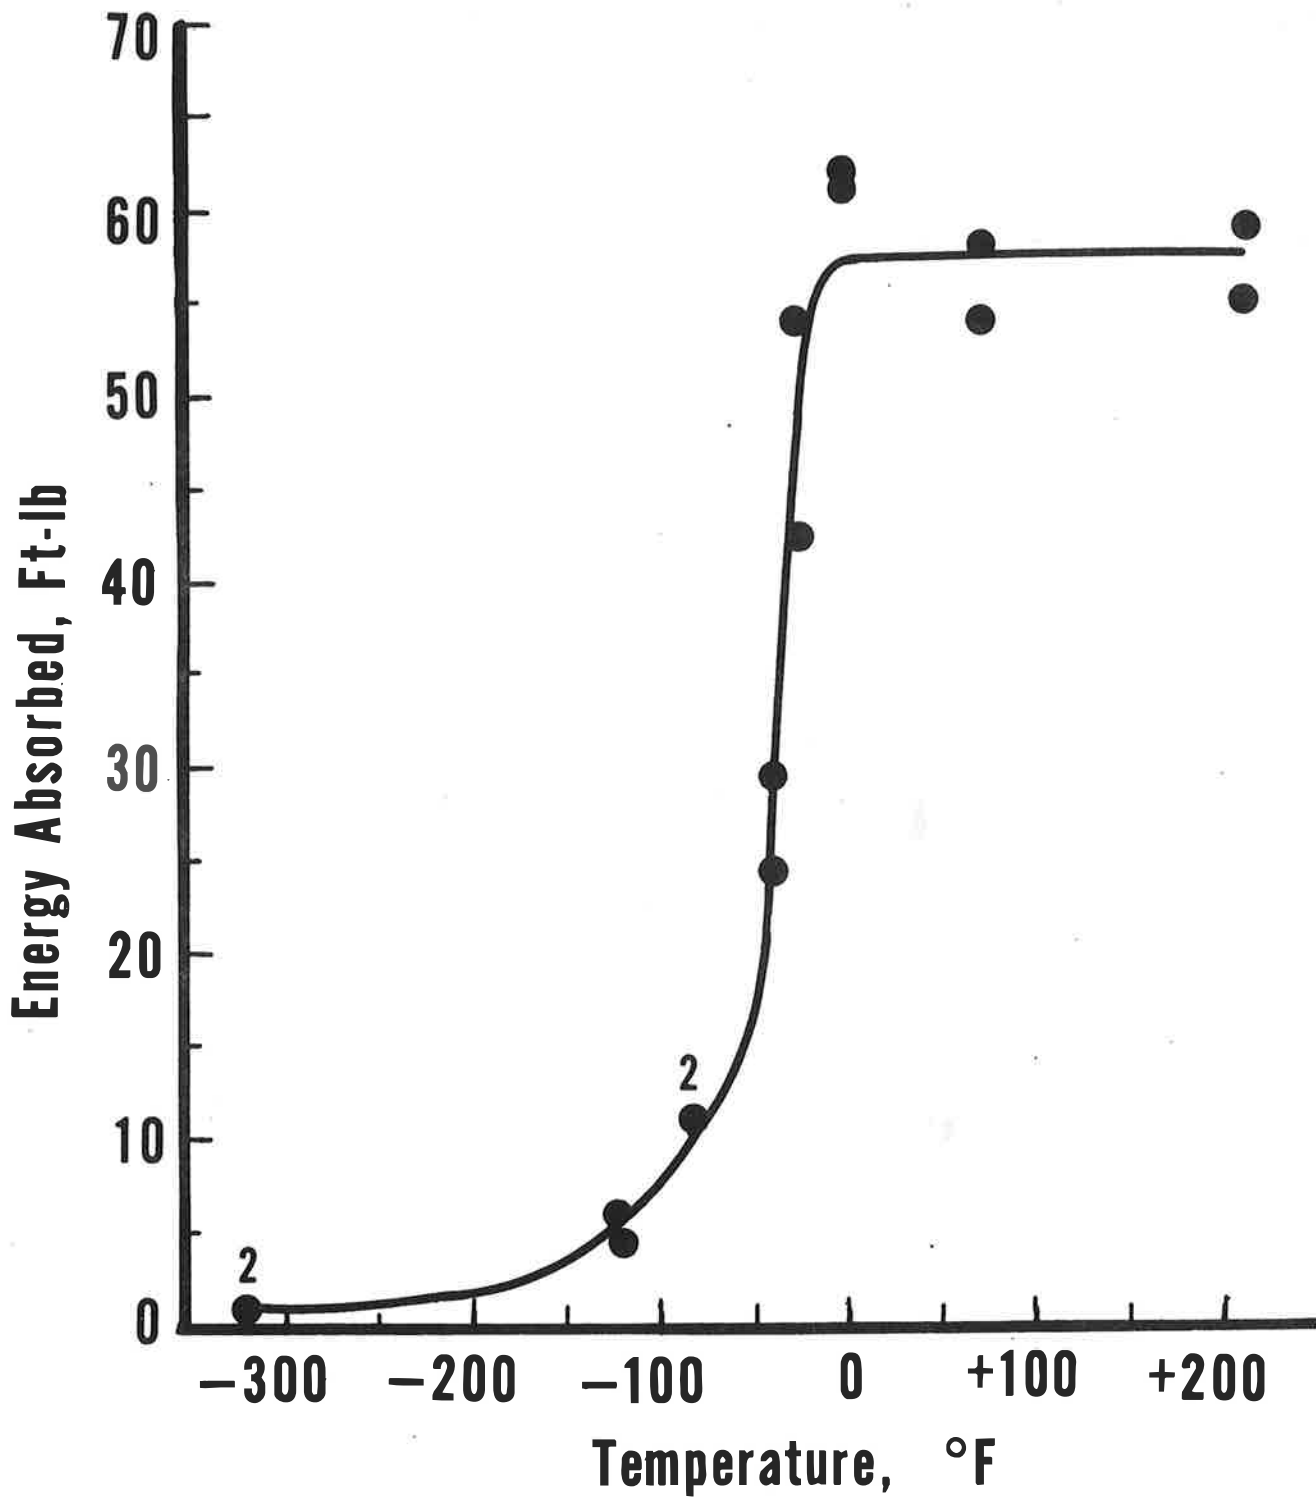
Specimens made from group A1 had a crack propagation direction perpendicular to the plate. The crack plane of these impact specimens was approximately parallel to the average plane of the plate fracture (Fig. 3). The specimens of this group had a transition temperature of -10° F and an energy-absorbed value of 57 ft-lb. Specimens of group C1 had their crack propagation direction through the plate, as did group A1, but their crack plane was approximately perpendicular to the plate fracture. The impact results of this group show the transition temperature to be -30° F with an energy-absorbed value of 115 ft-lb.

Figure 18. Effect of test temperature on the percentage of brittle fracture area of Group A1 impact specimens.

Figure 19. Effect of test temperature on the energy absorbed during fracture of Group A1 impact specimens.

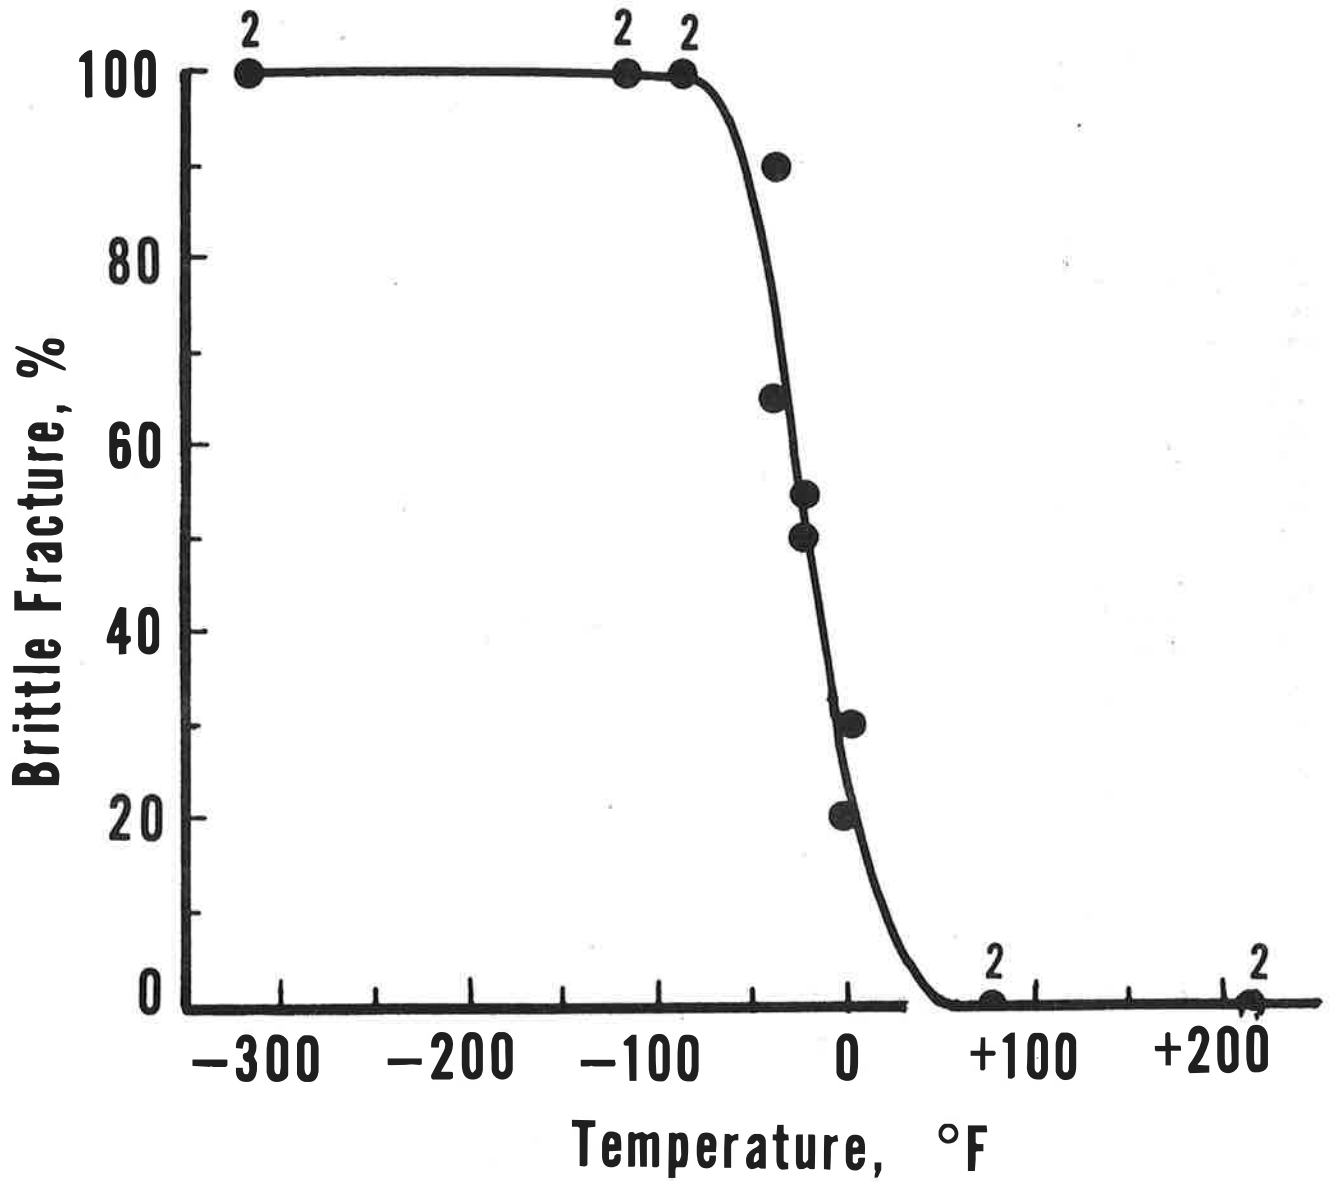
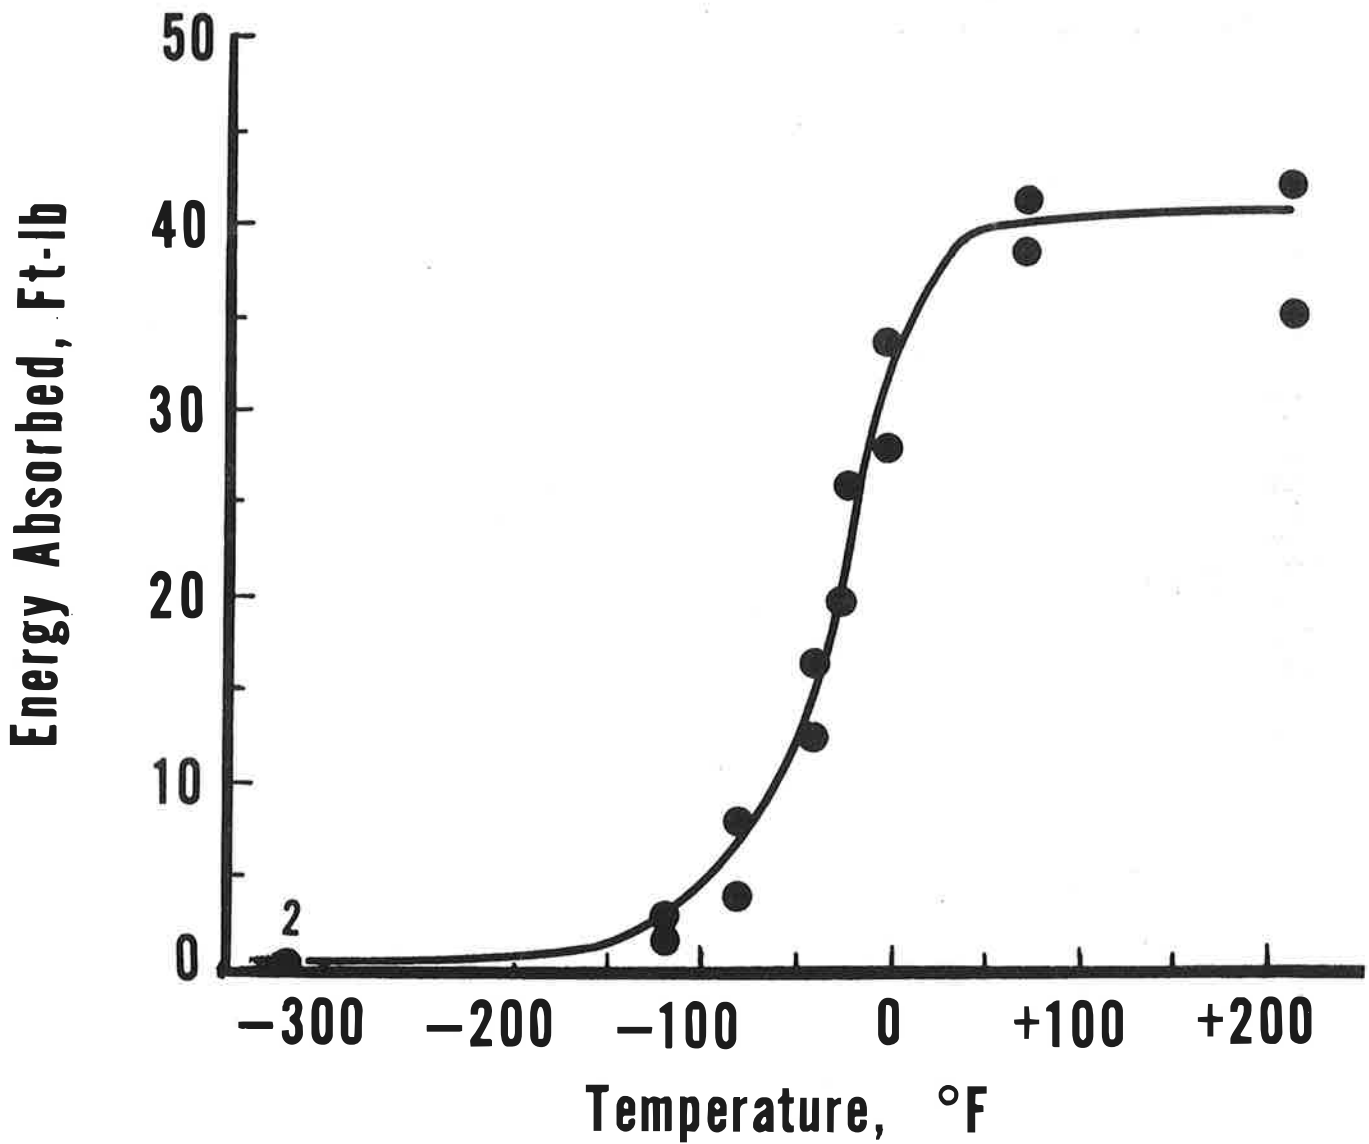
Specimens in groups B1 and D1, with their notch orientation normal to the surface have a crack propagation direction parallel to the surface. The crack plane of group B1 was approximately parallel and that of group D1 was approximately perpendicular to the fracture plane of the plate. There was no significant difference in the TT_E in both groups of these specimens. Group D1 specimens had higher energy-absorbed values at TT_E than group B1. Group C1 specimens had a higher energy-absorbed values at TT_E than group A1.

The impact values for groups B1 and D1 at -50° F as obtained from the curves, figures 21 and 25, indicate the impact strength of these specimens to be slightly below the required specification. Since these specimens were taken from the plate, which had been cold formed, it is possible that the impact properties in the as rolled plate would have met the specifications.

Figure 20. Effect of test temperature on the percentage of brittle fracture area of Group B1 impact specimens.

Figure 21. Effect of test temperature on the energy absorbed during fracture of Group B1 impact specimens.
