REPORT NO. FRA-OR&D 75-46

HAZARDOUS MATERIALS TANK CARS- EVALUATION OF TANK CAR SHELL CONSTRUCTION MATERIAL

G. E. Hicho
C. H. Brady

**Prepared For
DEPARTMENT OF TRANSPORTATION
FEDERAL RAILROAD ADMINISTRATION
Office of Research and Development
Washington, D.C. 20590**

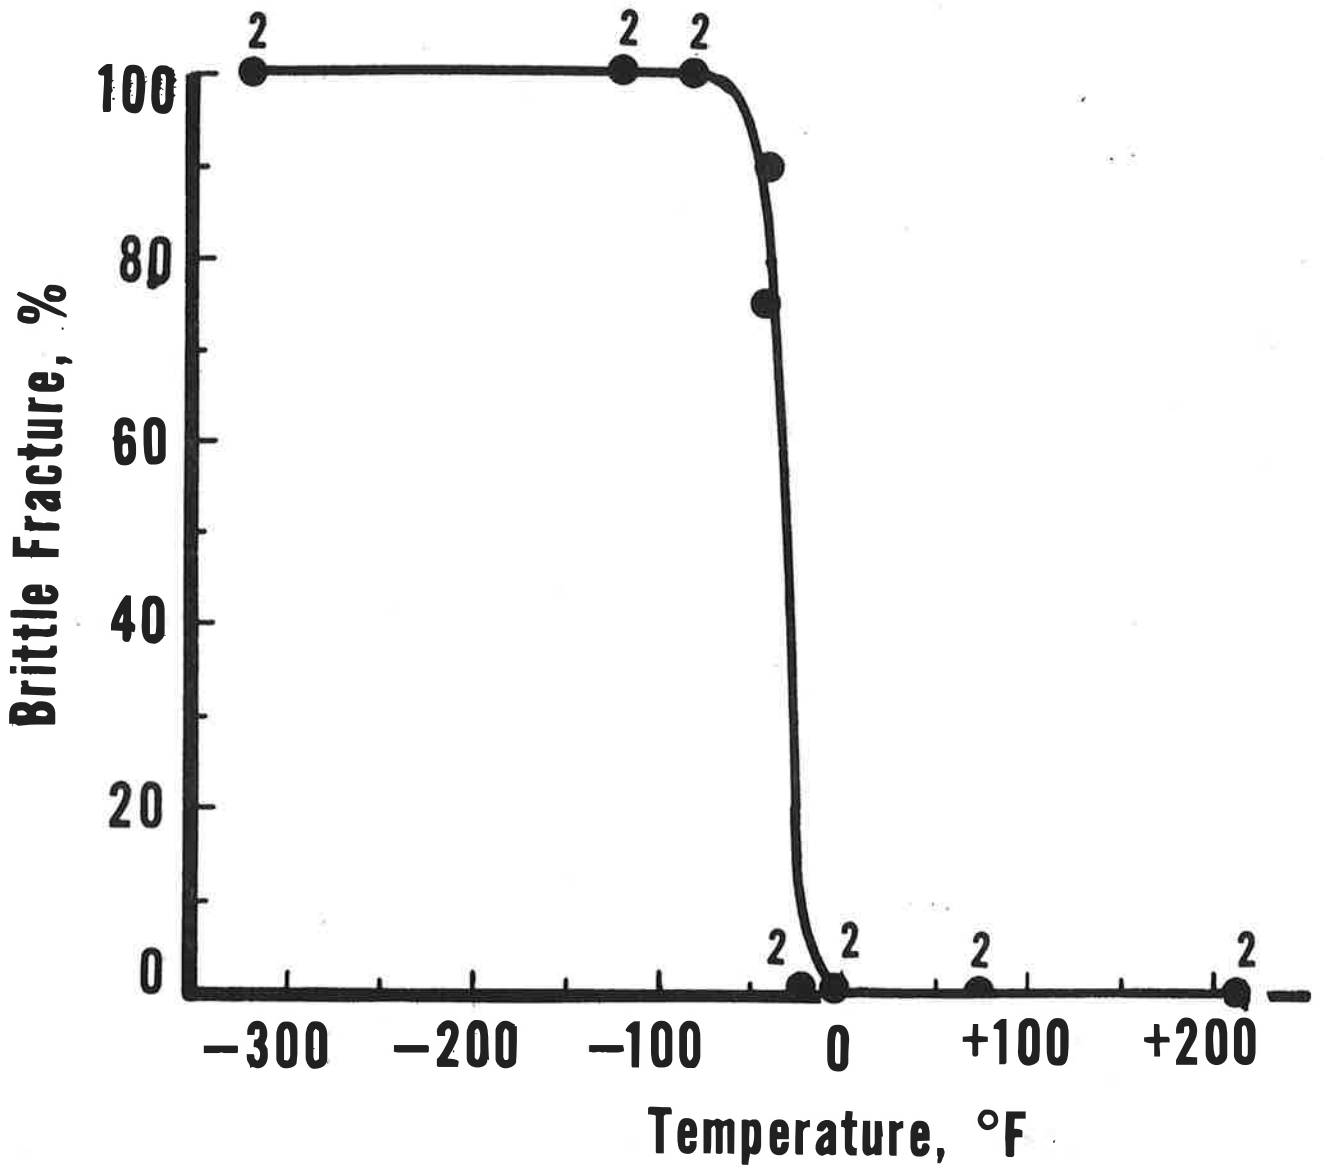
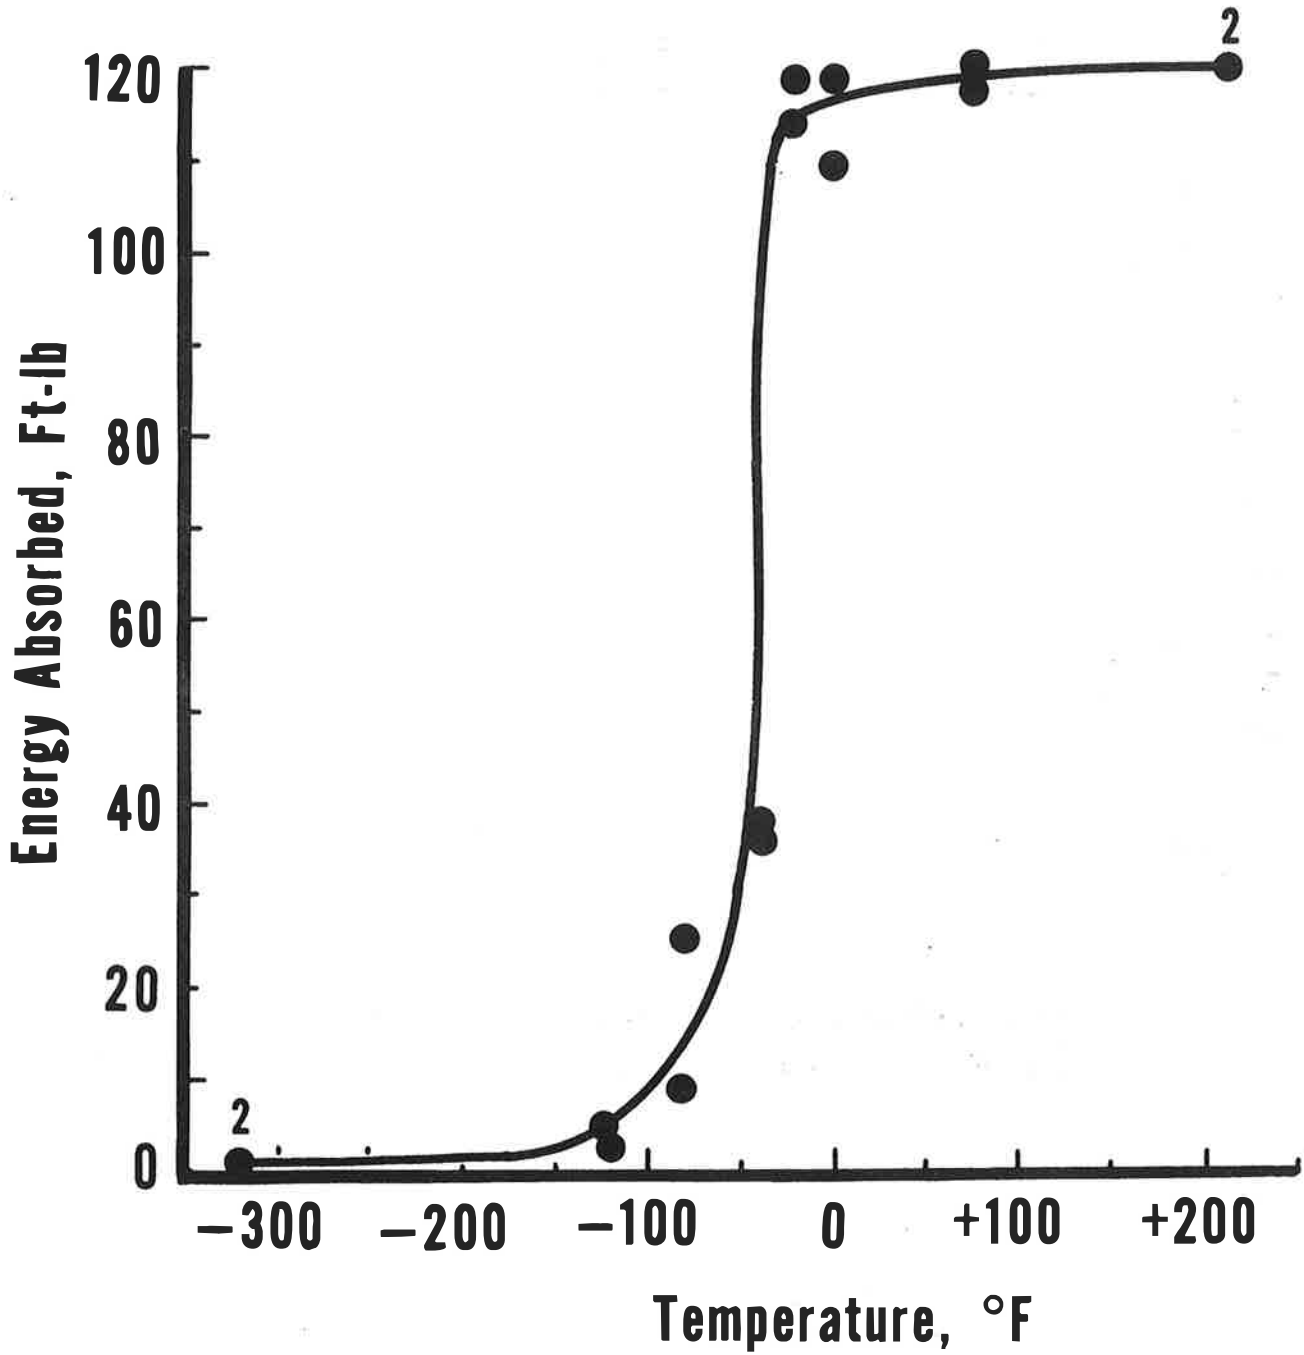
Figure 22. Effect of test temperature on the percentage of brittle fracture area of Group C1 impact specimens.

Figure 23. Effect of test temperature on the energy absorbed during fracture of Group C1 impact specimens.

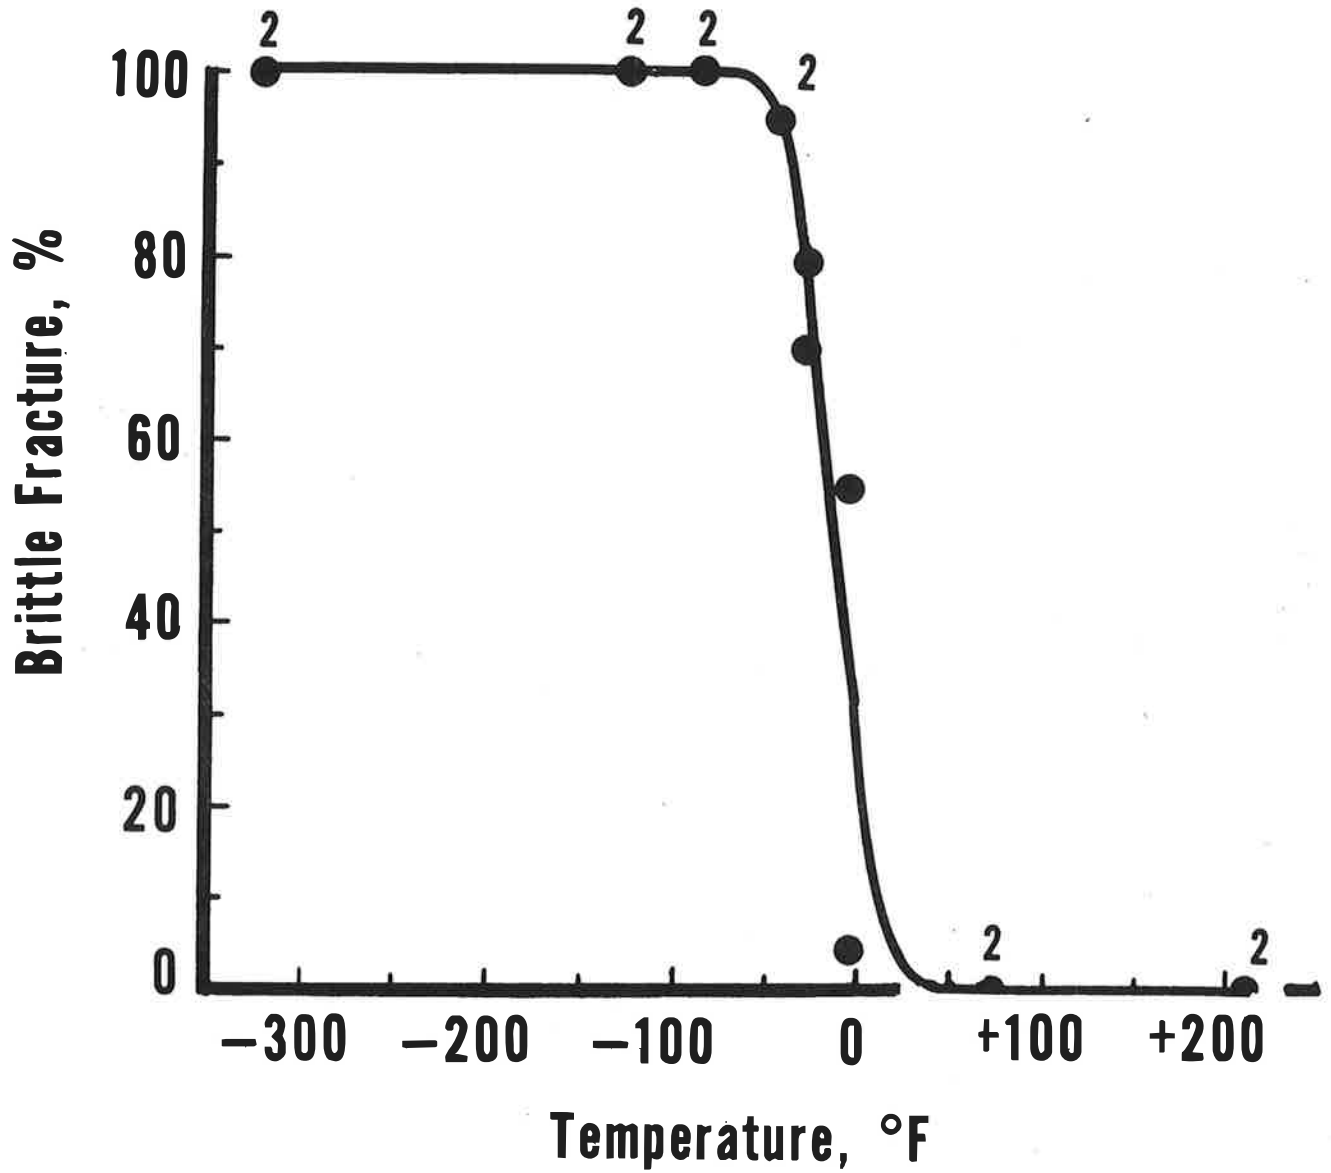
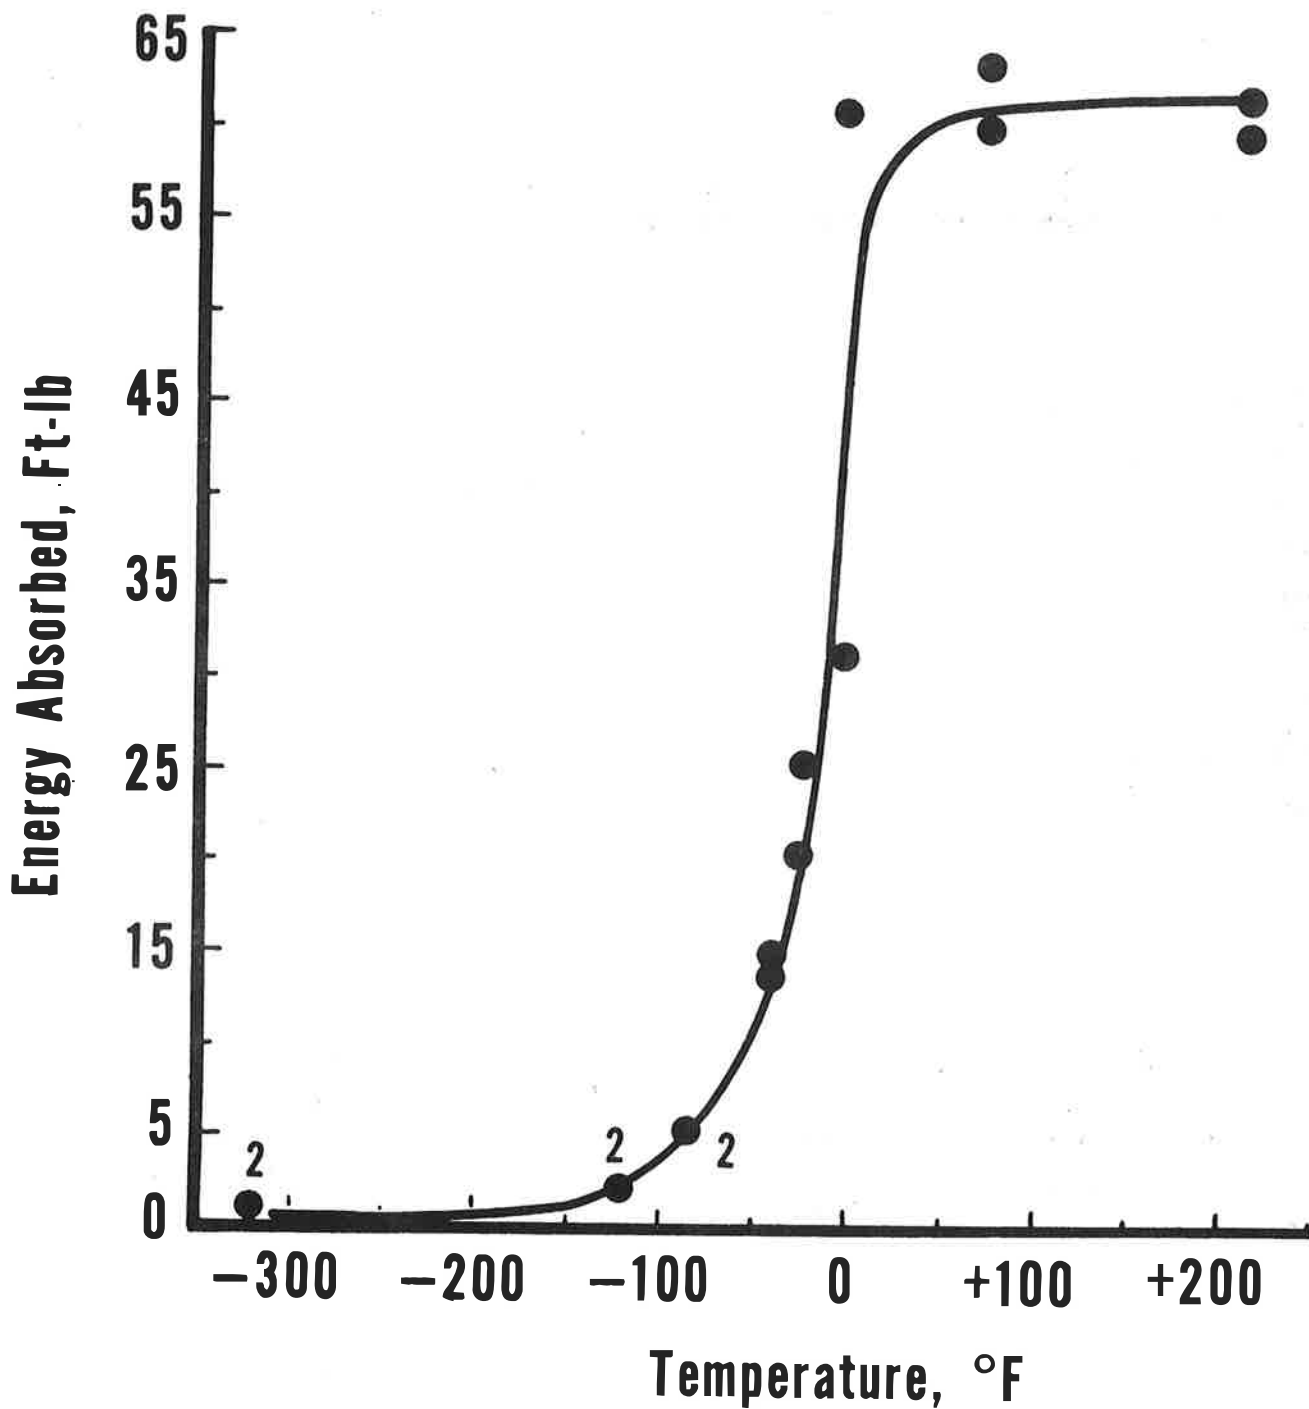
The impact values for groups B1 and D1 at -50° F as obtained from the curves, figures 21 and 25, indicate the impact strength of these specimens to be slightly below the required specification. Since these specimens were taken from the plate, which had been cold formed, it is possible that the impact properties in the as rolled plate would have met the specifications.

Figure 24. Effect of test temperature on the percentage of brittle fracture area of Group D1 impact specimens.

Figure 25. Effect of test temperature on the energy absorbed during fracture of Group D1 impact specimens.
