**Federal Railroad
Administration**

Crippling Load Test of Budd Pioneer Car 244, Test 3

1. AGENCY USE ONLY (Leave blank)		2. REPORT DATE April 2013	3. REPORT TYPE AND DATES COVERED Technical Report	
4. TITLE AND SUBTITLE Crippling Load Test of Budd Pioneer Car 244, Test 3			5. FUNDING NUMBERS DTRF53-00-C-00012 Task Order 235

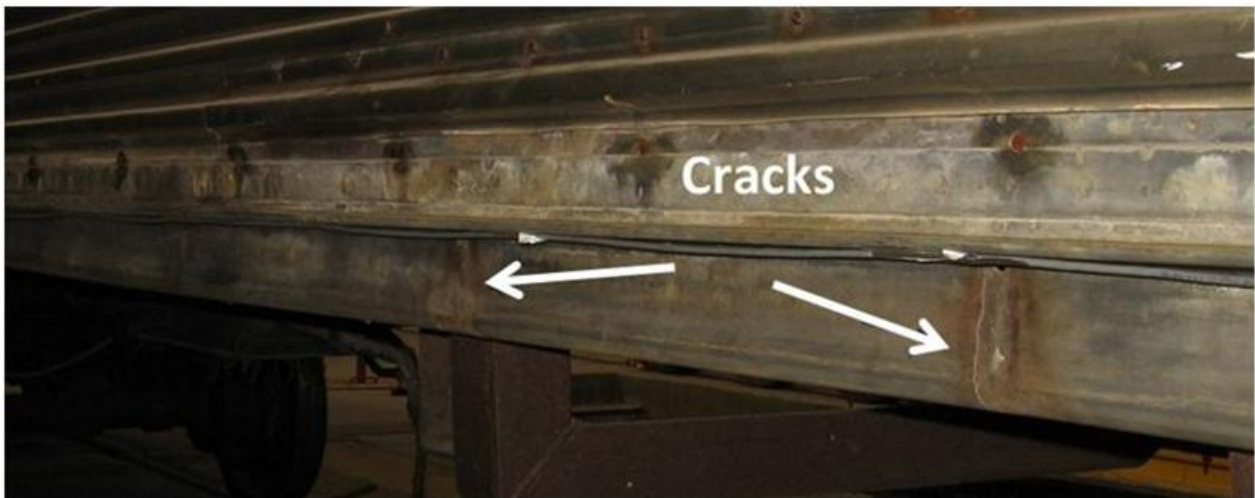
After Test 1, two fatigue cracks were discovered in the right side sill where brackets had been welded to support undercar equipment (Figure 4). A steel patch (Figure 5) was welded over the cracks to keep the sill side in line during compression for Test 2. Another patch was welded over the left sill to preserve car structural symmetry (Figure 6). Figure 7 and Figure 8 show the locations of the steel patches relative to the car windows. Test 2 was conducted in January 2011. It had the same setup and procedures as Test 1. No significant permanent compression of the car structure occurred after the two tests. Therefore, Car 244 was determined to be suitable for Test 3, the crippling load test.

Figure 4. Two Fatigue Cracks Found in the Right Side Sill after Test 1 on Car 244

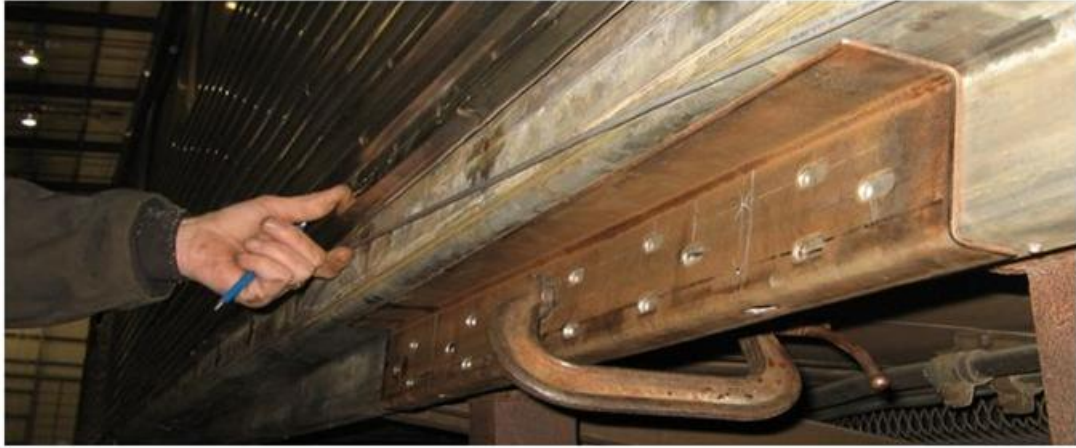
Figure 5. Steel Patch to Repair Fatigue Cracks

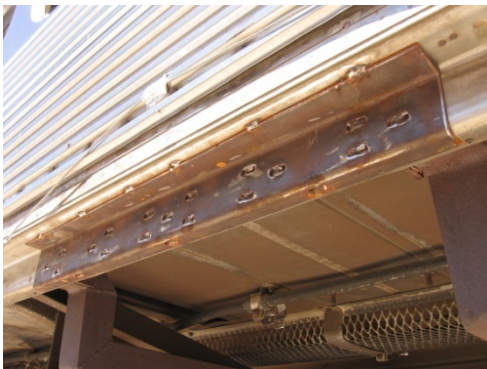
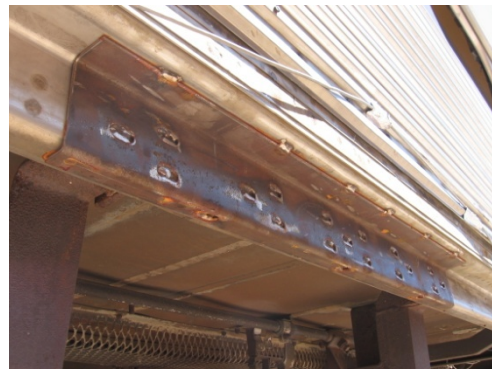
Figure 6. Steel Patch Welded onto Both Side Sills on Car 244

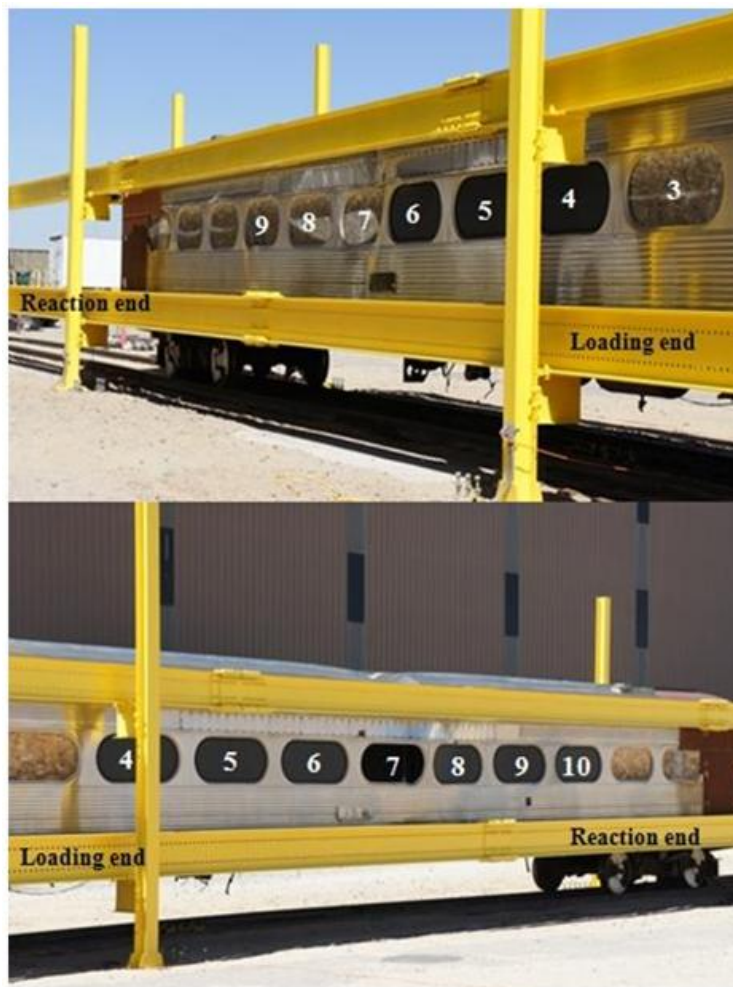
Figure 9 shows the load history during the shakedown test. The car first crippled at approximately 963,000 lb. The maximum total load applied by the four actuators in the shakedown test was approximately 1,148,000 lb. That load completely crippled the car. Figure 10 through 12 show crippling on Car 248. The crippling on Car 248 occurred between cross-members 4 and 5 in the vicinity of window 8. Unlike Car 244, Car 248 had no side-sill patches below window 8.

Figure 10. Crippling of Side Walls (Car 248)

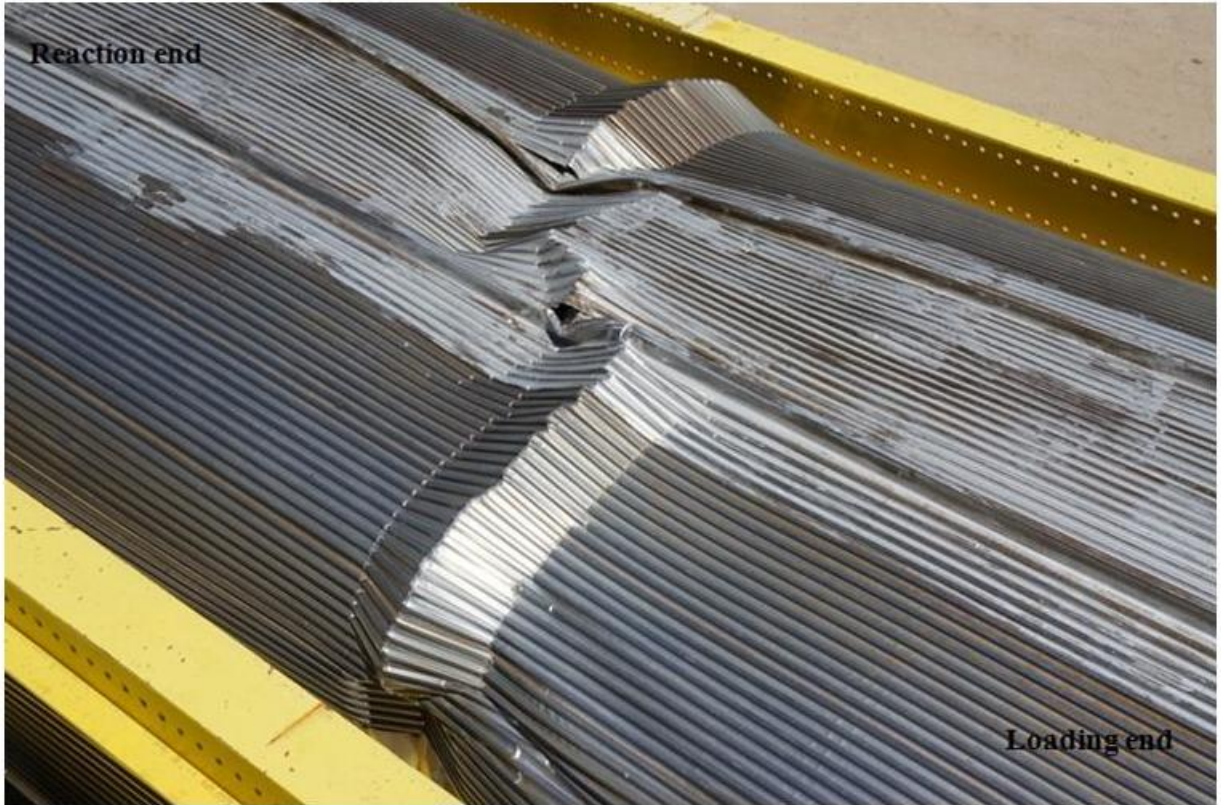
Figure 11. Crippling of Roof (Car 248)

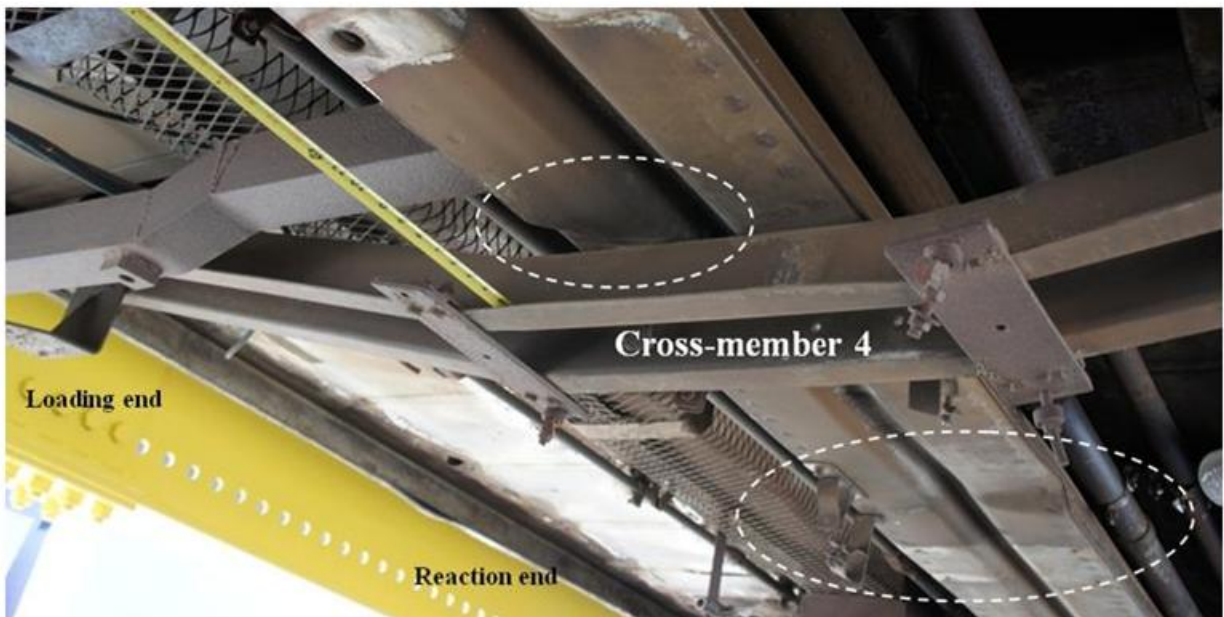
Figure 12. Crippling of Center Sill between Cross-Members 4 and 5 (Car 248)

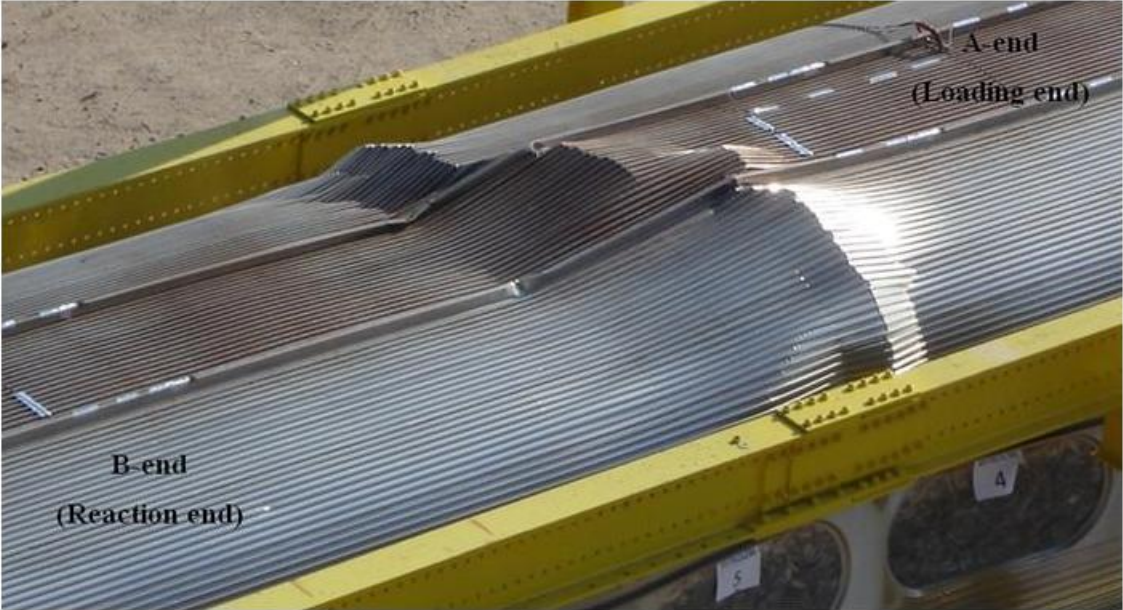
Figure 28. Crippling on Roof – Side View

Figure 37 shows the load-deflection history for Test 3 on Car 244, including the 200,000-, 400,000-, and 600,000-pound load cycles, the dwell at 800,000 lb, and the crippling. The first crippling at the roof level occurred at approximately 1,070,000 lb. The complete crippling, including the center sill and side sills, occurred at approximately 1,200,000 lb.

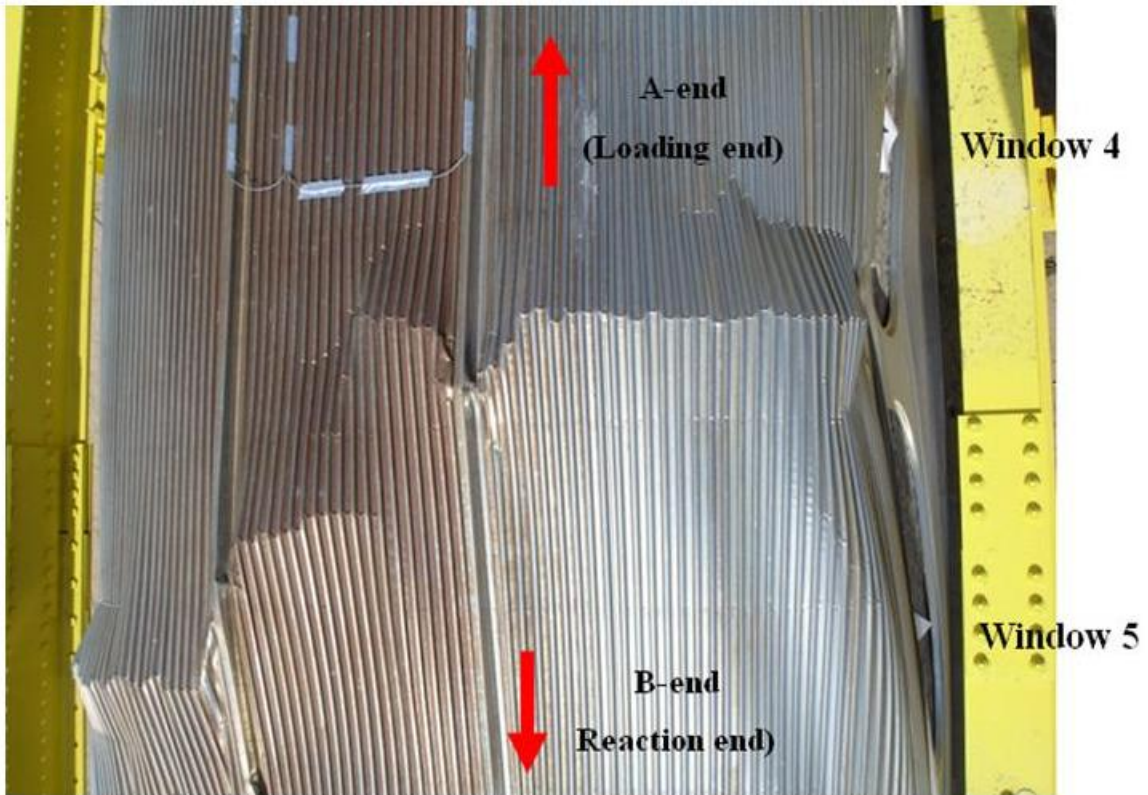
Figure 29. Crippling on Roof – Top View

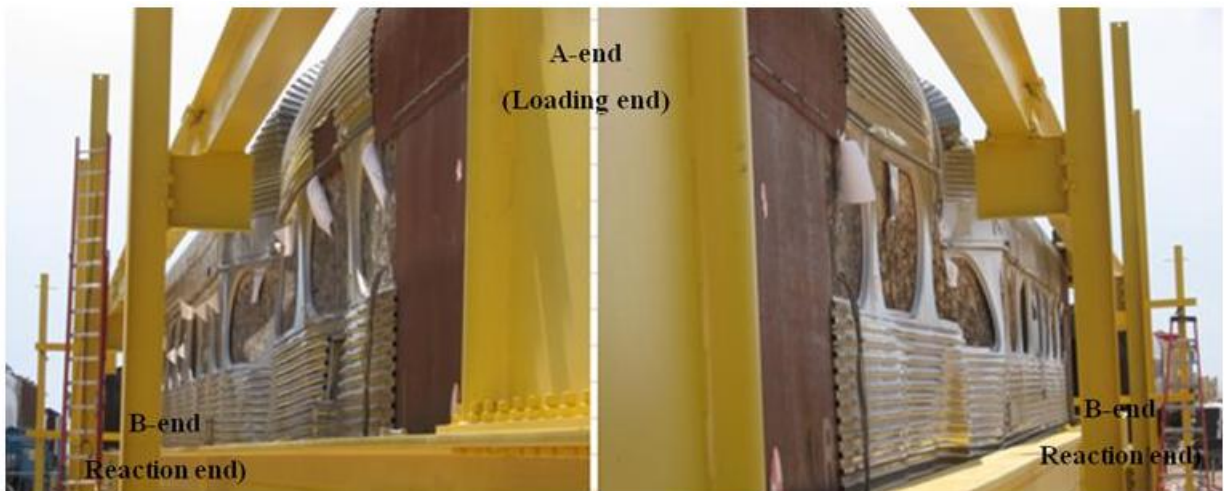
Figure 30. Crippling on Side Walls

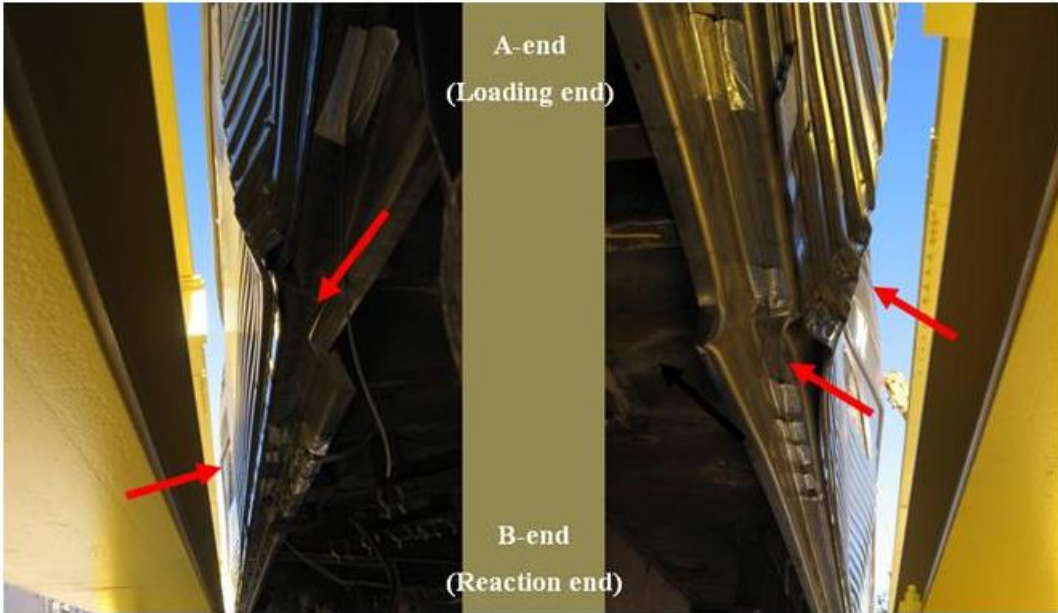
Figure 31. Crippling on Side Sills and Walls

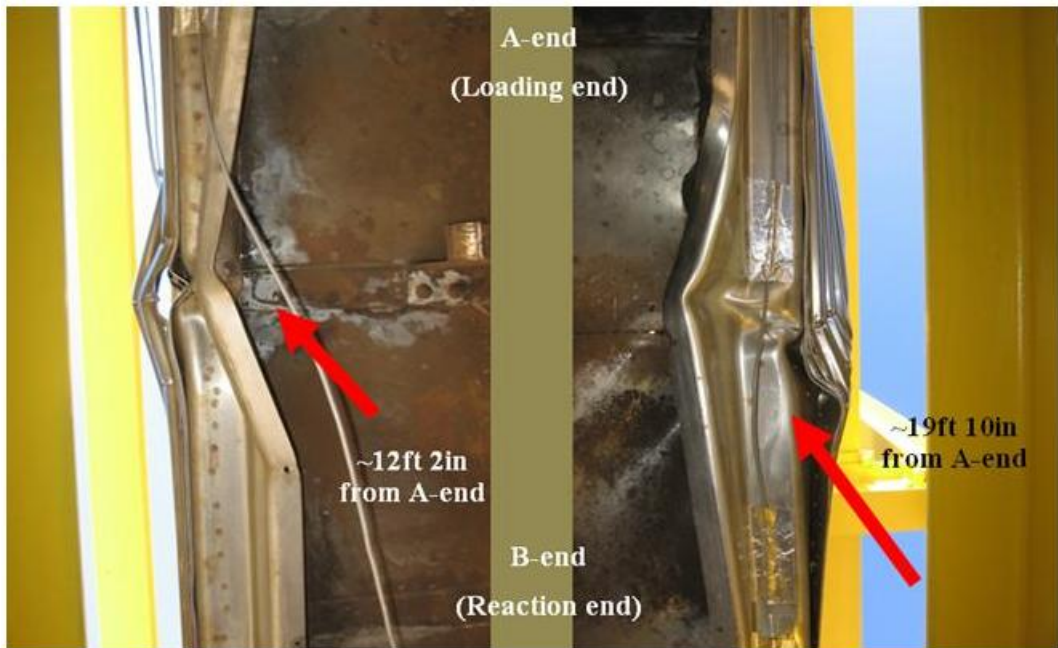
Figure 32. Kinks on Side Sills

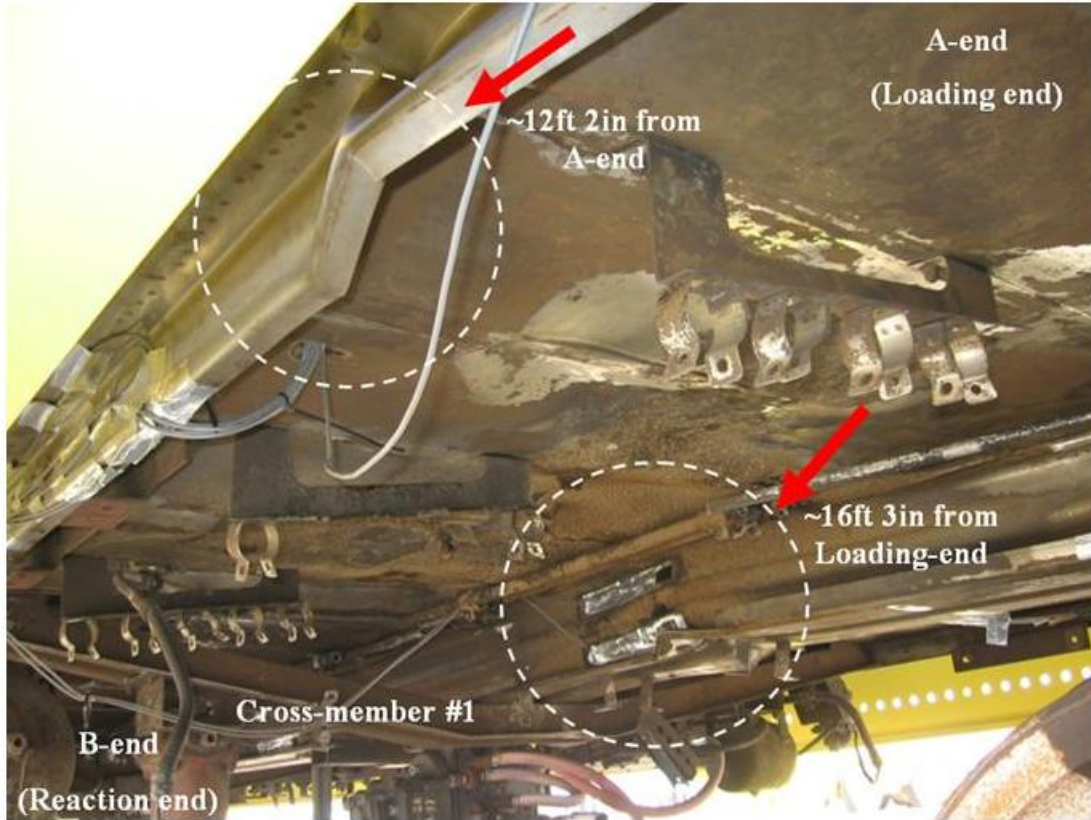
Figure 33. Locations of Kinks on Side Sill and Center Sill

Figure 38 shows longitudinal movement of several locations on the center sill relative to the ground. The cross-sections where the measuring string potentiometers were located beneath the car are shown in Figure 19. Location 1 is at the loading end, and location 7 is at the reaction end. The center sill at location 2 stopped moving longitudinally relative to the ground at 800,000 lb, whereas the other locations along the center sill continued to move at higher loads. This indicates that under compressive loads Car 244 crippled in close proximity to location 2. Had these measurements been displayed in real time during the test, they could have provided an indication of the major crippling location even before the 800,000-pound load level was reached. The crippling location shown by the test data in Figure 38 contains the physical damage shown in Figure 33 and Figure 34.

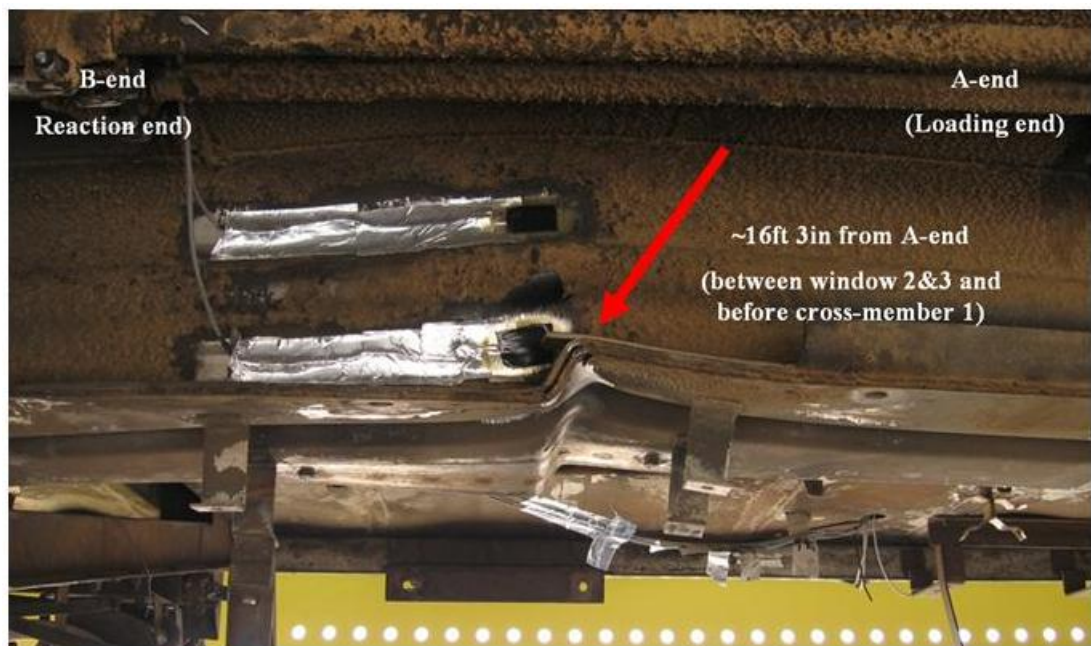
Figure 34. Center Sill Crippling

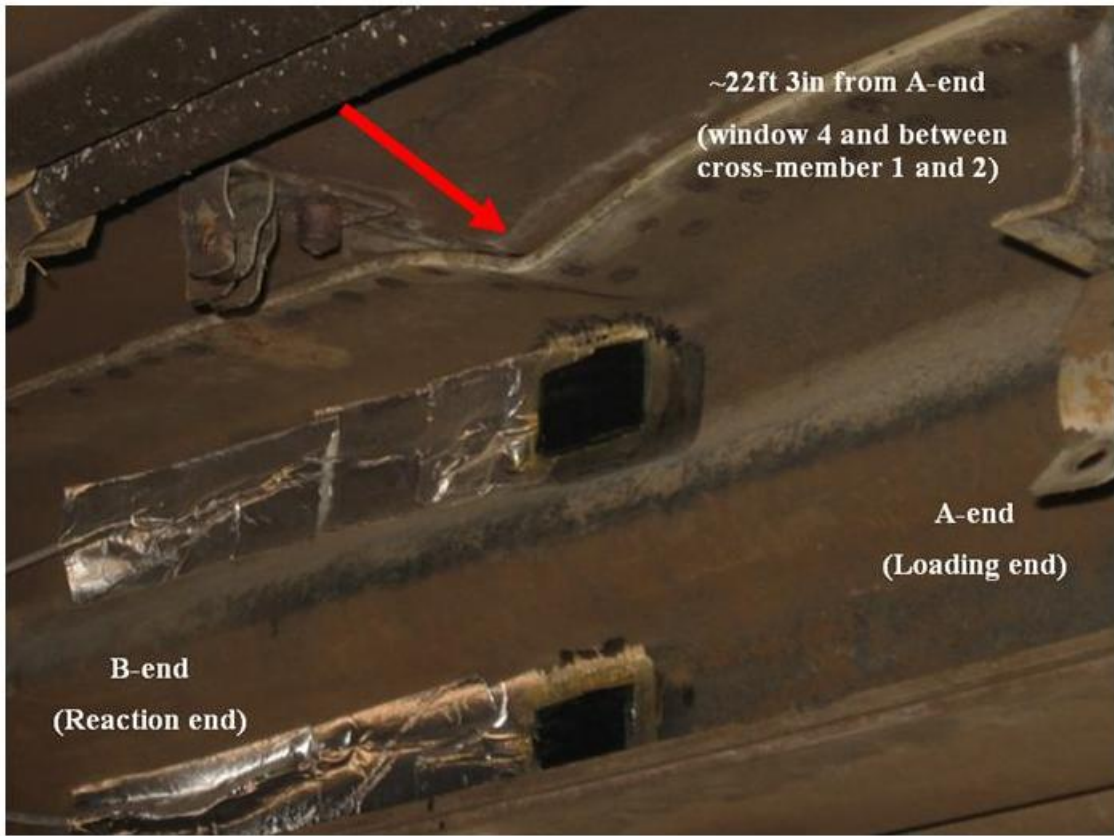
Figure 35. Kink on Center Sill under Car Floor

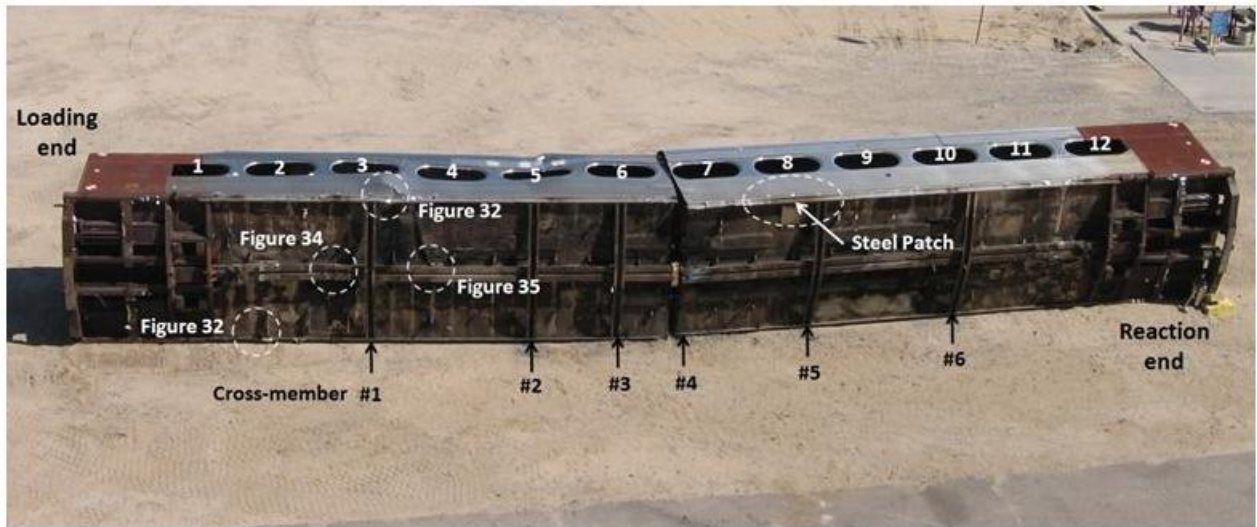
Figure 36. Relative Locations of Crippling
