***Federal Railroad Administration  
Office of Safety  
Headquarters Assigned  
Accident Investigation Report  
HQ-2012-22***

***Union Pacific (UP)  
Northbrook, IL  
July 4, 2012***

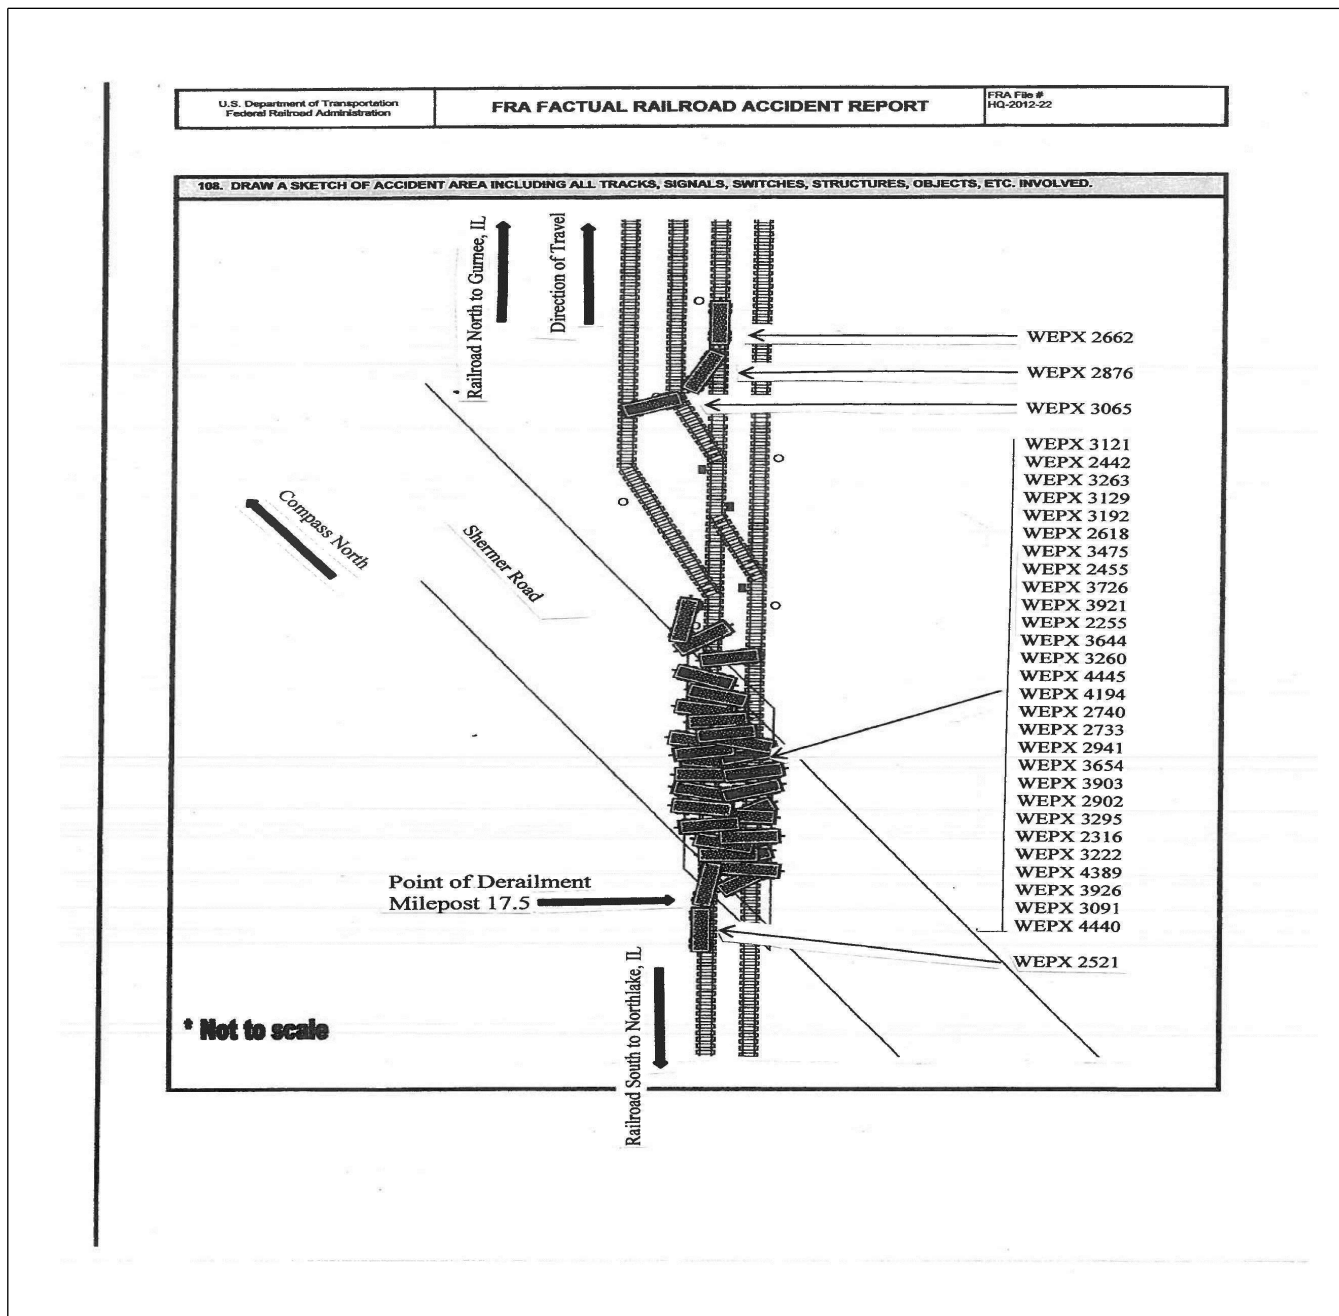
136. DRAW A SKETCH OF ACCIDENT AREA INCLUDING ALL TRACKS, SIGNALS, SWITCHES, STRUCTURES, OBJECTS, ETC., INVOLVED.

The 28th through the 59th cars derailed and were concentrated in a short area. The force of the derailment caused the bridge over Shermer Road to collapse onto the roadway below, crushing one automobile that was traveling southeast on Shermer Road. The derailment also knocked down power lines on the west side of right-of-way causing a grass fire.

FRA viewed the track image recording (TIR) taken from the lead locomotive of CCDPP 02. In the video it was evident that there was a track alignment anomaly on the No. 1 Main Track approximately 15 feet south of the Shermer Road Bridge. The recording showed that the track was shifted to the east at this location.
