NAR Case Studies

Paul Nony, Ph.D.

CENTER FOR TOXICOLOGY
AND ENVIRONMENTAL HEALTH, LLC

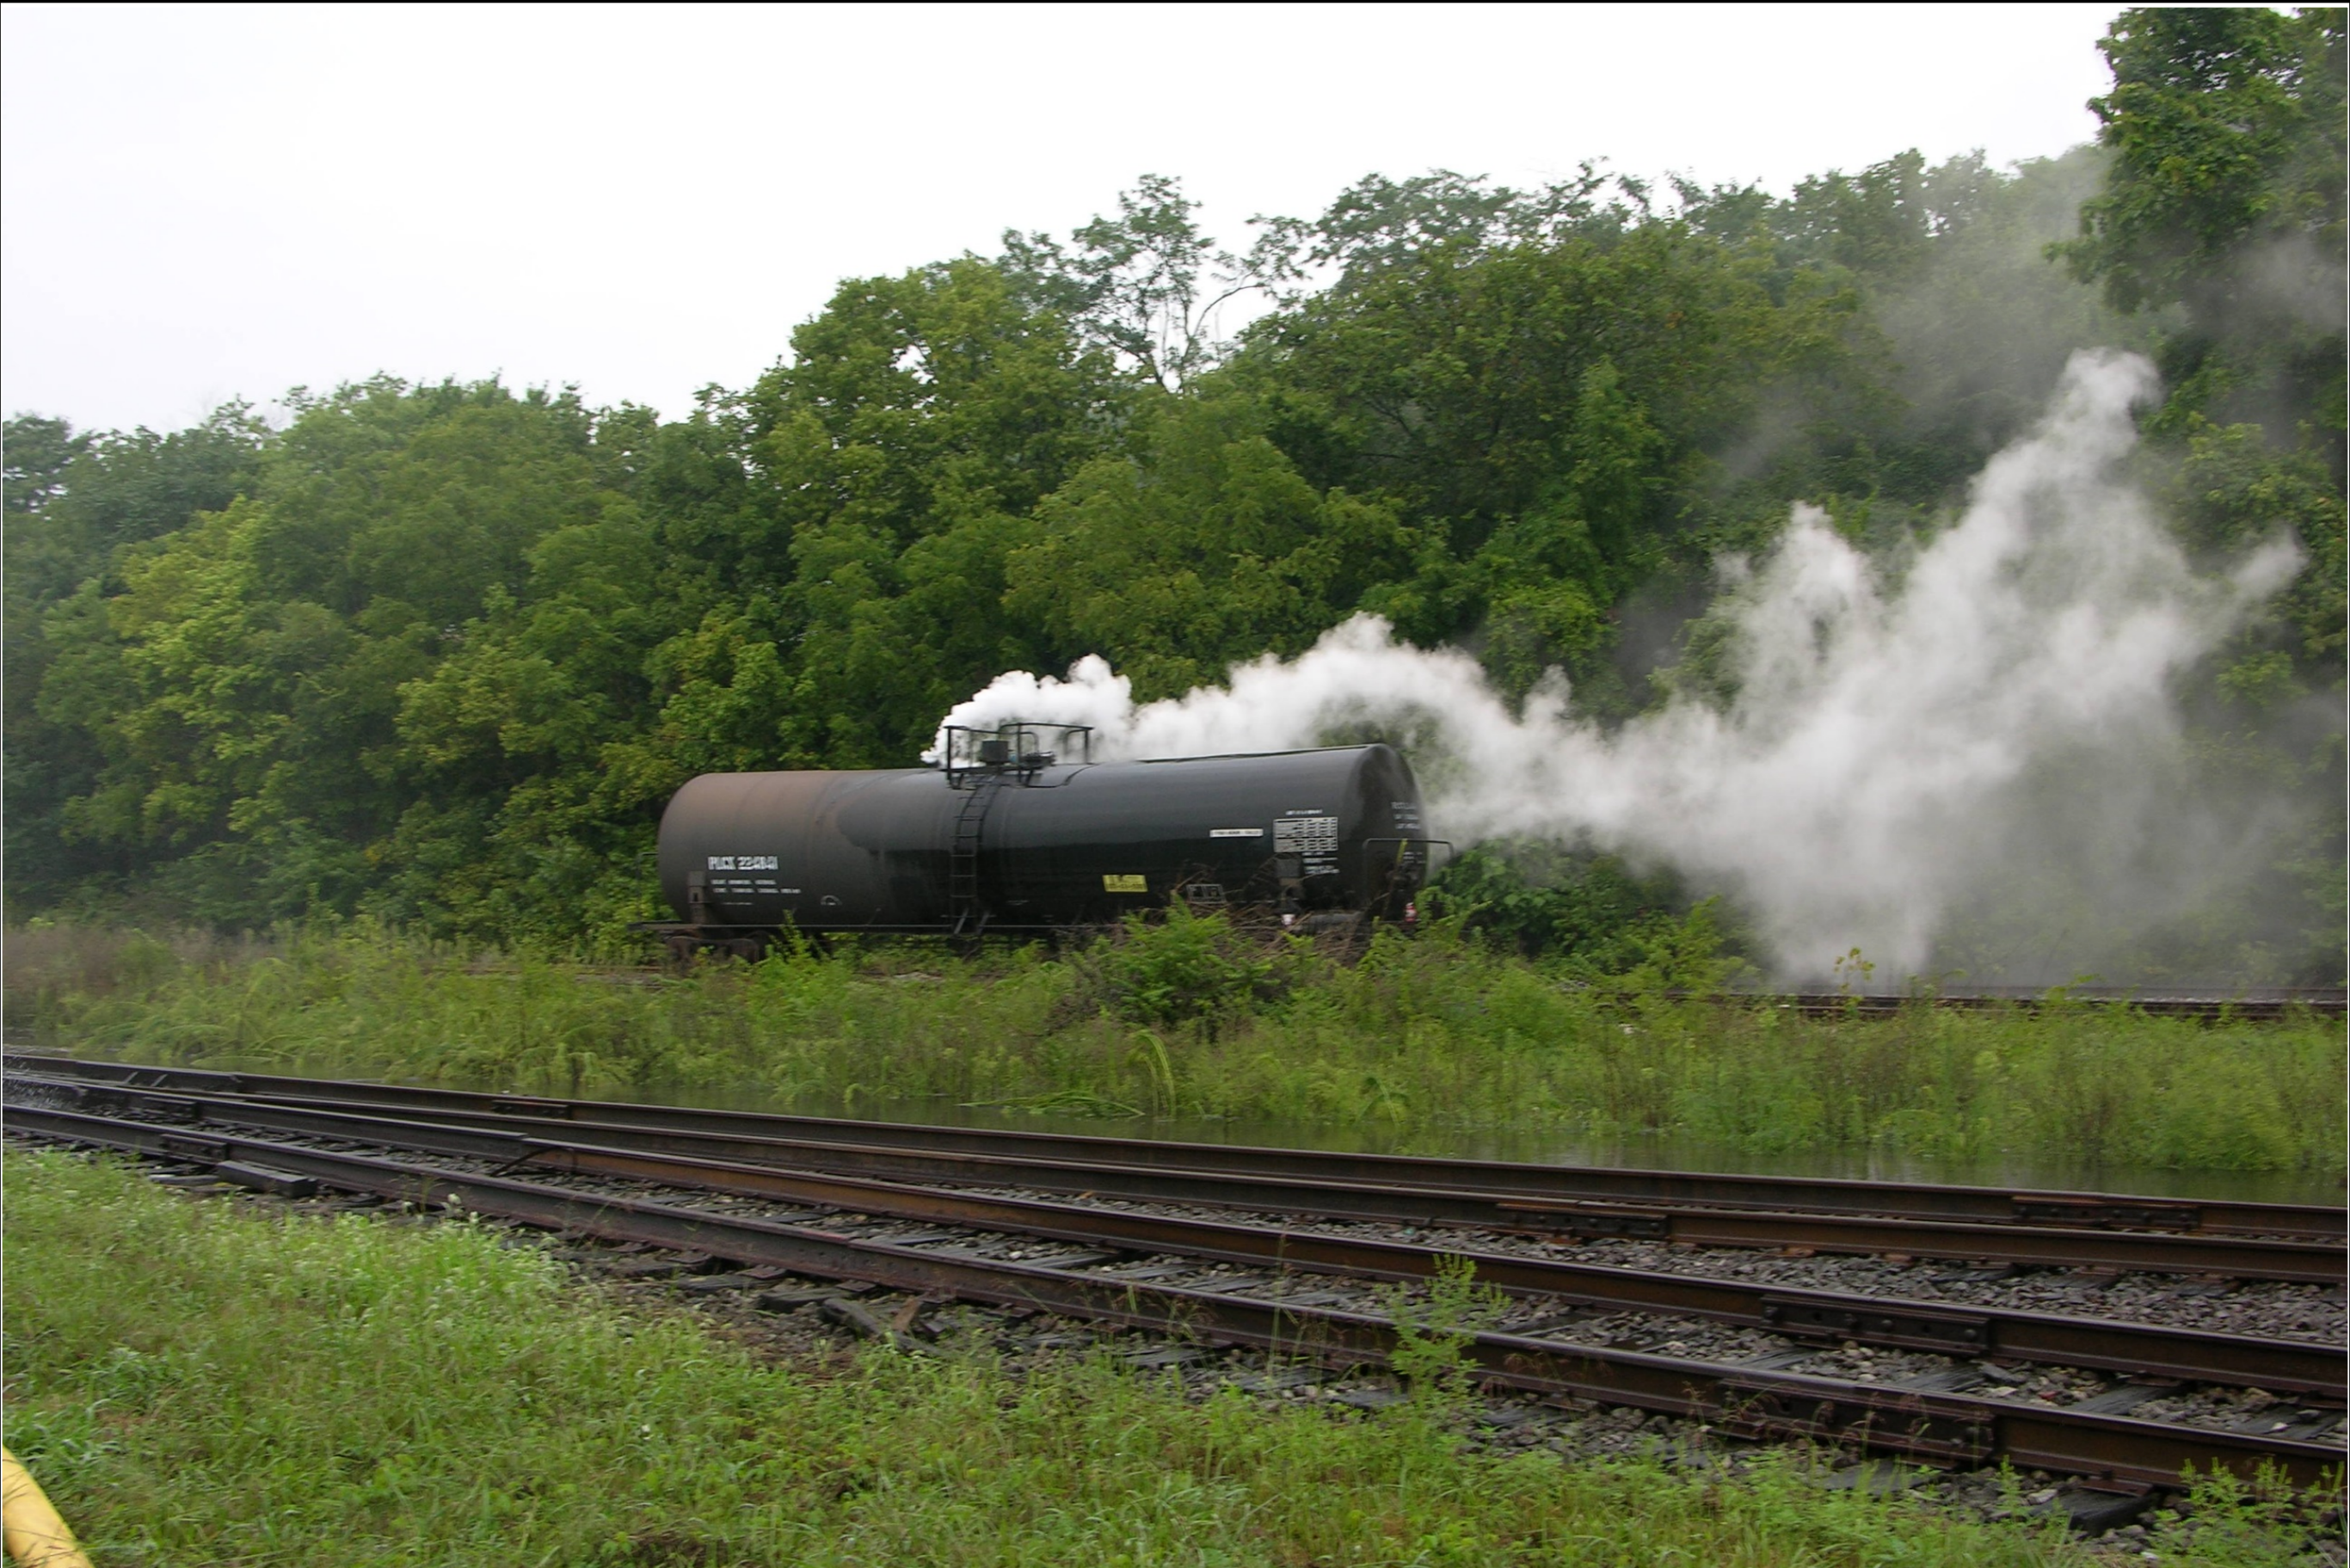
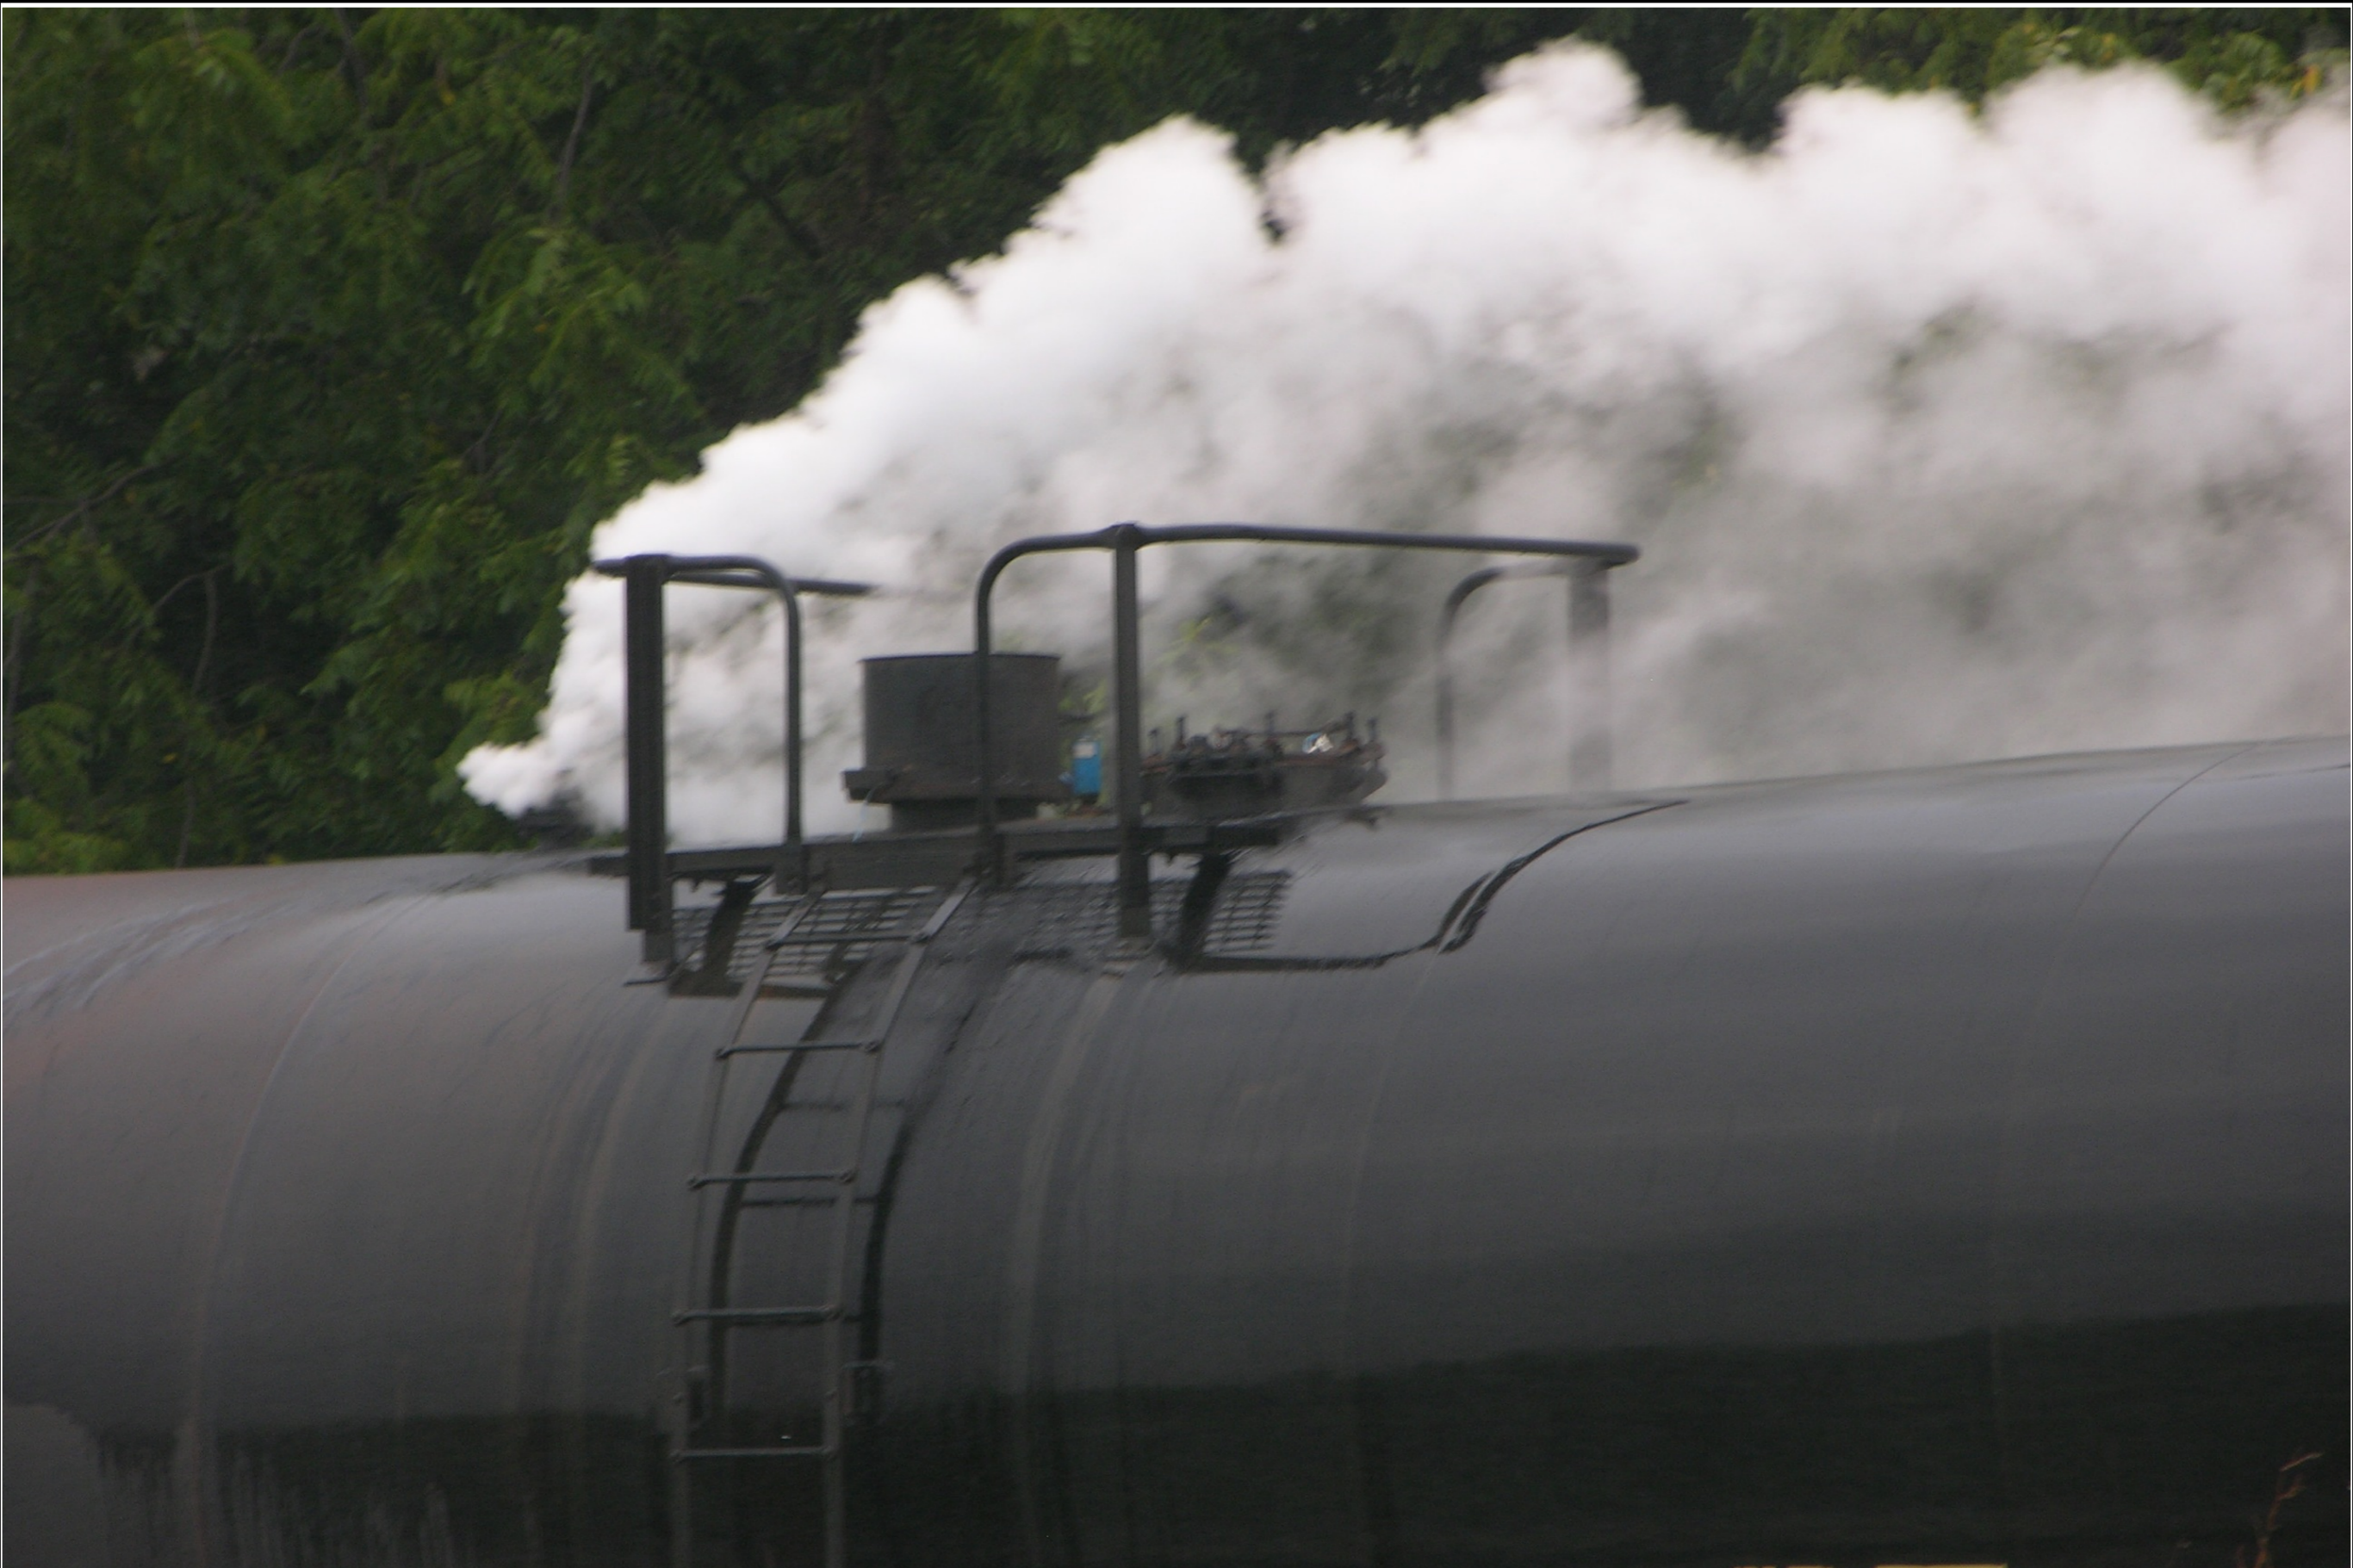
Case Study #1: Styrene Monomer- Cincinnati, OH

- Full load of styrene monomer left on spur track for approximately 9 months.
- Neither shipper nor receiver noticed it had not been delivered.
- Car began venting through the PRD resulting in evacuations of neighborhoods and businesses

- Venting at the PRD is an indicator of product polymerization inside the rail car
- The temperature inside the rail car will rise as the reaction continues
- Decrease in venting can mean one of two things:
 - The reaction is coming to an end, or
 - The PRD has become plugged preventing the relief of pressure within the container.

- The venting came almost to a stop several hours into the release event
- After several nervous hours, the venting started again
- Tank temperature started to decrease indicating the slowing of polymerization
- The event ended without failure of the tank car
- The evacuation resulted in a large, multi-agency response

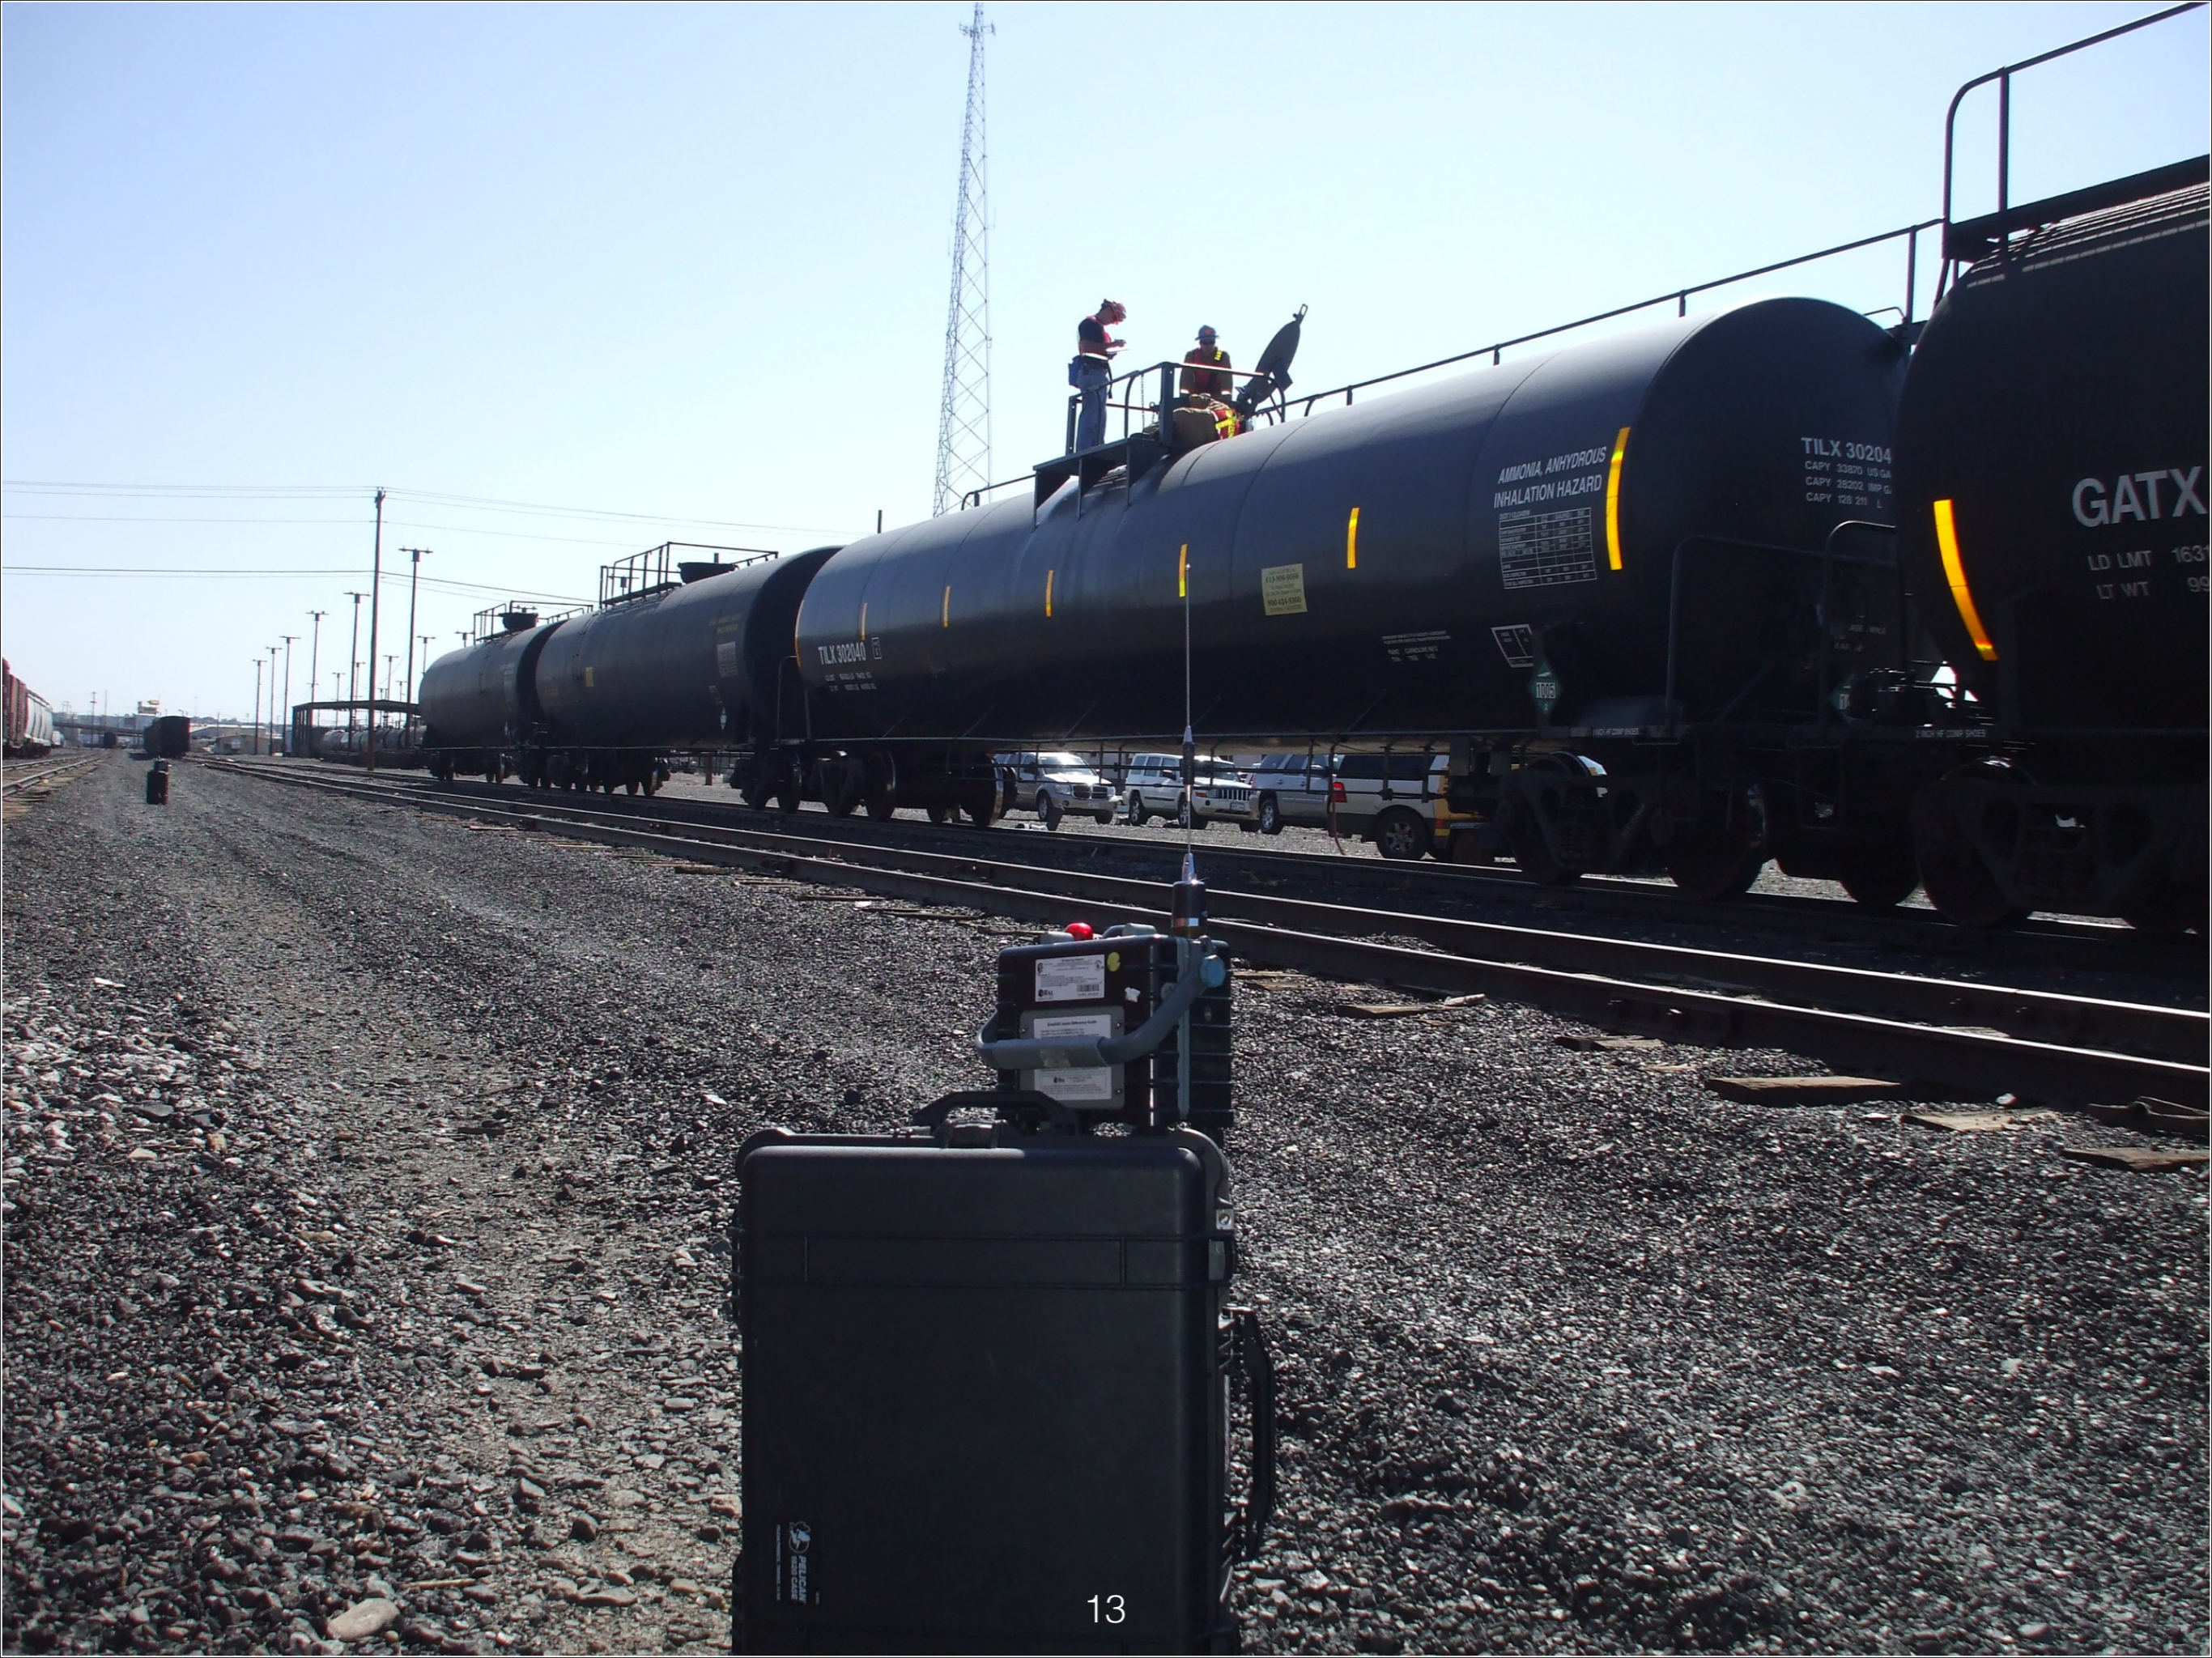
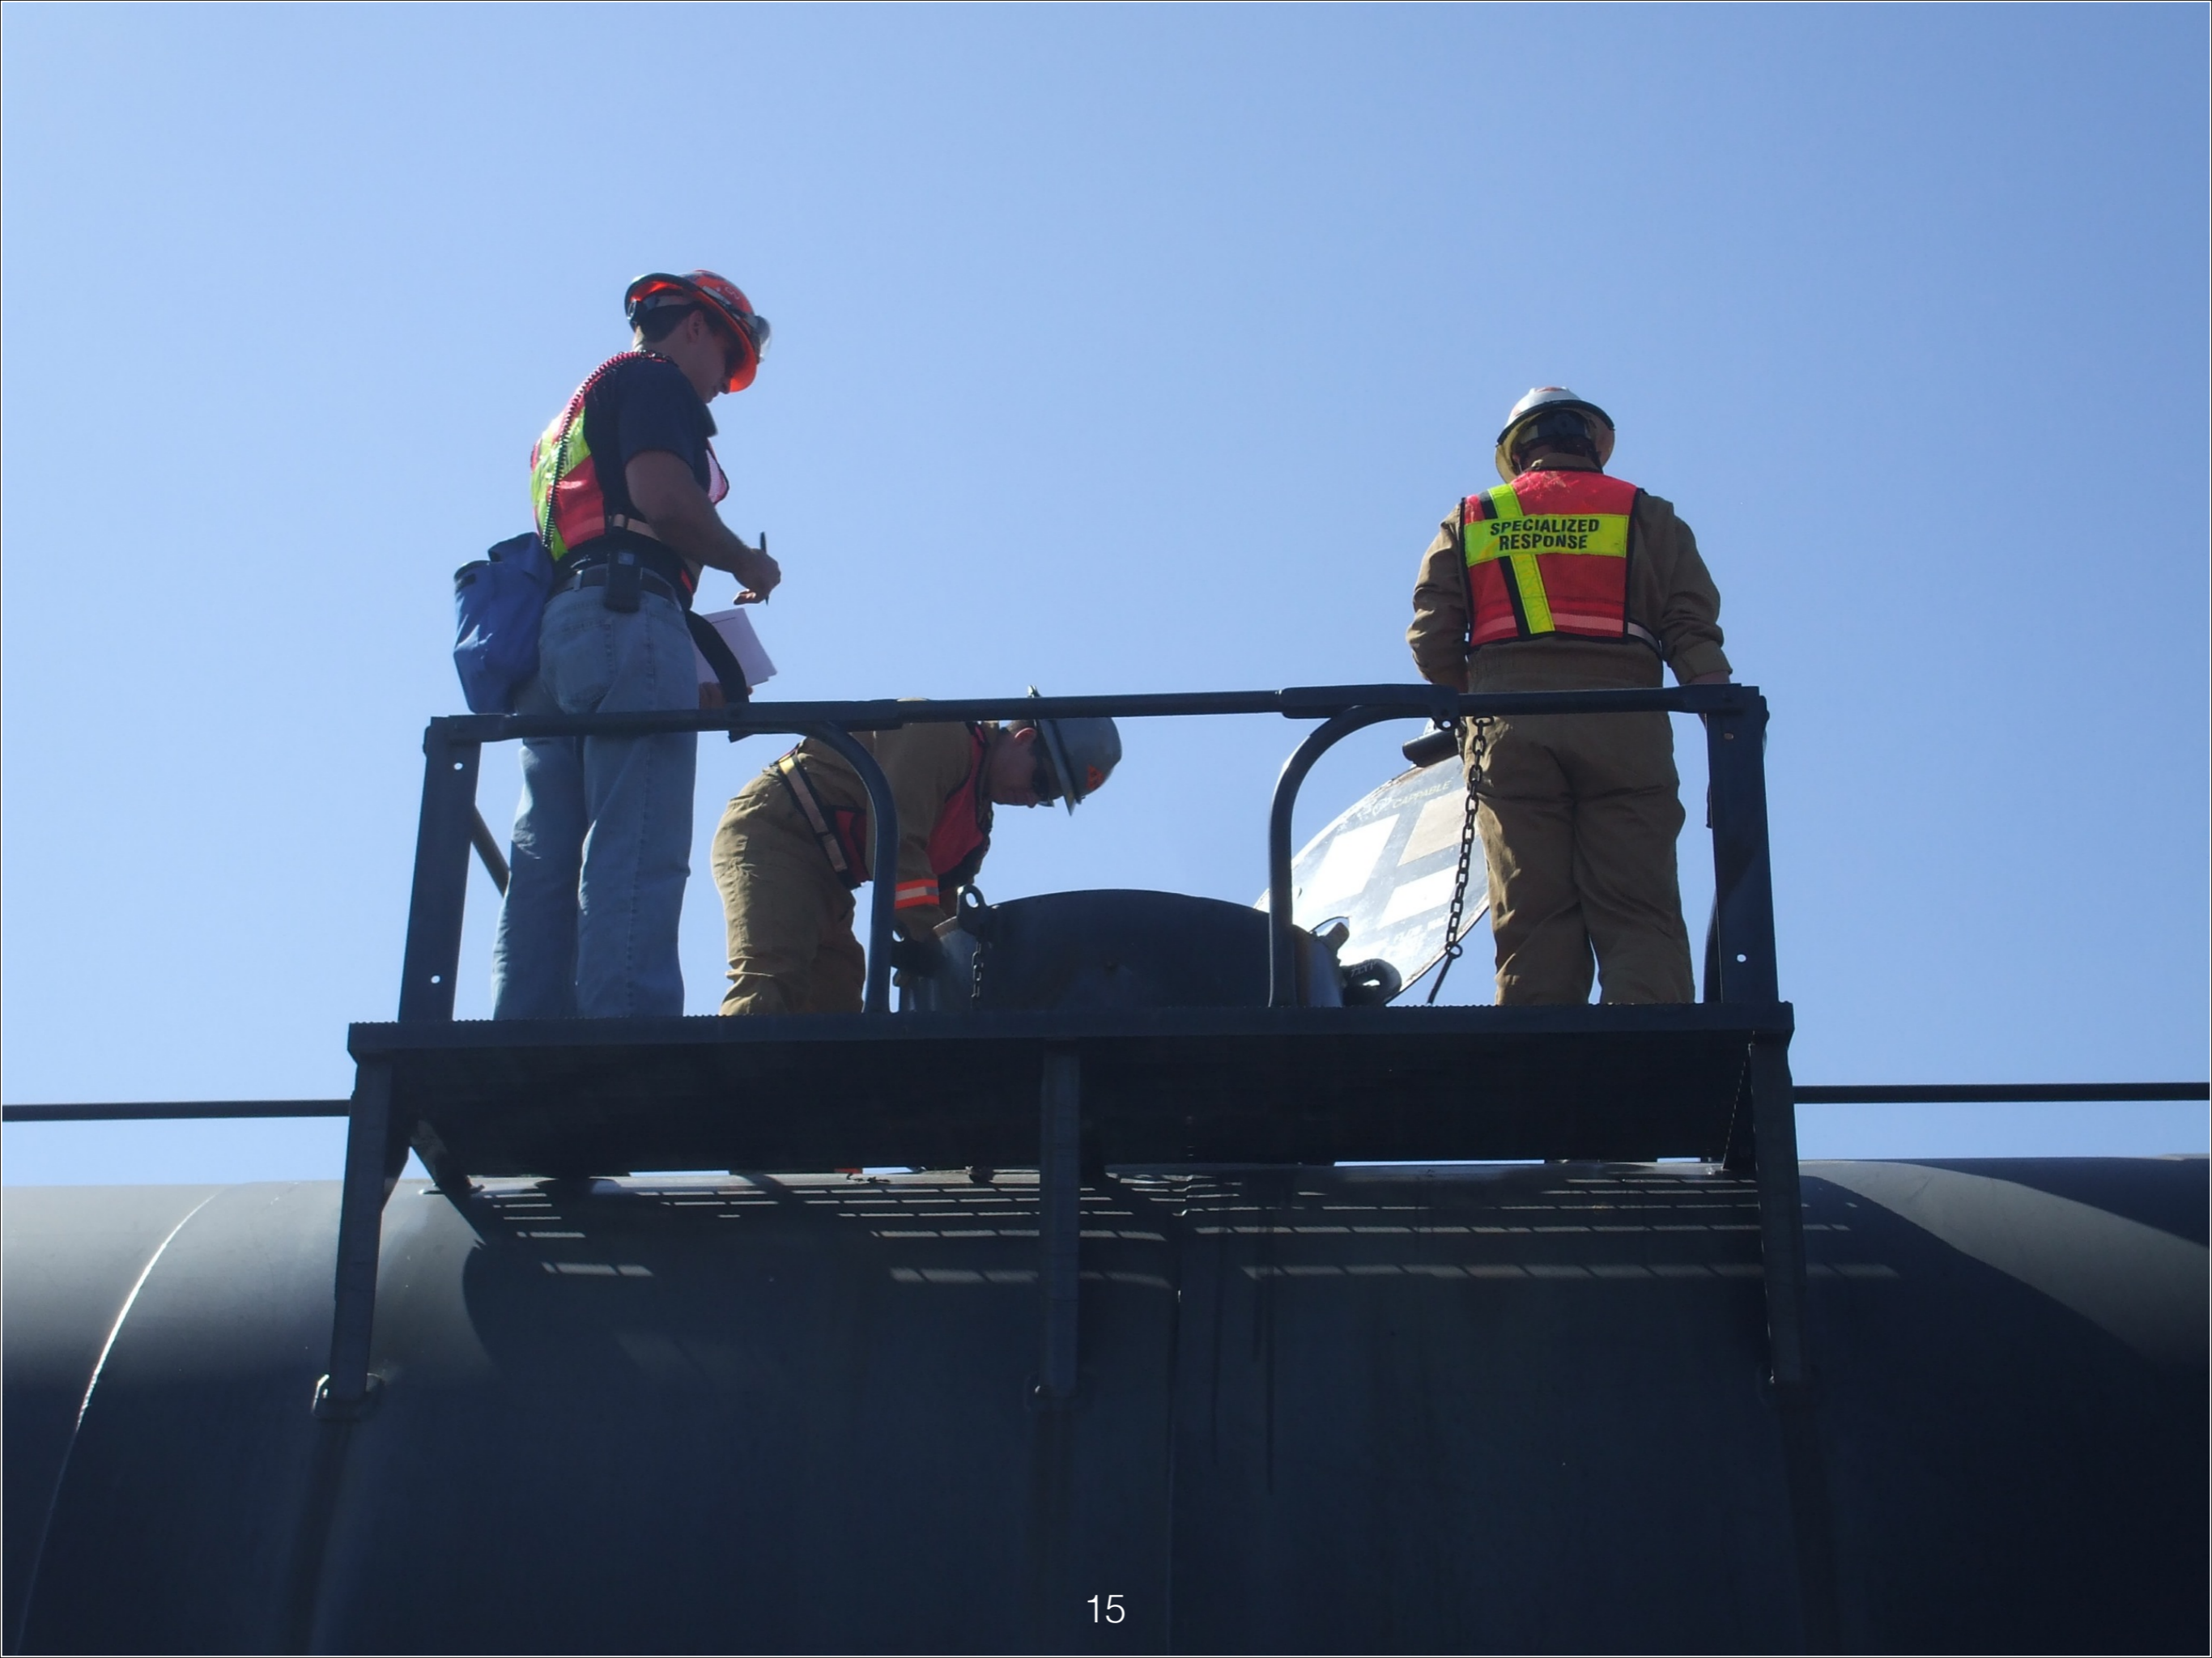
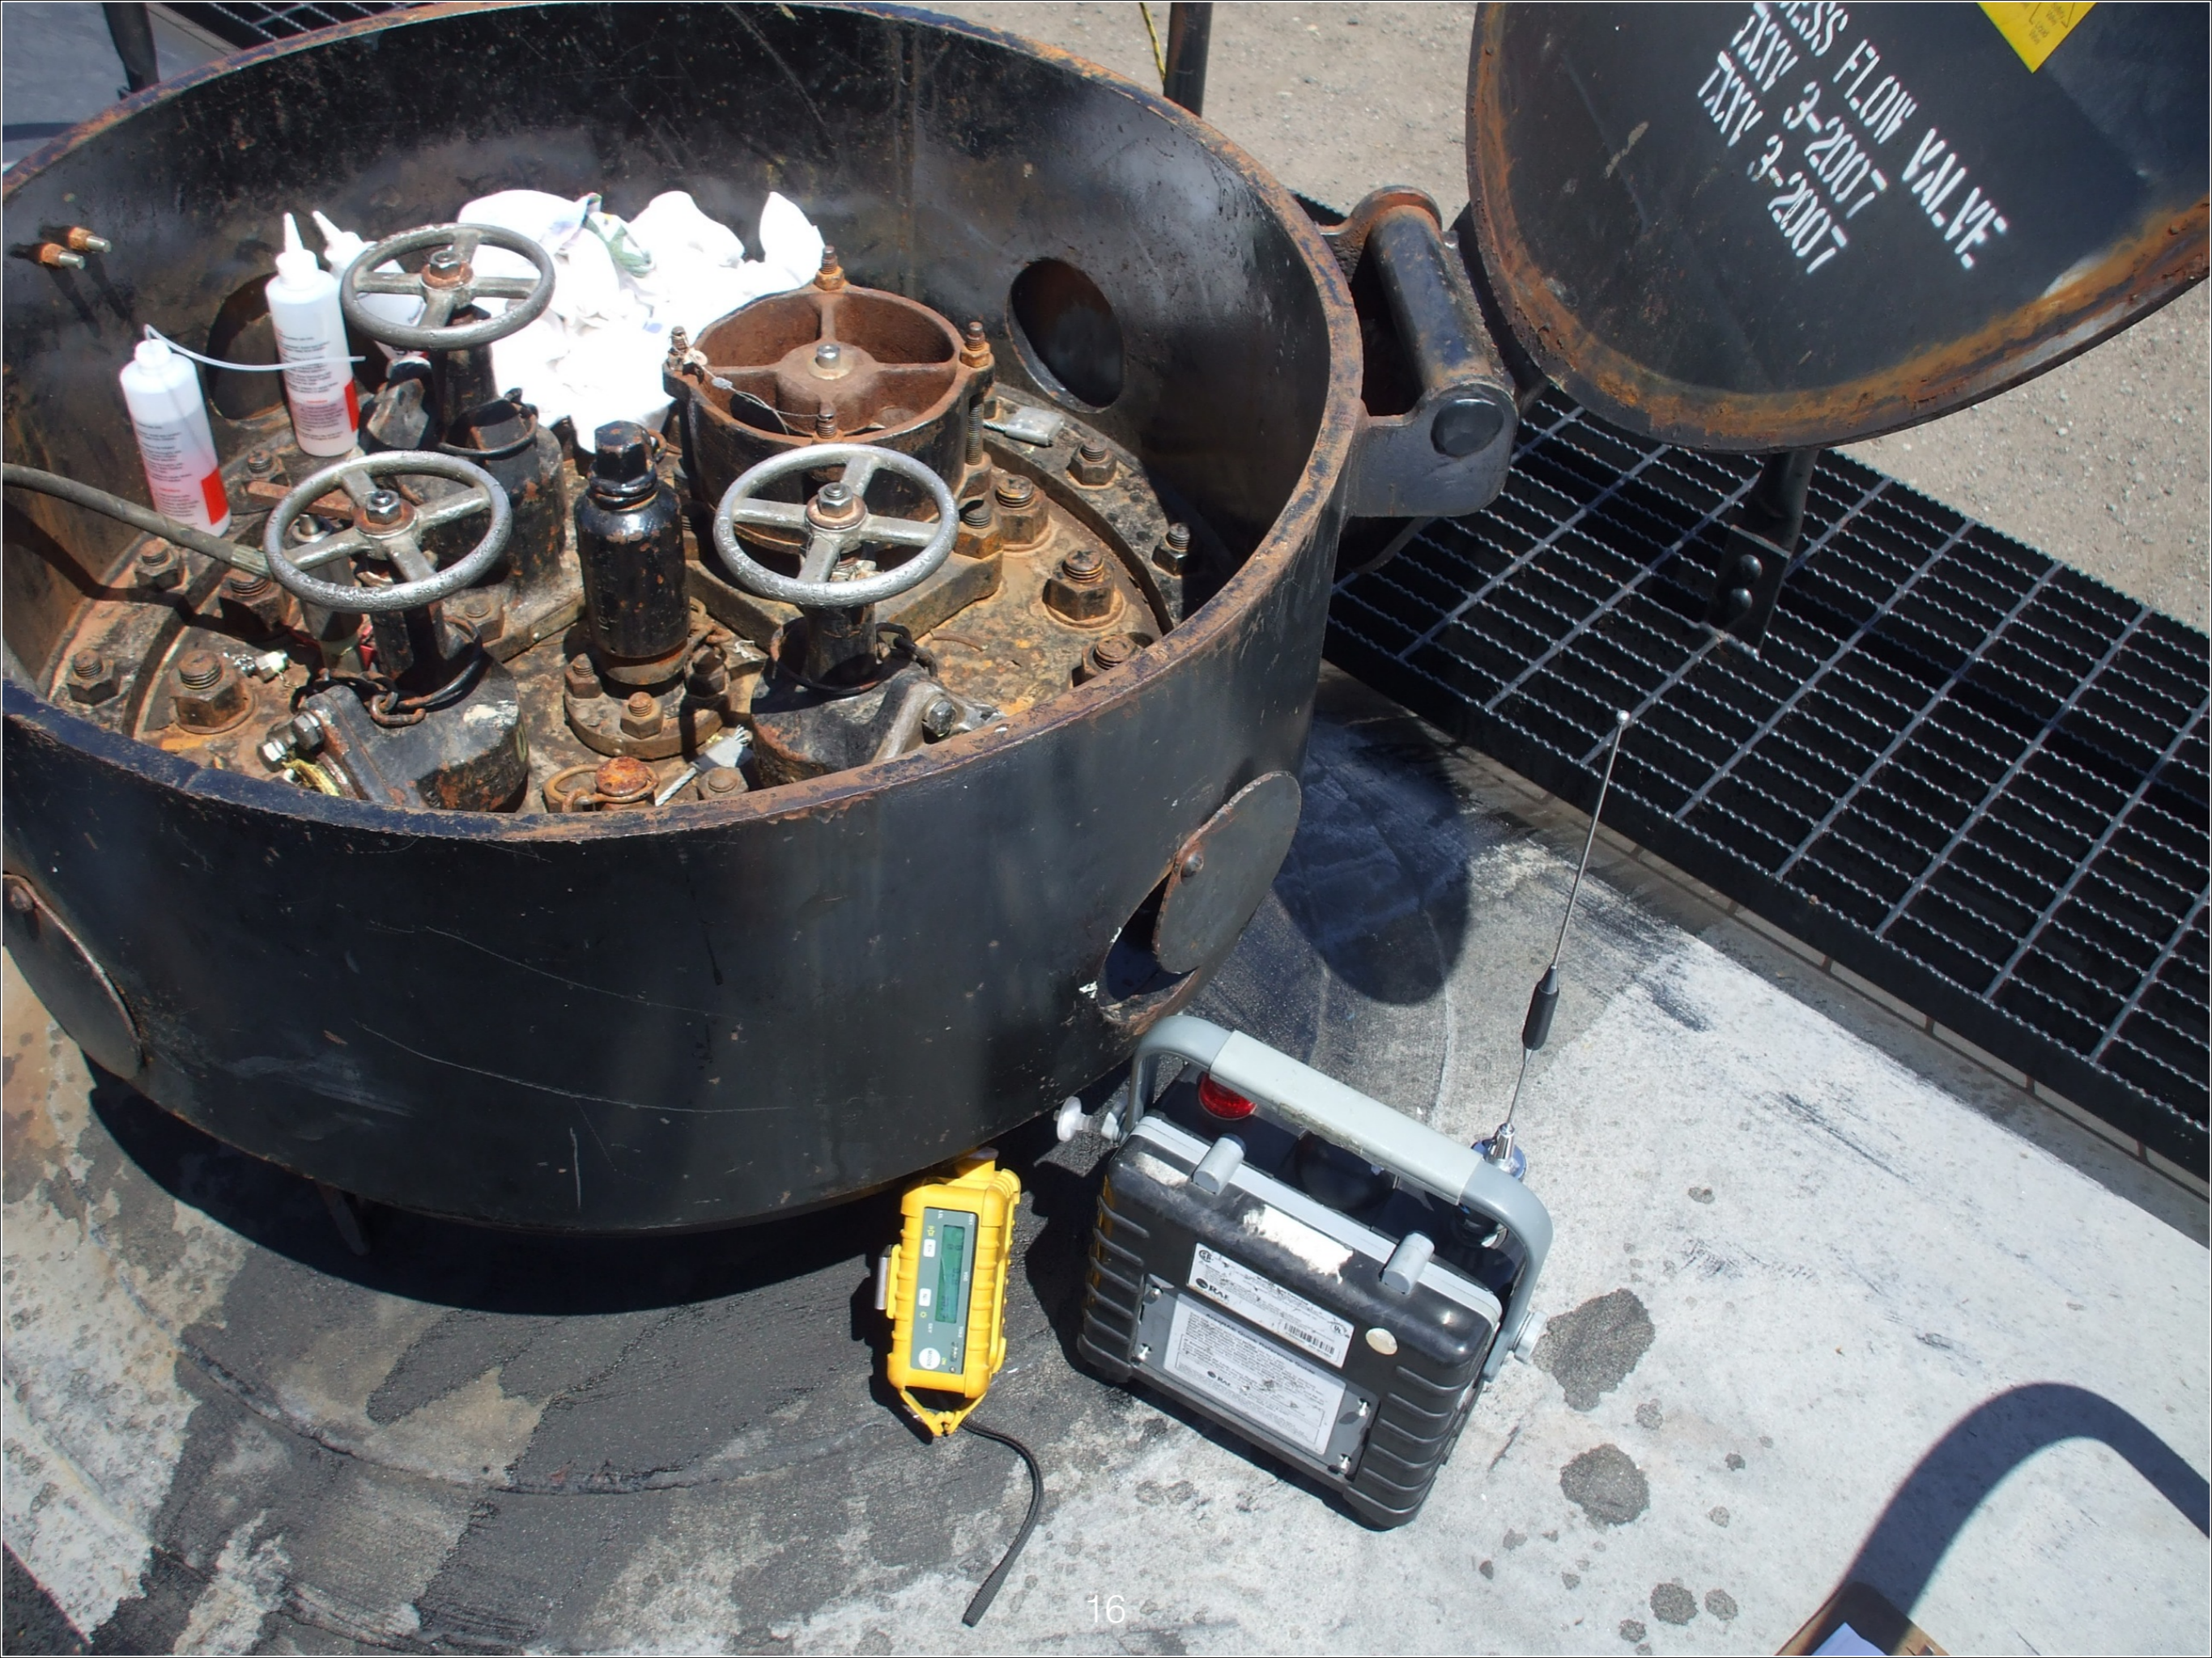
Case Study #2: Ammonia Rail Car, El Paso, TX

- An anhydrous ammonia rail car experienced a release from the top of the car during transit
- The car was isolated at the El Paso rail yard and inspected
- Ammonia was detected leaking from a valve on top of the car

- The source of the leak was determined to be a valve that was not closed completely
- The valve was closed and the tank car was shipped down the road after the stopped leak was confirmed
