NAR Case Studies

Paul Nony, Ph.D.

CENTER FOR TOXICOLOGY
AND ENVIRONMENTAL HEALTH, LLC

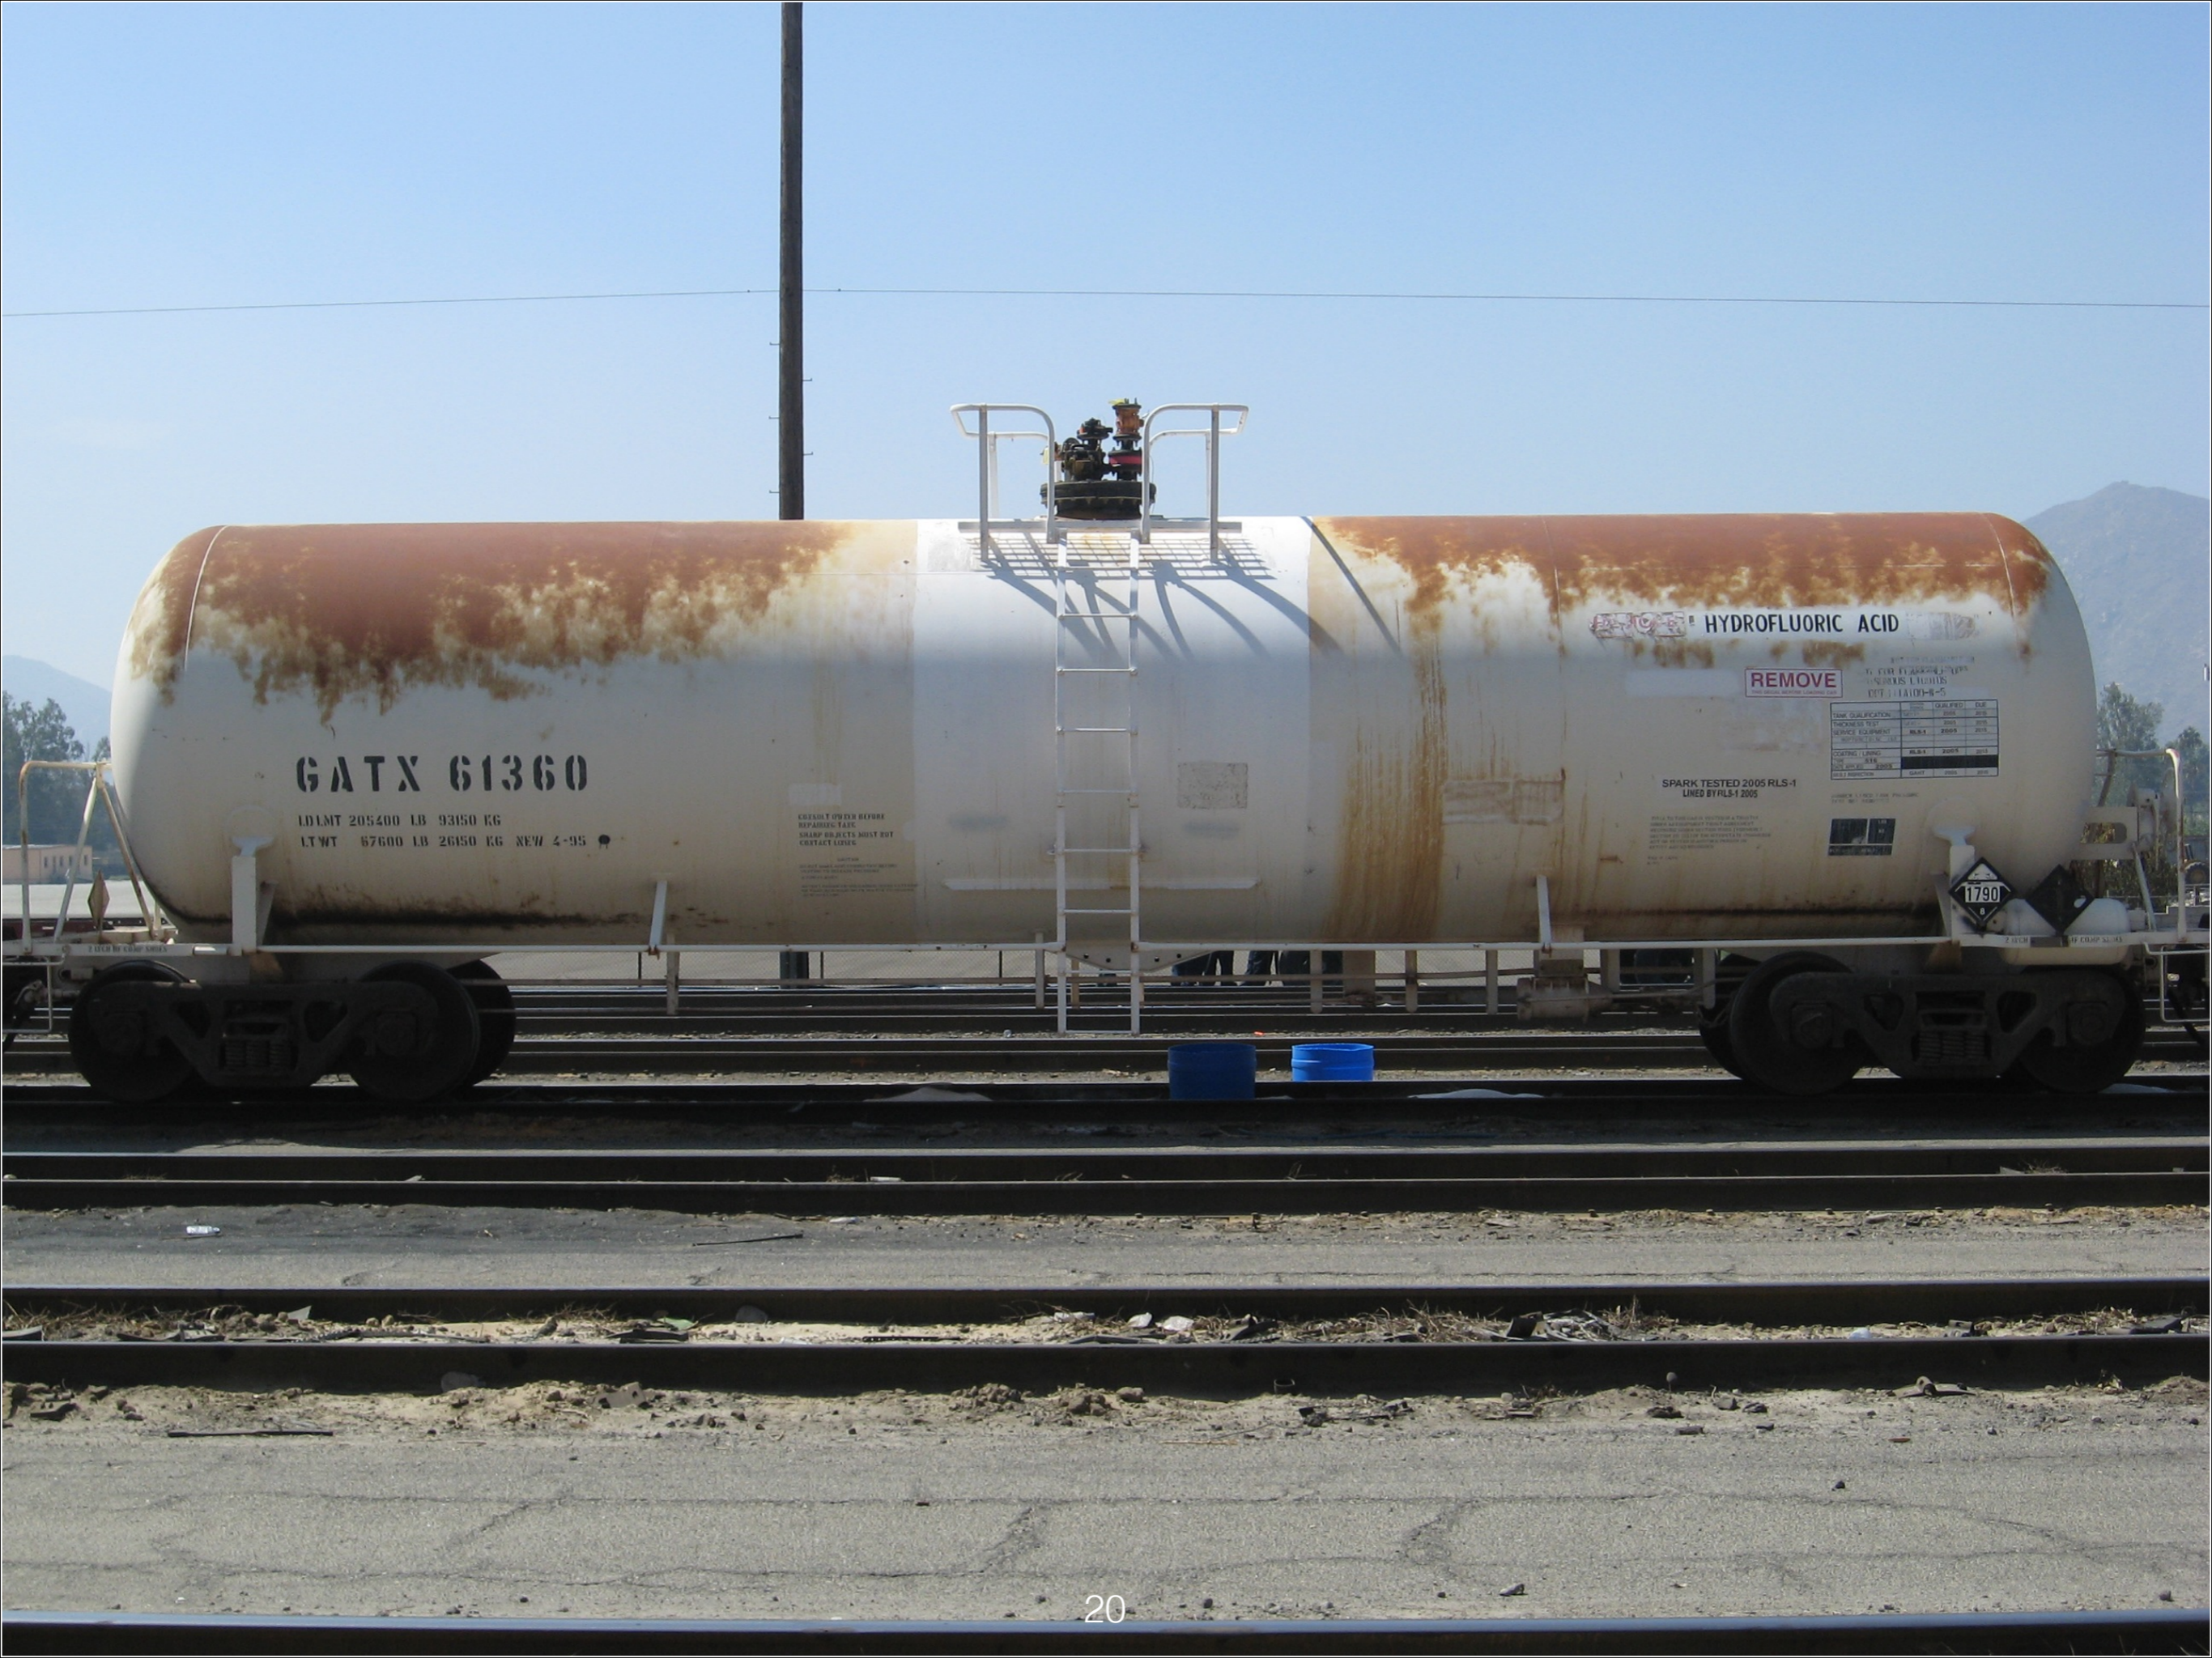
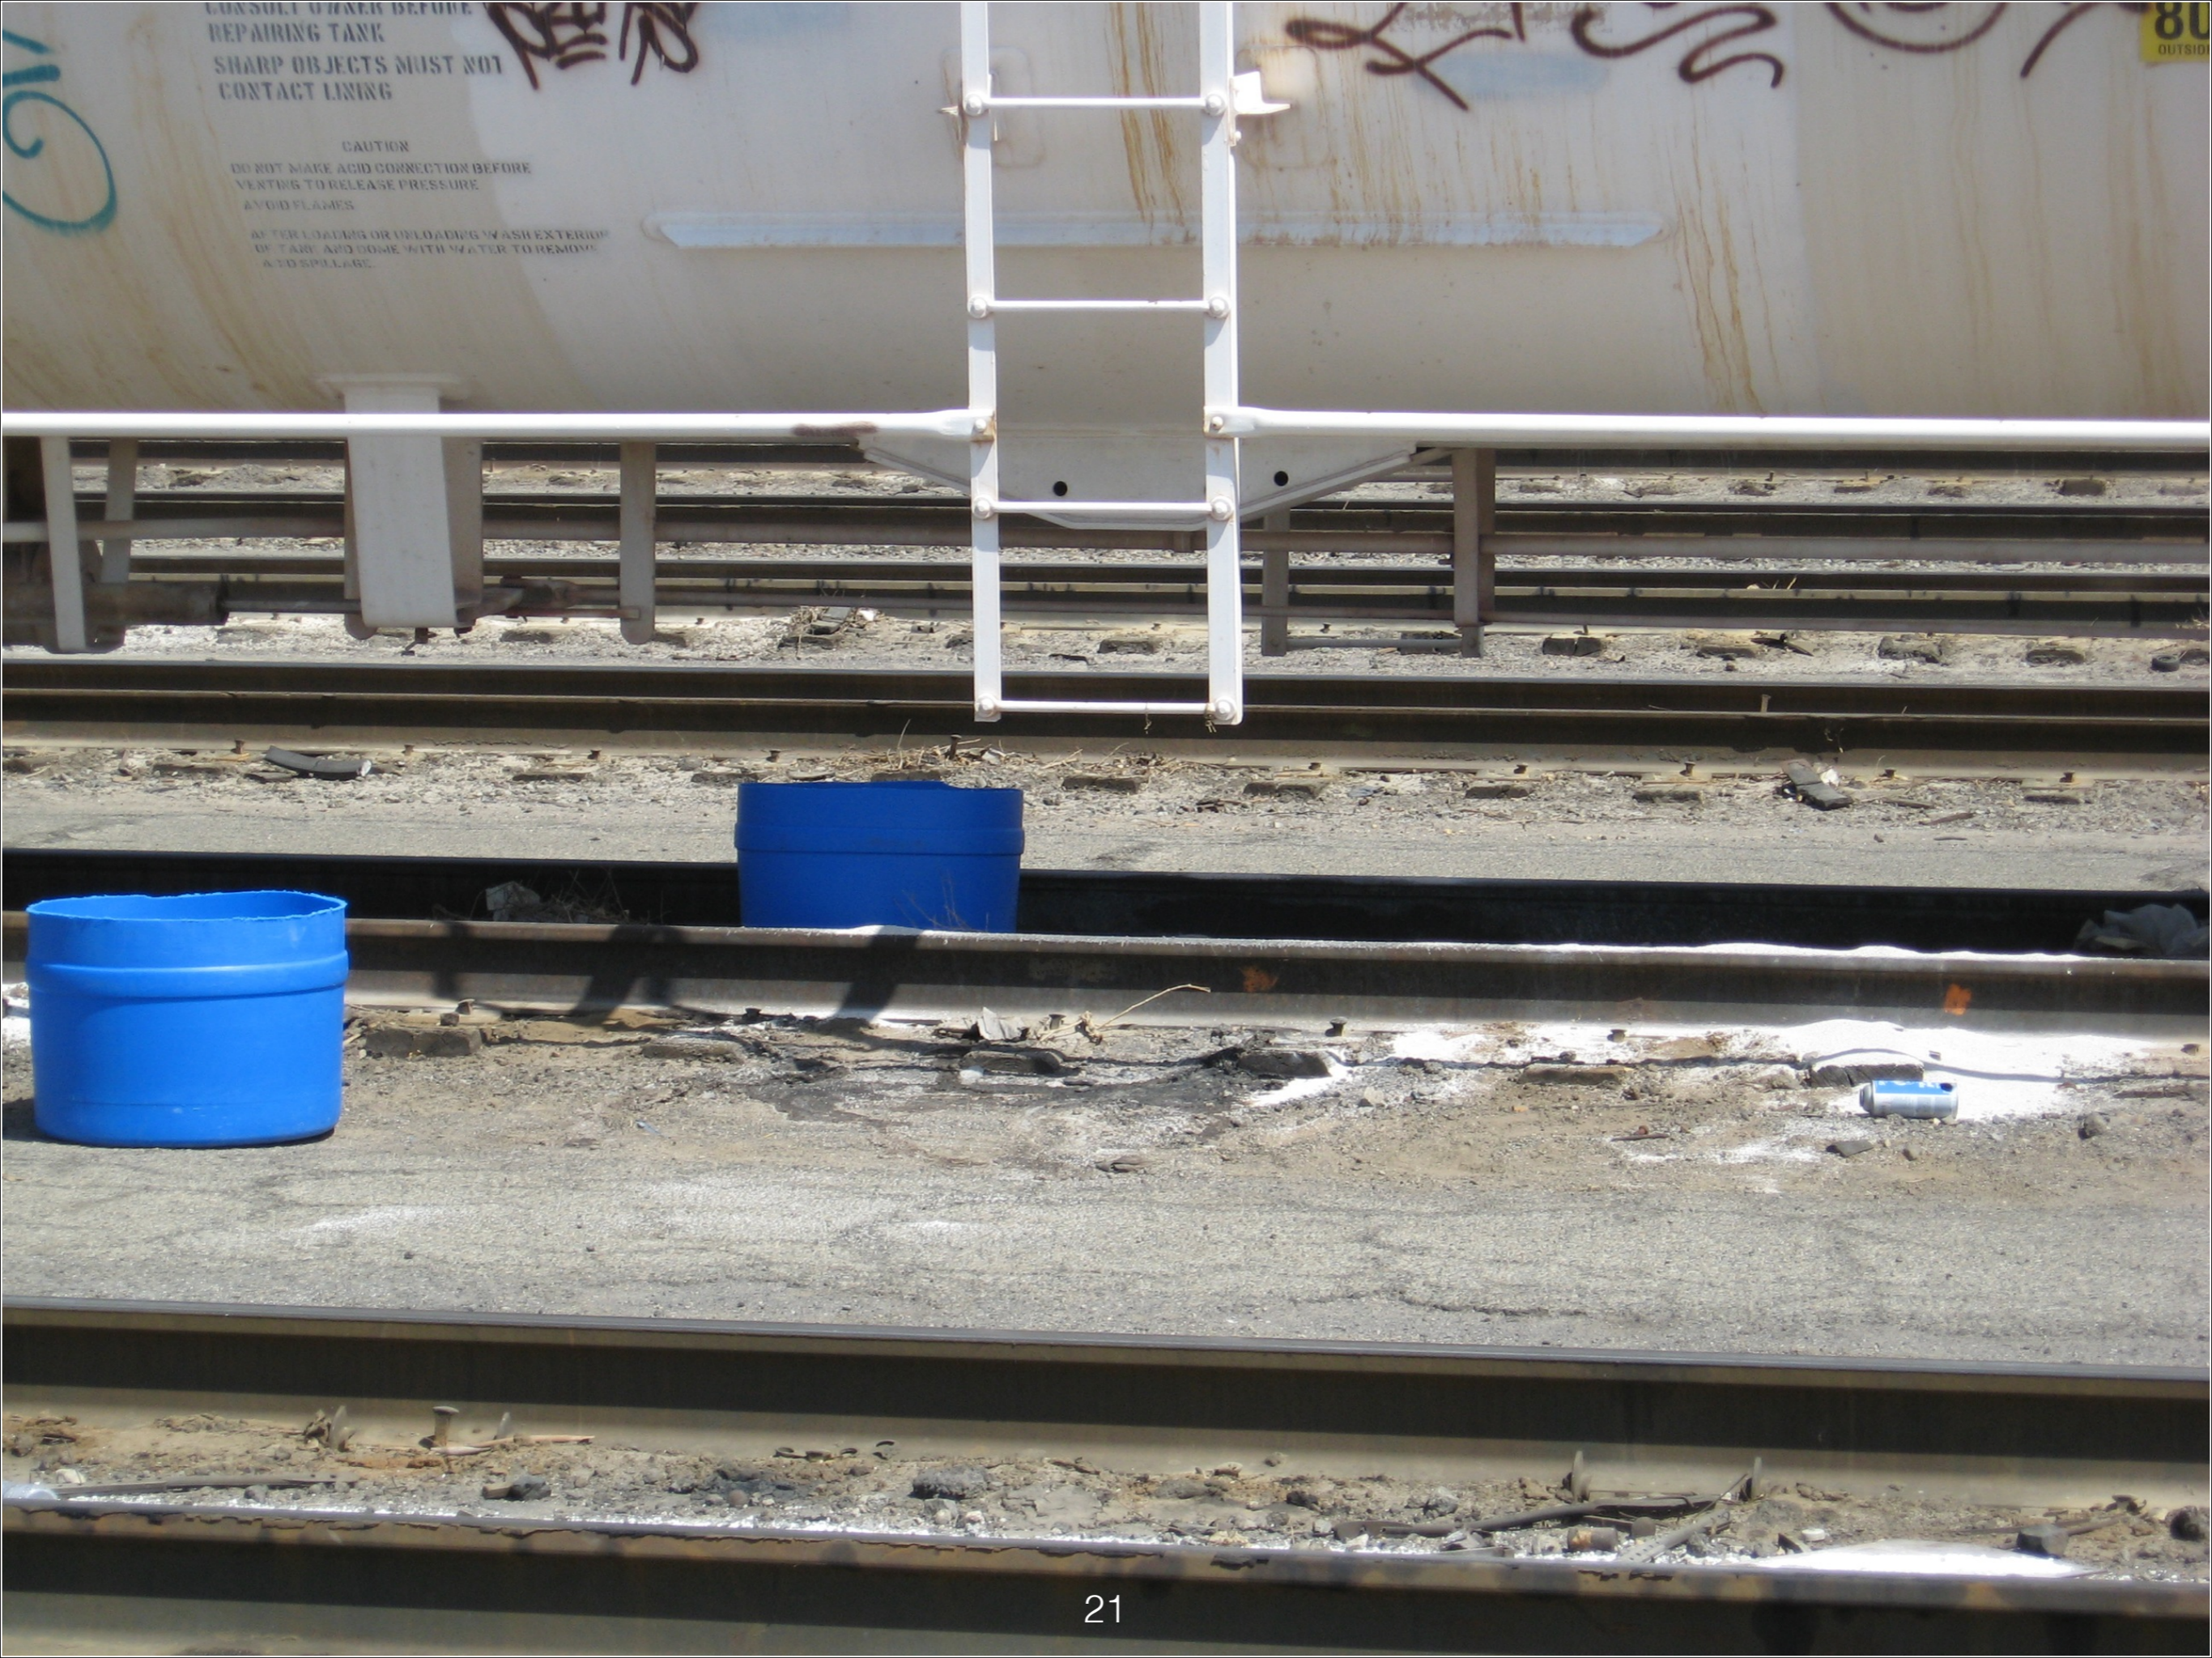
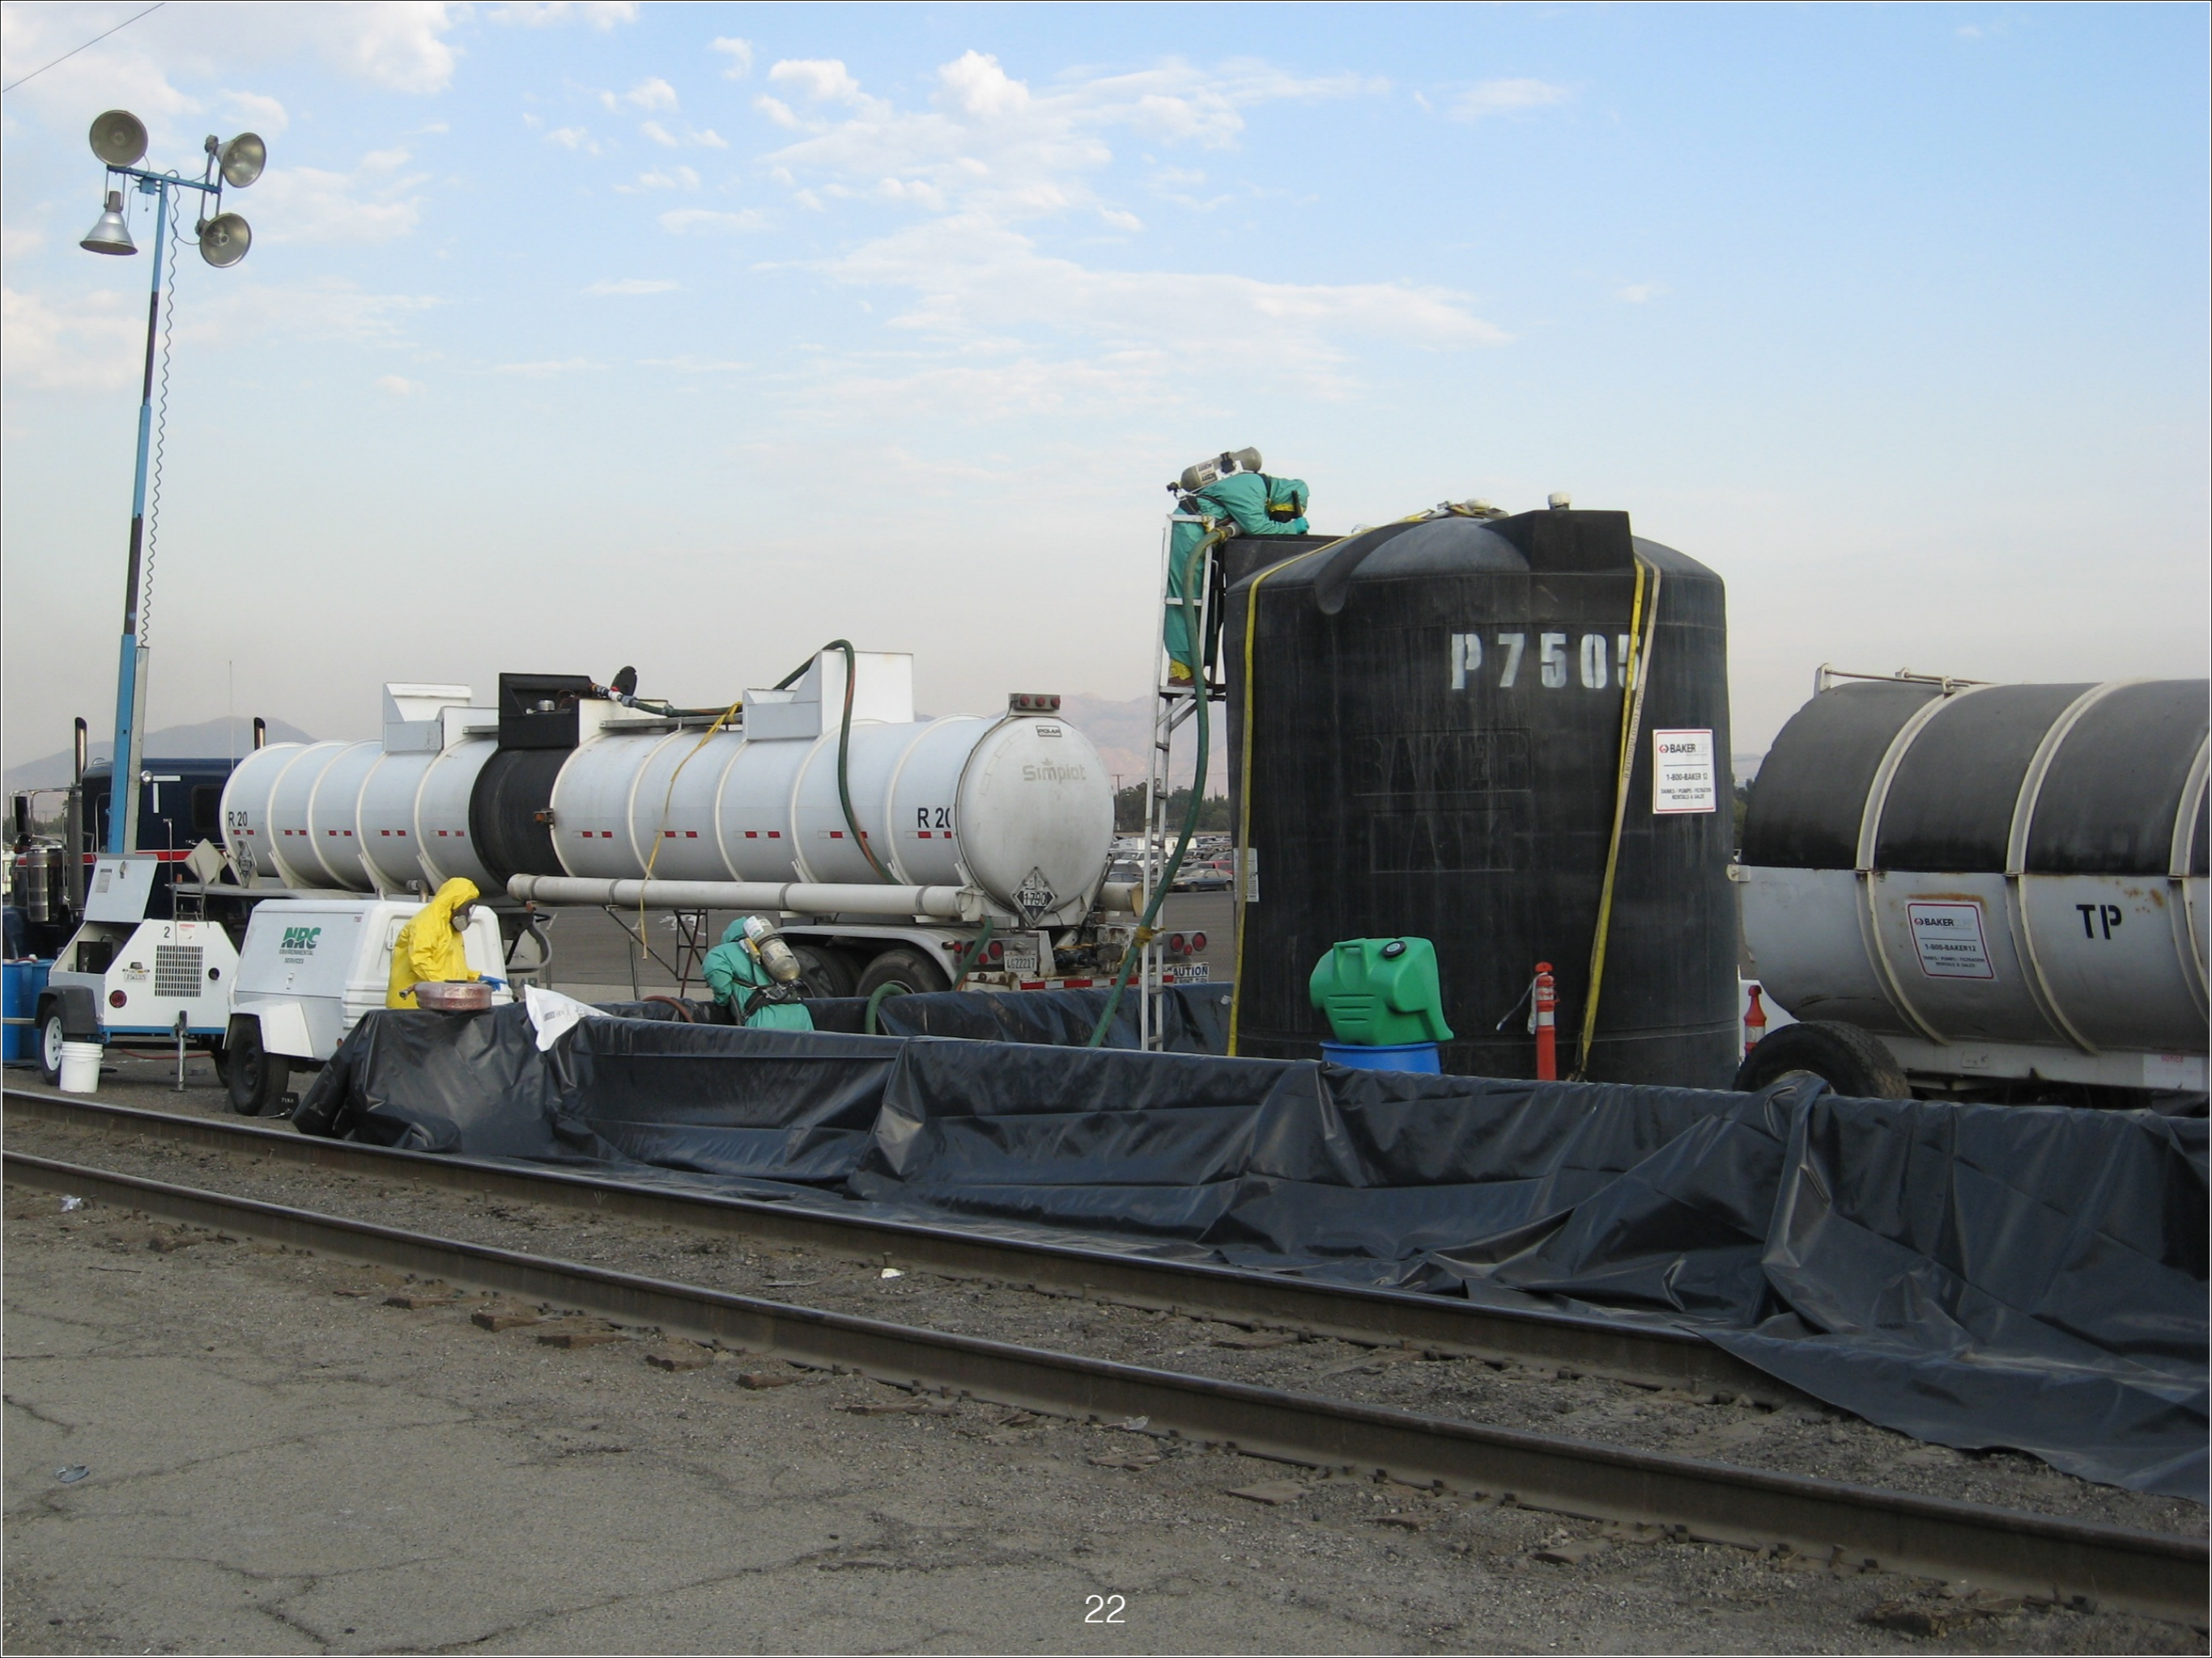
Case Study #3: HF Leak, Colton, CA

- 30-40 gallons of hydrofluoric acid were reported to have leaked from a tank car in Colton Yard, CA.
- The leak appeared to come from the bottom outlet valve of the tank car
- The product had to be transferred from the tank car on site

- The rail car was isolated near the entrance to the yard where many active tracks were in use
- The product was transferred into tanker trucks and polypropylene tanks for transport offsite
- Both the tanker trucks and the poly tanks subsequently developed leaks
- A railcar had to be brought in for the offload of the product from the Baker tanks

- Air monitoring was performed in the surrounding rail yard and community to determine potential impacts to human health
- Due to issues with the containment of the transferred product, the response was prolonged for several days
- It was later determined that the HF product was contaminated prior to initial loading of the railcar

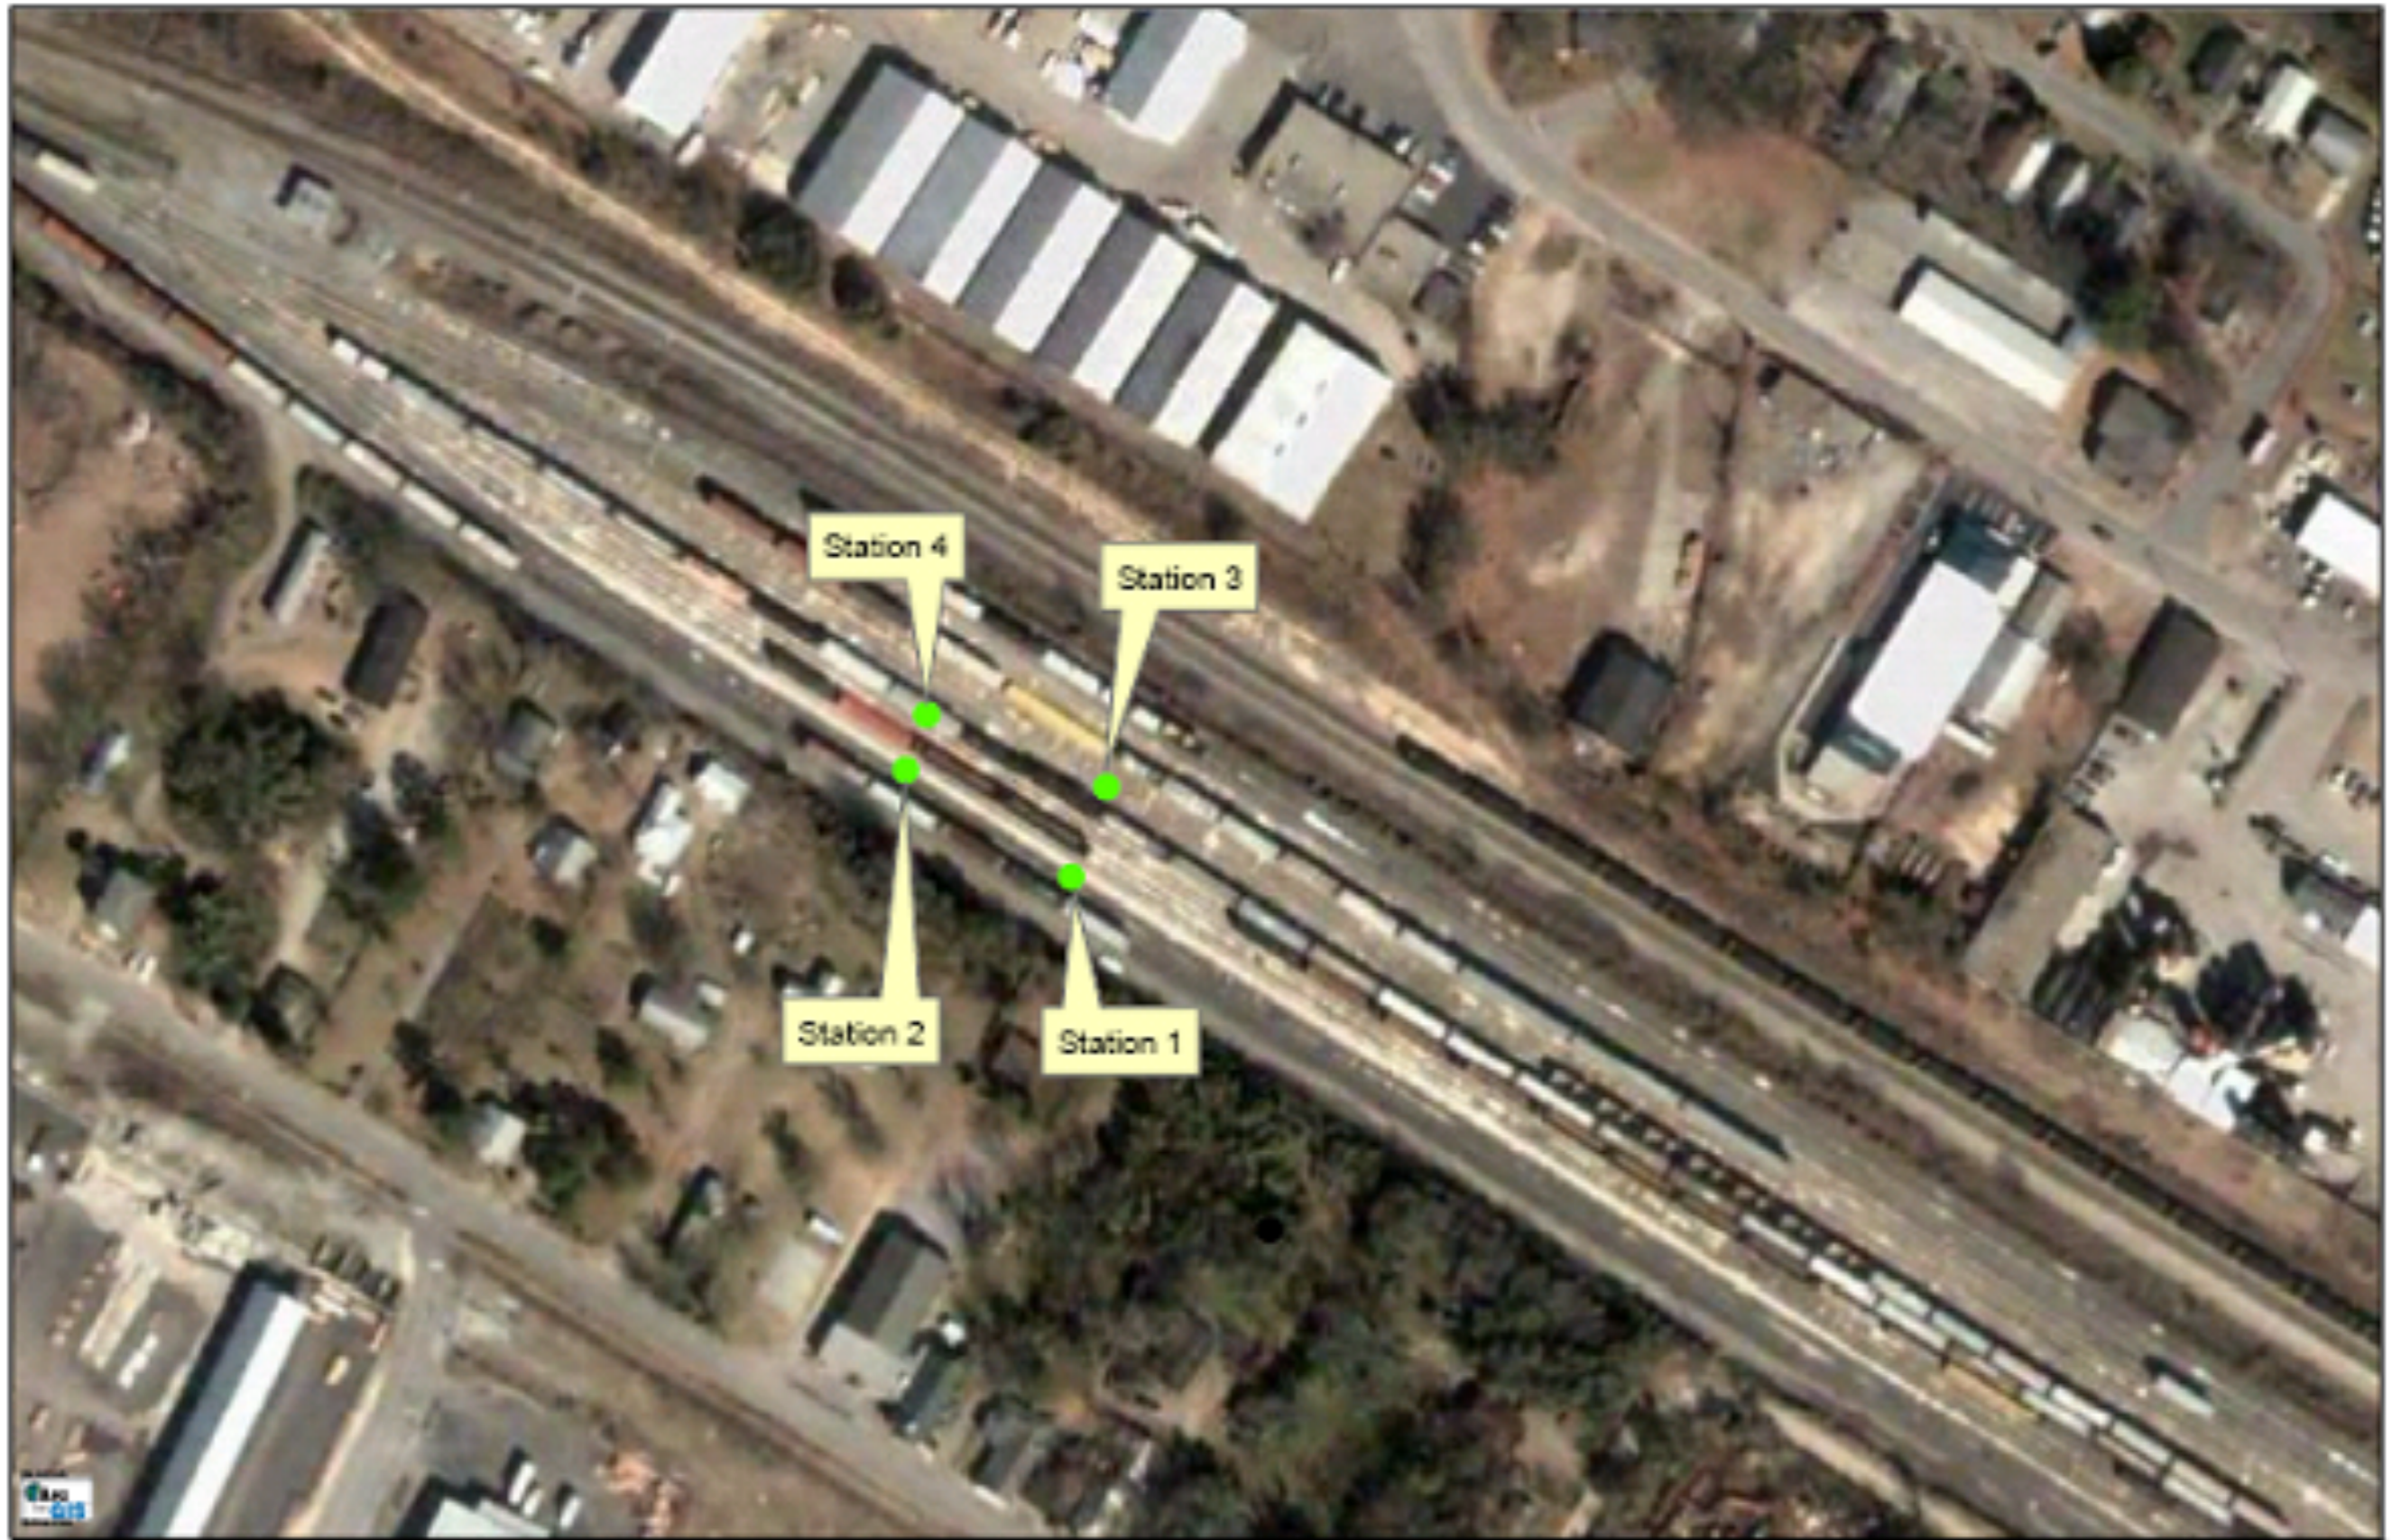
Case Study #5: HCl Tank Car Leak, Columbia, SC

- Workers reported visible liquid dripping down the side of a HCl rail car in the rail yard
- Visible vapors were reported emanating from the liquid
- Workers were evacuated from the rail yard
- Local responders evacuated residences near the rail yard

- Responders determined that the rail car had been overfilled prior to shipping
- High ambient temperatures likely caused the product to expand
- Movement of the rail car caused the HCl to slosh out of the manway of the general service tank car
- Part of the product was transferred out of the car resulting in an appropriate volume for transport
