Brunswick Layover Environmental Assessment (EA)

**Appendix G: MaineDEP TMDL Assessment Summary: Unnamed Tributary
to the Androscoggin (near River Rd.)**

TMDL Assessment Summary

Unnamed Tributary to the Androscoggin (near River Rd.)

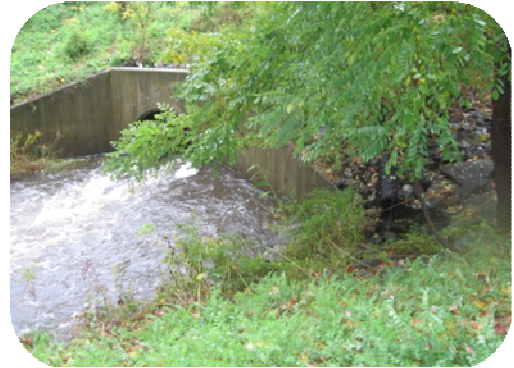
Unnamed Tributary downstream of River Road (Station 641). (Photo: FB Environmental)

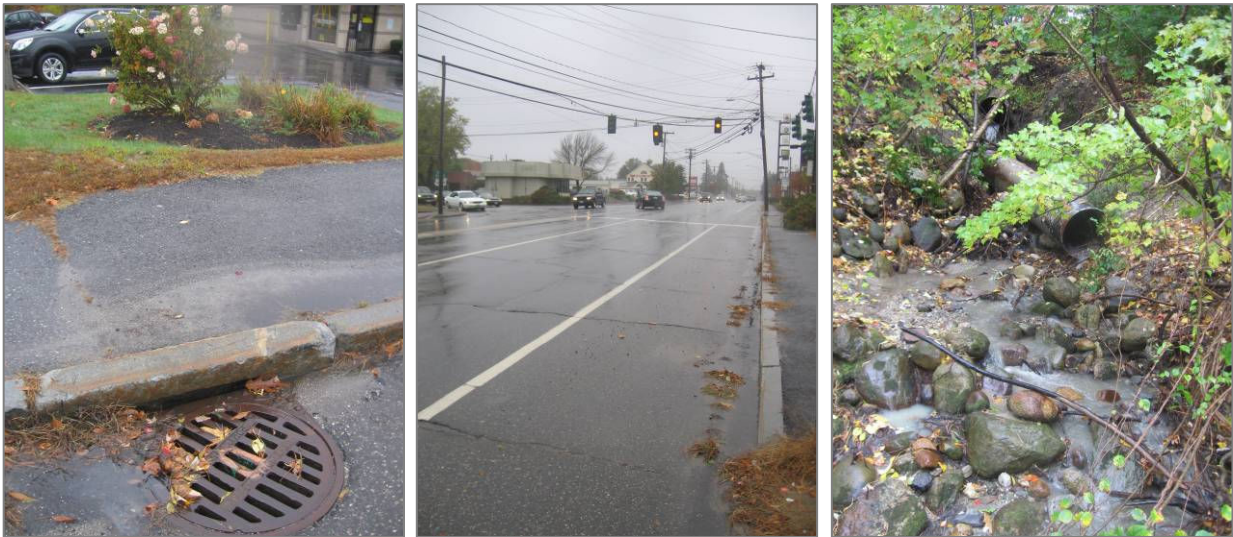
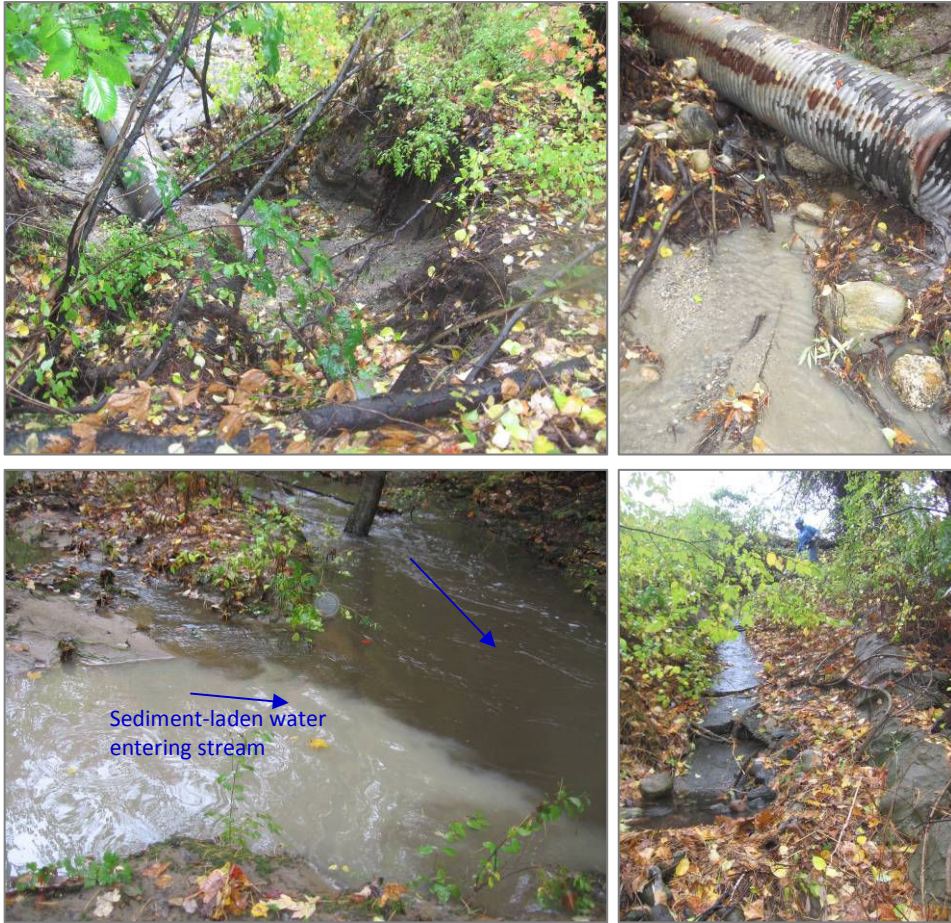
Site 1 is located behind the McDonalds building on Route 1. In this reach, the Unnamed Tributary flows parallel to Route 1. A steep slope behind the businesses along Route 1 leads down to the stream. At Site 1, two large culverts, stacked one above the other, emerge from the steep bank behind the McDonalds building. These culverts appear to be linked to a storm catchment that drains a portion of Route 1 and some of the nearby businesses. Where the culverts emerge from the embankment, slope failure and erosion has resulted in large amounts of soil entering the stream. At the time of the reconnaissance visit, heavily sediment-laden water was flowing under the culverts and directly to the stream in addition to stormwater flowing out of the culverts. Approximately 50 feet to the east of the culverts, a concrete sluiceway appears to drain the McDonald's parking lot. Runoff from the lot flows down the outfall and into the stream untreated.

Along this stream reach, similar steep slopes with embankment erosion were noted behind other businesses as well, in addition to trash and yard waste debris. Thus, this entire reach of river should be evaluated for potential mitigative BMP implementation. Several types of invasive species also grow thickly along the banks, including Japanese knotweed, Japanese barberry, multiflora rose, and bittersweet.

Site 1 Photos: Storm drain on Route 1 that is linked to the culverts behind McDonalds (left); view of area draining to the storm drain (middle); stacked culverts behind McDonalds (right).

Site 1 Photos, continued: View from above of failed bank surrounding the culverts (upper left); sediment-laden water flows under culverts (upper right); sediment laden water entering stream (bottom left); concrete sluiceway draining McDonalds lot (bottom right).

- 1. Retrofit Reconnaissance Inventory (RRI).** An RRI survey of the commercial businesses draining to the outlet at this site would support characterization and reduction of excessive stormwater flow volumes reaching the stream from this location. This type of survey includes a rapid field assessment of potential stormwater storage and on-site retrofit sites in the area. Retrofits provide stormwater treatment in locations where practices previously did not exist or were ineffective, and include modification to existing stormwater practices or construction of new practices. Typical sites that may be investigated for possible retrofitting include culverts, storm drain outfalls, highway rights-of-way, open spaces, parking lots, and existing detention ponds.

- 2. Rock rip-rap and native vegetation.** Stabilizing bare soil on the steep slopes surrounding the culverts at Site 6 with stone rip-rap and native vegetation would help to reduce impacts to water quality at the site. Riprap is a permanent, erosion-resistant ground cover constructed of large, loose, angular or rounded stone. Its purpose is protecting the soil surface from the erosive forces of concentrated runoff; to slow the velocity of concentrated runoff while enhancing the potential for infiltration; and to stabilize steep slopes. It should be used in combination with native vegetation plantings to shade the stone and protect against increasing stream temperature.

- 3. Check dams.** A check dam is a small dam built across a minor channel, swale, or drainage ditch. Building check dams across the existing channel draining the McDonald's lot would help lower the speed of water flow during storm events and allow sediments and pollutants to settle.

- 4. Plunge pool.** A plunge pool at the outfall of the concrete channel and/or culverts would help to dissipate the velocity of stormwater runoff and provide some pretreatment.

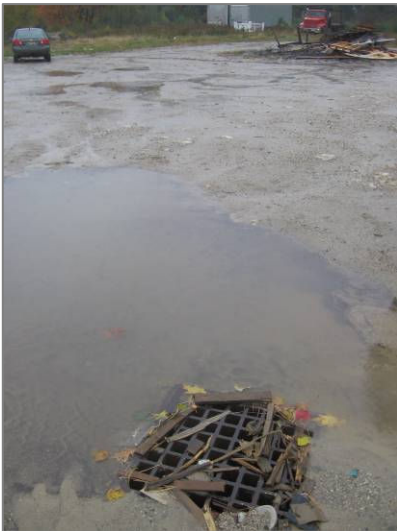
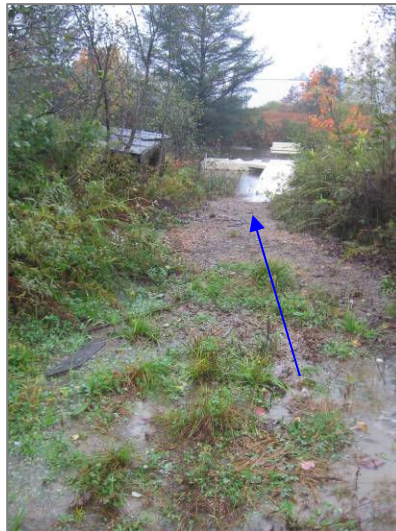
- **Site 2A:** On the northeastern side of the property, a large portion of the unpaved lot drains into a storm drain which outlets into the nearby stream. Because the soil around the drain is not stabilized, sediment and debris flow freely into the drain and the stream. Nearby, overland flow from the portions of the unpaved lot drains directly to the stream, which has little to no vegetated buffer to help filter sediment.
- **Site 2B:** On the northwestern side of the property, overland flow from the unpaved lot and roof runoff drains directly to the stream. Large pieces of trash were also noted in the stream nearby.

Site 2A Photos: A storm drain surrounded by unstabilized soil drains the unpaved lot, delivering sediment and debris to the stream (left). Portions of the unpaved lot drains through an unvegetated passage directly to the stream (right).

1. **Stabilize bare soil.** Stabilizing bare soil in the unpaved lot and around the storm drain at Site 2A will greatly reduce impacts to water quality at the site. A coarse gravel surface material could be used to resurface the lot. With the high amounts of traffic at the site, regular maintenance is critically important.

2. **Redirect flow.** The unpaved lot could be regraded to direct stormwater flow away from the stream to a grassed swale, detention basin and/or rain garden.

3. **Vegetated buffers.** Plant to increase the buffer strip of native vegetation adjacent to the stream. Vegetated buffers slow stormwater runoff, provide an area where runoff can permeate the soil, contribute to ground water recharge, and filter sediment. Slowing runoff also helps to prevent soil erosion and streambank collapse.

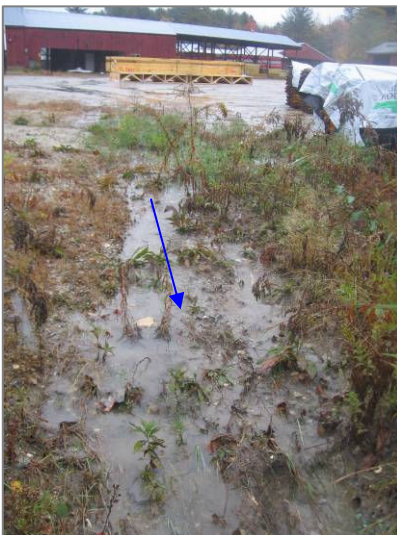
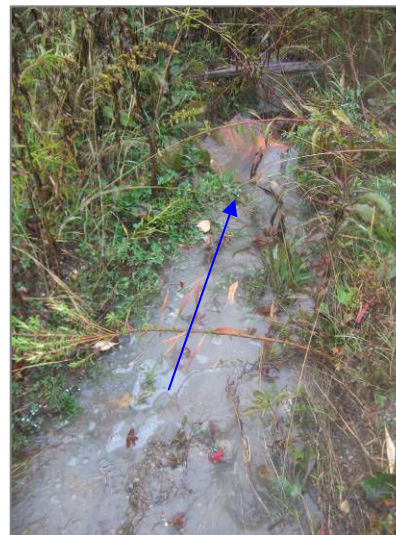
Site 2B Photos: Runoff from the unpaved lot and from nearby structure roofs drains to the stream (left). Sediment-laden water flows directly to the stream (right).

4. **Redirect flow.** Stormwater flowing directly from roofs and unpaved parking lots should be redirected and hydrologically disconnected from the stream. This could be accomplished by regraded to direct stormwater flow away from the stream to a grassed swale or infiltration gallery.

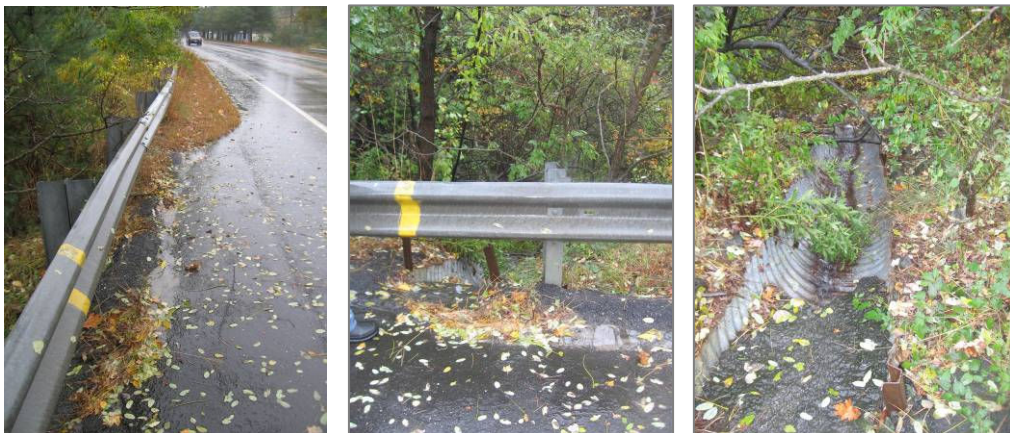
Site 3 is located on Industrial Parkway, just south of the property at 4 Industrial Parkway (Figure 7). As shown in the photographs below, a curb cut leads to a ~15 foot long metal half-culvert at this site. Runoff from the roadway and adjacent commercial building flows down the culvert and directly to a stream. The invasive Japanese knotweed was also noted at the site.

Site 3 Photos: Stormwater from Industrial Parkway drains to a road curb cut (left and middle) which leads to a metal half-culvert (right) that channels water to the stream.

1. Rock rip-rap and native vegetation. Replacing the metal culvert at Site 3 with a channel of rock rip-rap interspersed with native vegetation would help to slow water flow and filter sediments. Riprap is a permanent, erosion-resistant ground cover constructed of large, loose, angular or rounded stone. Its purpose is protecting the soil surface from the erosive forces of concentrated runoff; to slow the velocity of concentrated runoff while enhancing the potential for infiltration; and to stabilize steep slopes. It should be used in combination with native vegetation plantings to shade the stone and protect against increasing stream temperature.

2. Plunge pool. A plunge pool at the channel outlet would allow the dissipation of energy filtration of sediment before water enters the stream.

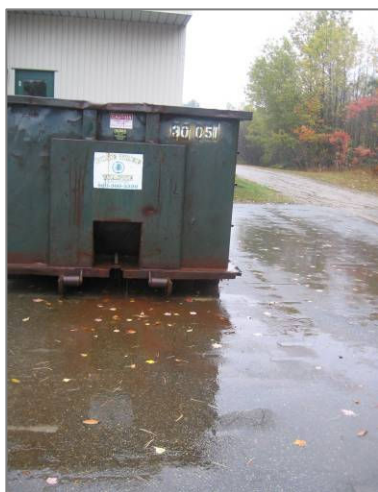
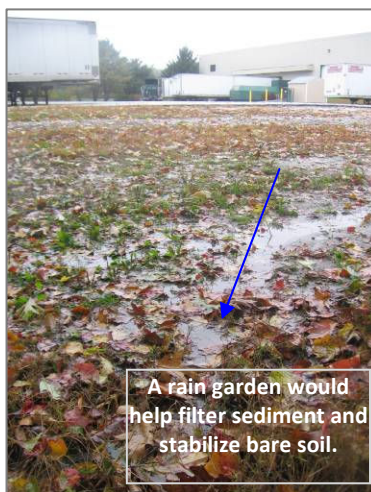
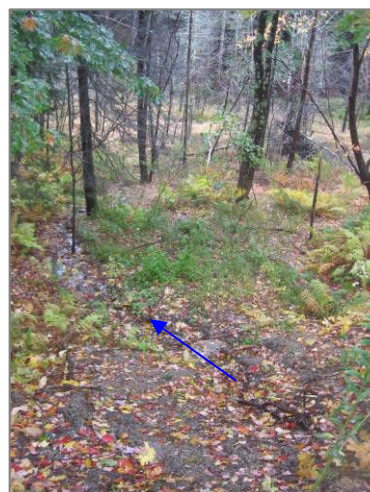
Site 4 is located at the LL Bean warehouse off Industrial Parkway in the central part of the watershed (Figure 8). The property is located adjacent to a small stream that flows into the Unnamed Tributary (Figure 8). Although much of the stormwater runoff from this property is directed to a stormwater detention pond, the existing treatment does not capture all of the stormwater on the property. Specifically, some of the stormwater drains to the northeast corner of the property. Here, stormwater flows across an area of bare soil and down an eroding channel that leads directly to the stream. Additionally, an uncovered dumpster was noted at the northeast corner of the building. Runoff from the dumpster was noticed nearby.

Site 4 Photos: An uncovered dumpster is located near the NE corner of the building (left). Stormwater flowing over ran area of bare soil (middle) leads to an eroding ditch (right) which flows directly to the stream.

- 1. Good housekeeping.** Implementation of aggressive street sweeping, catch basin cleanout and other good housekeeping measures in the parking lot will help reduce pollutant loads by removing materials from impervious surfaces prior to storm events. *The dumpster should also remain covered at all times.*

- 2. Plant vegetation.** The area of bare soil in the northeast corner of the lot is a good location for a grassed swale or rain garden that would help capture and detain runoff. A rain garden is a planted depression that allows rainwater runoff from impervious urban areas like roofs, driveways, walkways, parking lots, and compacted lawn areas the opportunity to be absorbed. This reduces rain runoff by allowing stormwater to soak into the ground.

- 3. Stabilize ditch.** The existing eroding ditch on the northeast corner of the property could be stabilized with vegetation or stone rip-rap to prevent further erosion.

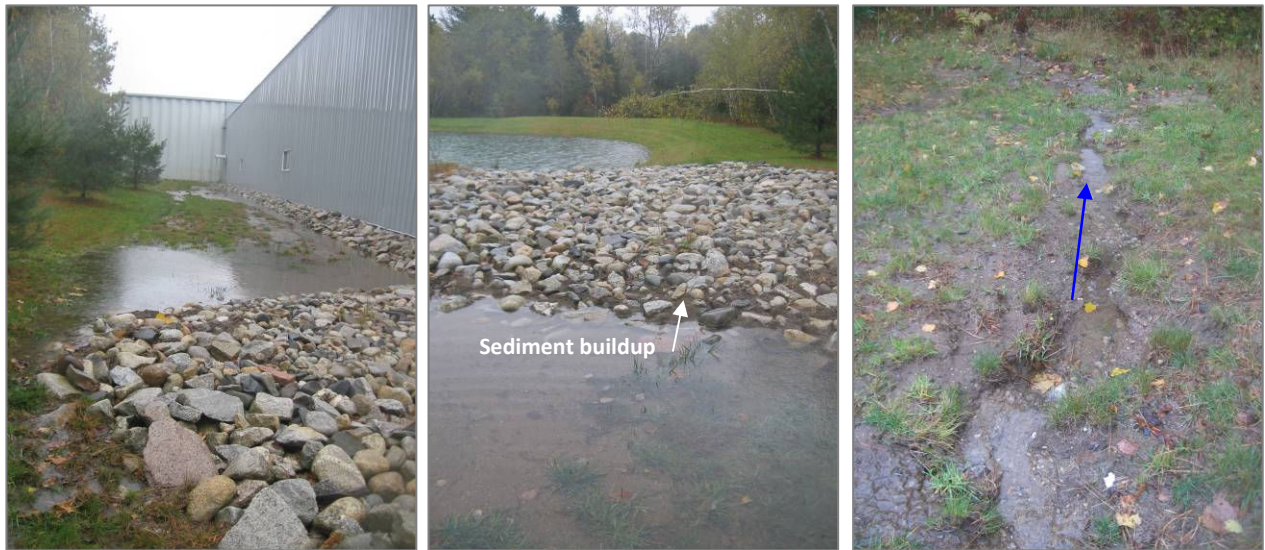
- **Site 5A:** On the back side of the Owen’s Corning building, a large volume of water flows off the roof during rain storms. A rock lined swale on the back side of the building directs some of the flow to a stormwater detention pond. However, during the reconnaissance visit, it was noted that instead of being filtered through the rock swale, some of the rainwater pools nearby, creating an erosive channel that flows into the woods above the stream rather than flowing into the detention basin. This problem seems to be due to inadequate maintenance of the treatment system.

Site 5A Photos: Stormwater runoff pools behind the Owen's Corning building (left); water pools at the detention basin inlet (middle); excess runoff results in an eroding channel (right).

1. **Maintain and inspect existing BMPs regularly.** Properly conducted inspections and maintenance ensure that BMPs function properly and help prevent pollution discharges.

Infiltration systems in particular should be inspected several times in the first year of operation and at least annually thereafter. Conduct the inspections after large storms to check for surface ponding near the inlet that may indicate clogging (e.g. Site 5A).

Additionally, implementation of aggressive street sweeping, catch basin cleanout and other good housekeeping measures in the driveway and parking lot will help to reduce pollutant loads by removing materials from impervious surfaces prior to storm events.

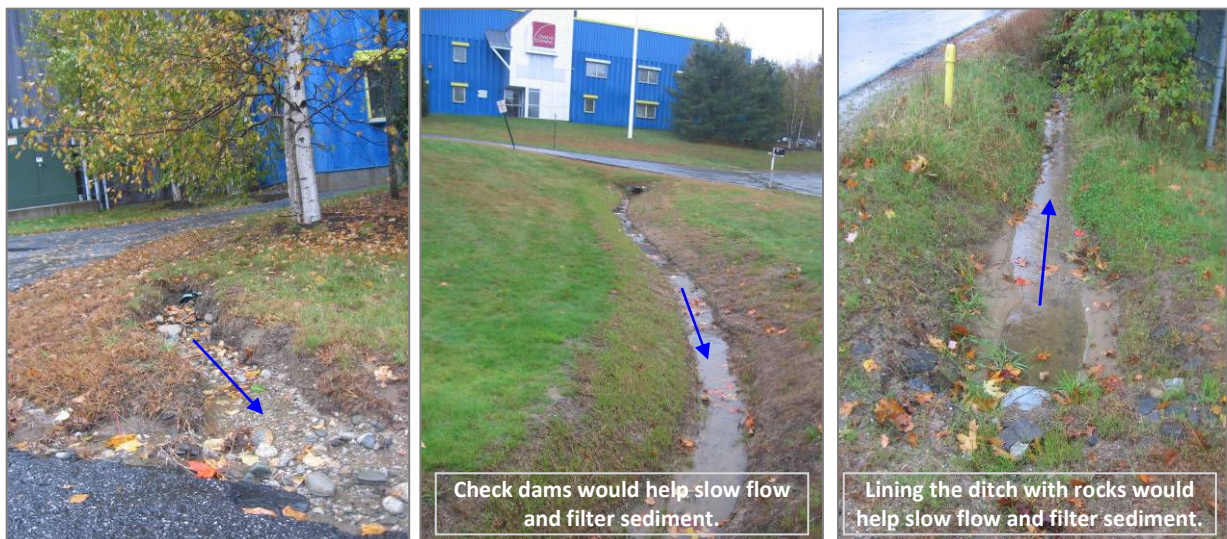
- **Site 5B:** On the front side of the building, flow from a building drainage pipe has created an eroding channel that flows down the driveway and eventually into a grass-lined ditch that is also eroding. Water from this ditch then flows past the Bibber Parkway pump station, and sediment-laden water flows directly to the stream.

Site 5B Photos: Flow from the drainage pipe creates an eroding channel (left); the flow then leads to an eroding grass-lined swale (middle); runoff flows in a channel parallel to the road to the stream (right).

- 2. Improve ditches.** At Site 5B, adding a rock-lined catch basin or plunge pool at the drainage pipe outlet and check dams to the grass swale would help slow and filter stormwater, thus reducing erosion issues. From the pump station down to the stream, lining the ditch with rock rip-rap would further reduce the chances of sediment-laden water reaching the the stream.
- 3. Redirect flow.** Stormwater flowing directly from roofs and parking lots should be redirected and hydrologically disconnected from the stream. This could be accomplished by reggraded to direct stormwater flow away from the stream to a grassed swale, detention basin or rain garden.

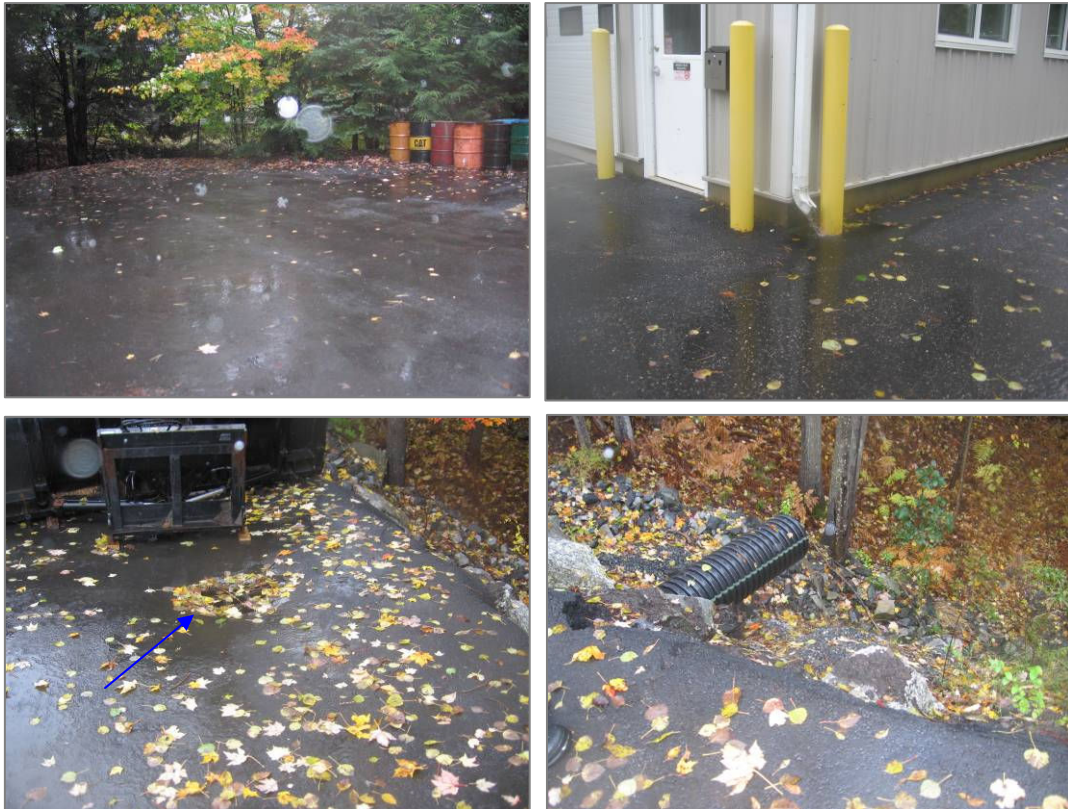
Site 6 is situated immediately downstream of Site 5 (Figure 10). From the Owens Corning property, the Unnamed Tributary flows under Bibber Parkway and past a property owned by Ouellette Associates (Figure 10). Behind the Ouellette office building, a large paved area is located adjacent to the stream. The steep slope leading from the paved area to the stream is stabilized with rock rip-rap. However, much of the runoff from the roof and paved appears to reach the stream untreated. Roof and paved-area runoff flows to a storm drain on the eastern corner of the property, which outlets from a culvert in the steep bank near the stream. Contracting equipment and machinery is stored uncovered on the paved area. This equipment and any associated pollutants would flow directly to the stream during rain events.

Site 6 Photos: *Runoff from paved surfaces (upper left) and the building rooftop (upper right) drains to a stormwater drain in the back corner of the property (bottom left). The drain outlets from a culvert adjacent to the stream (bottom right).*

1. **Good housekeeping.** Implementation of aggressive street sweeping, catch basin cleanout and other good housekeeping measures in the parking lot adjacent to the stream will help reduce pollutant loads by removing materials from impervious surfaces prior to storm events.

2. **Covered storage.** Providing a covered storage area for machinery and supplies may reduce pollutants being washed into the stream via stormwater.
3. **Sediment basin.** There are many techniques available to capture and route the runoff to an appropriately designed discharge location. The goal of these systems is to reroute harmful stormwater flows to areas where water can infiltrate to groundwater or receive treatment prior to entering the stream. One option at Site 6 would be the installation of a sediment basin or plunge pool at the storm drain outlet to allow sediment to settle out before the runoff is discharged to the stream.

4. **Redirect flow.** Stormwater flowing directly from roofs and parking lots should be redirected and hydrologically disconnected from the stream. This could be accomplished by regraded to direct stormwater flow away from the stream to a grassed swale, infiltration gallery or rain garden.
