Federal Railroad
Administration

Collision of Amtrak Passenger Train and Norfolk Southern Freight Train—November 30, 2007, Chicago, Illinois

1. AGENCY USE ONLY (Leave blank)		2. REPORT DATE October 2013		3. REPORT TYPE AND DATES COVERED Final Report
4. TITLE AND SUBTITLE Collision of Amtrak Passenger Train and Norfolk Southern Freight Train— November 30, 2007, Chicago, Illinois			5. FUNDING NUMBERS

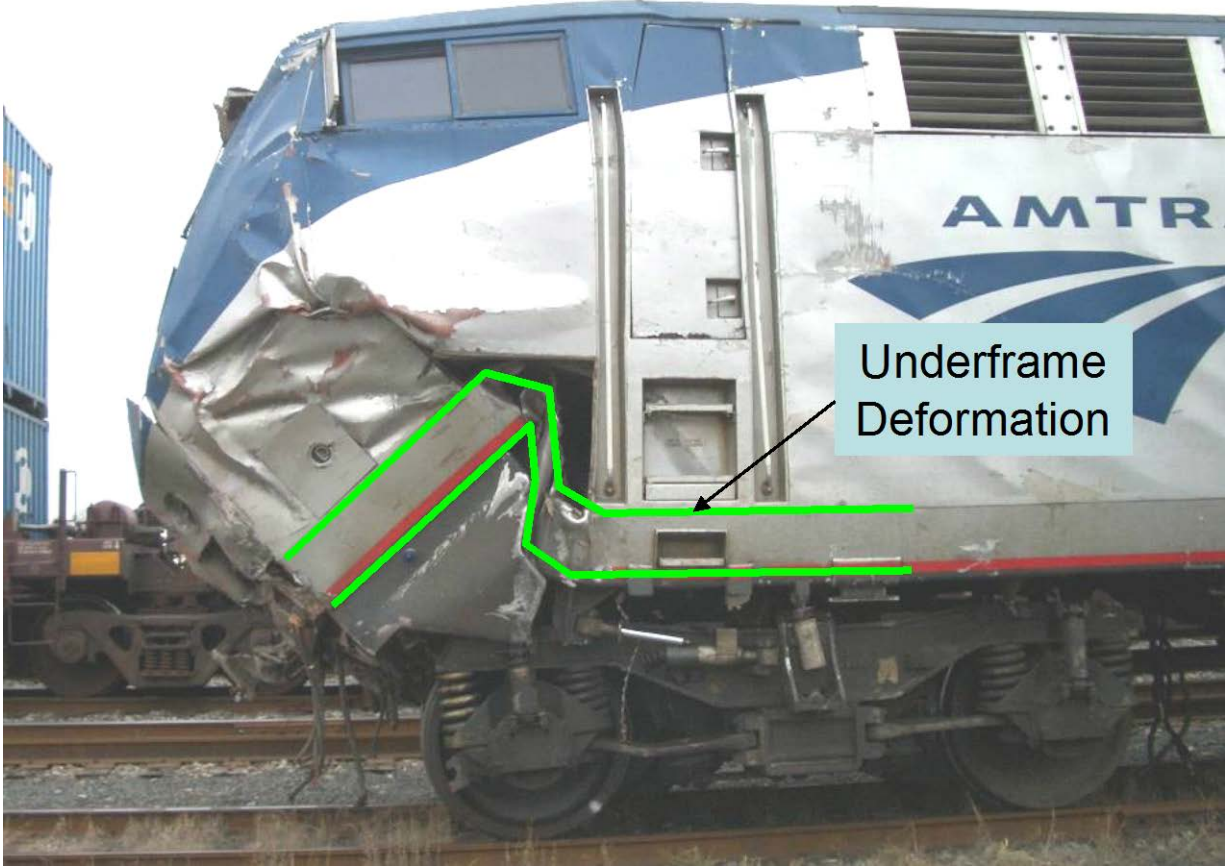
Figure 6. Locomotive nose and underframe deformed inward and upward.

Figure 6 is a photograph of the impact locomotive after it had been separated from the freight car and the lead truck had been moved back under the front end. The locomotive was reduced in length by approximately 5 feet. The collision caused the underframe to deform into a 'Z' pattern, as illustrated in the figure. This deformation promoted the locomotive overriding the freight car, and also pushed the floor of the engineer's cab upward by approximately 1½ feet. The majority of the deformation was in the longitudinal and vertical directions, with very little lateral deformation.

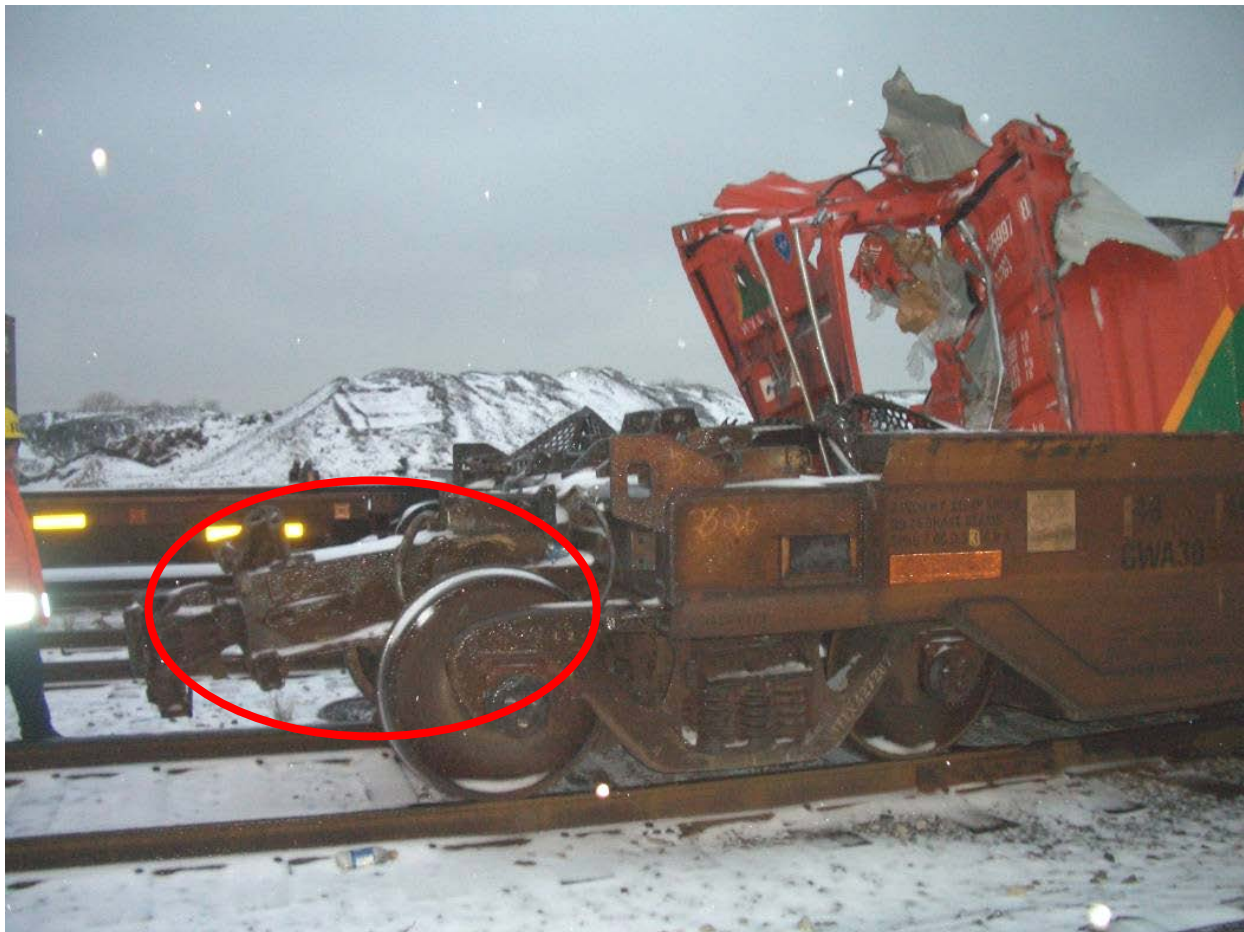
Figure 7. Deformed draft sill of freight car.

Figure 7 shows the impacted end of the rear freight car. The draft sill is deformed downward at a slight angle. It is likely that this downward deformation occurred when the locomotive began to climb the freight car. The downward deformation of the freight car draft sill along with the 'Z' deformation of the locomotive underframe likely promoted override of the freight car by the locomotive. Normally, there is a transverse walkway at the end of the freight car. This walkway does not carry suspension or train loads and was completely destroyed during the impact. Other than the slight downward bend of the draft sill, there was no significant structural damage to the freight car body. The body bolster and side sills remained essentially intact, and the truck remained attached. However, there was significant damage to the rear intermodal container and some damage to the front intermodal container. The structure of the intermodal containers is not intended to carry train or suspension loads and is weak compared with the locomotive and freight car structures. The rear intermodal container held bags of sand, which likely provided little crush resistance during the impact. Video taken of the accident indicates that the freight train did not move as a result of the collision.

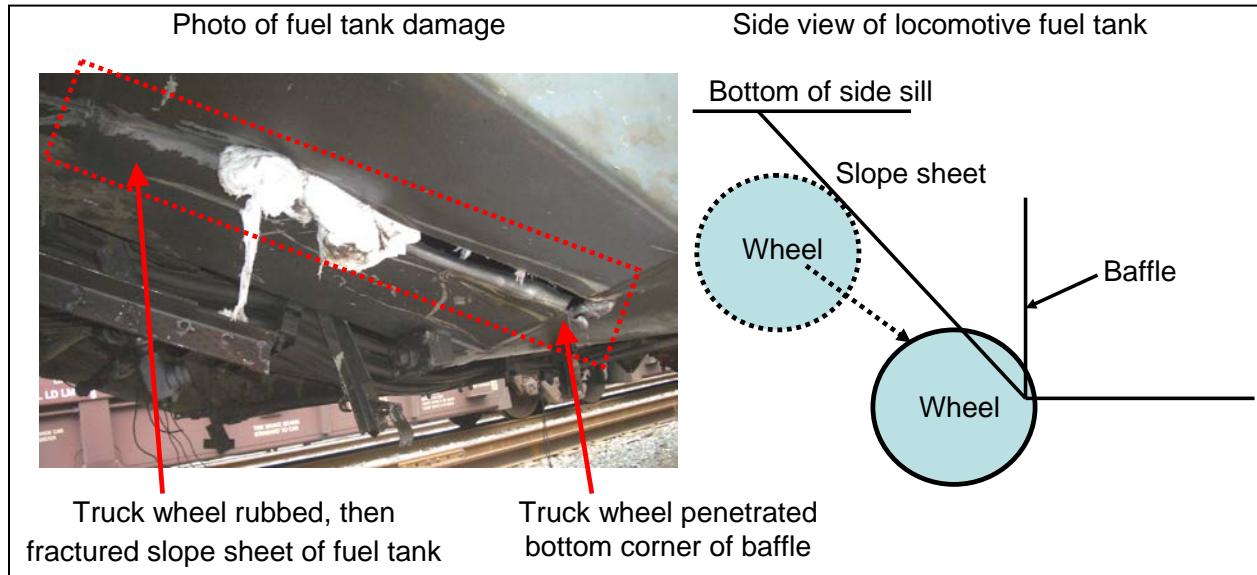
Figure 8. Fuel tank damage.

During the collision, the locomotive fuel tank was breached by the rear wheel of the front truck as the locomotive climbed the freight car. The damage to the fuel tank, along with a diagram of how the damage occurred, is shown in Figure 8. The rear wheel of the locomotive front truck was still spinning when it contacted the slope sheet of the fuel tank. As the locomotive climbed the freight car, the spinning wheel fractured the slope sheet then penetrated the corner of the fuel tank baffle. Approximately 300 gallons of diesel fuel spilled from the tank as a result [1].

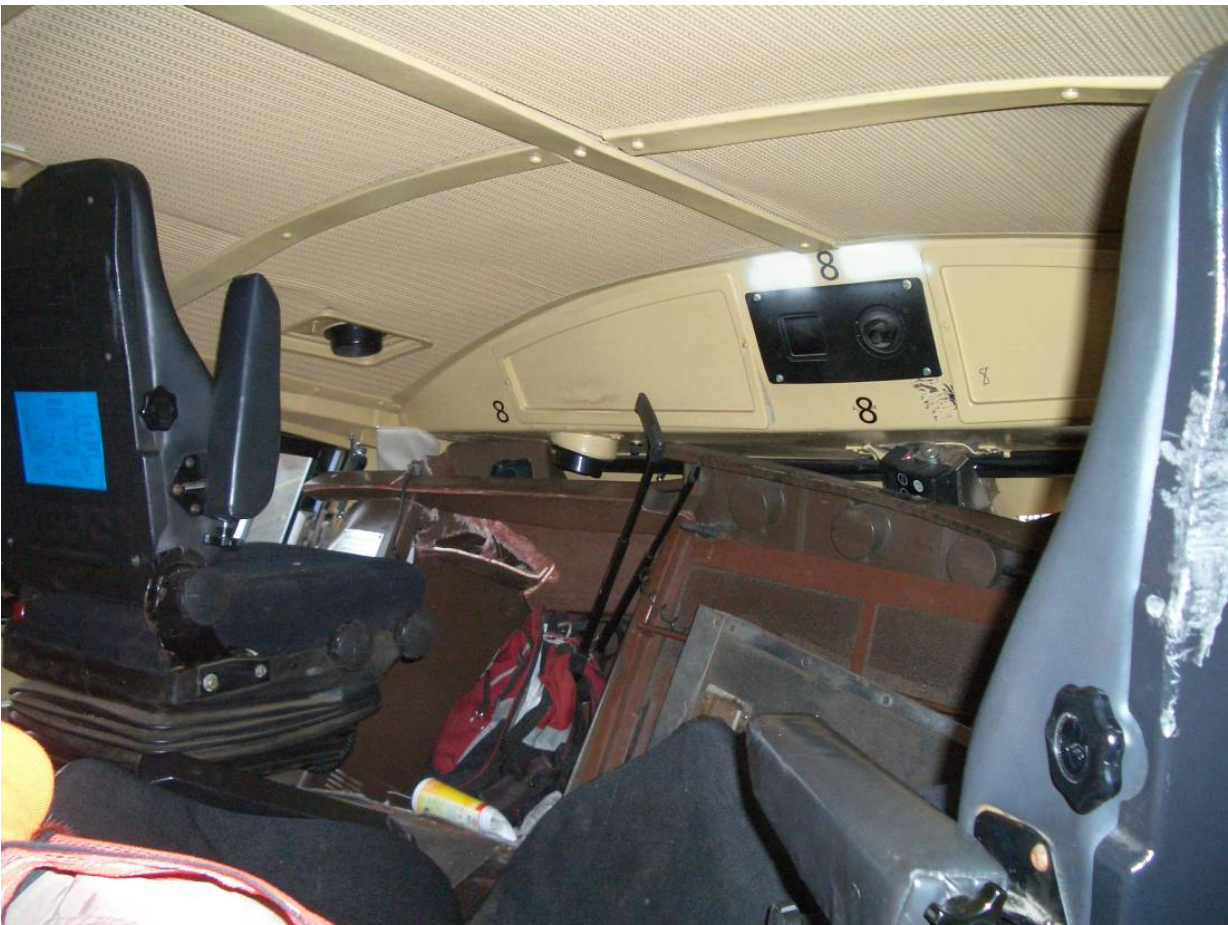
Figure 9. Locomotive interior cab damage and raised floor from impact.

The impact between the locomotive and the freight car caused the nose of the locomotive to roll under and push up, causing the underframe to buckle upward towards the engineer's cab. The deformation of the underframe caused failure of the floor of the cab, resulting in the floor and the seats in the cab to be pushed upward. As can be seen in Figure 9, the floor of the cab is raised sufficiently for the operating engineer's and the relief engineer's seats to be pushed into the ceiling of the cab. The deformation of the underframe and cab floor also caused the desktop components of the cab to roll forward and push through the front windows of the cab compartment, as shown in Figure 9. The interior damage is described in more detail with photographs in Appendix B.1.

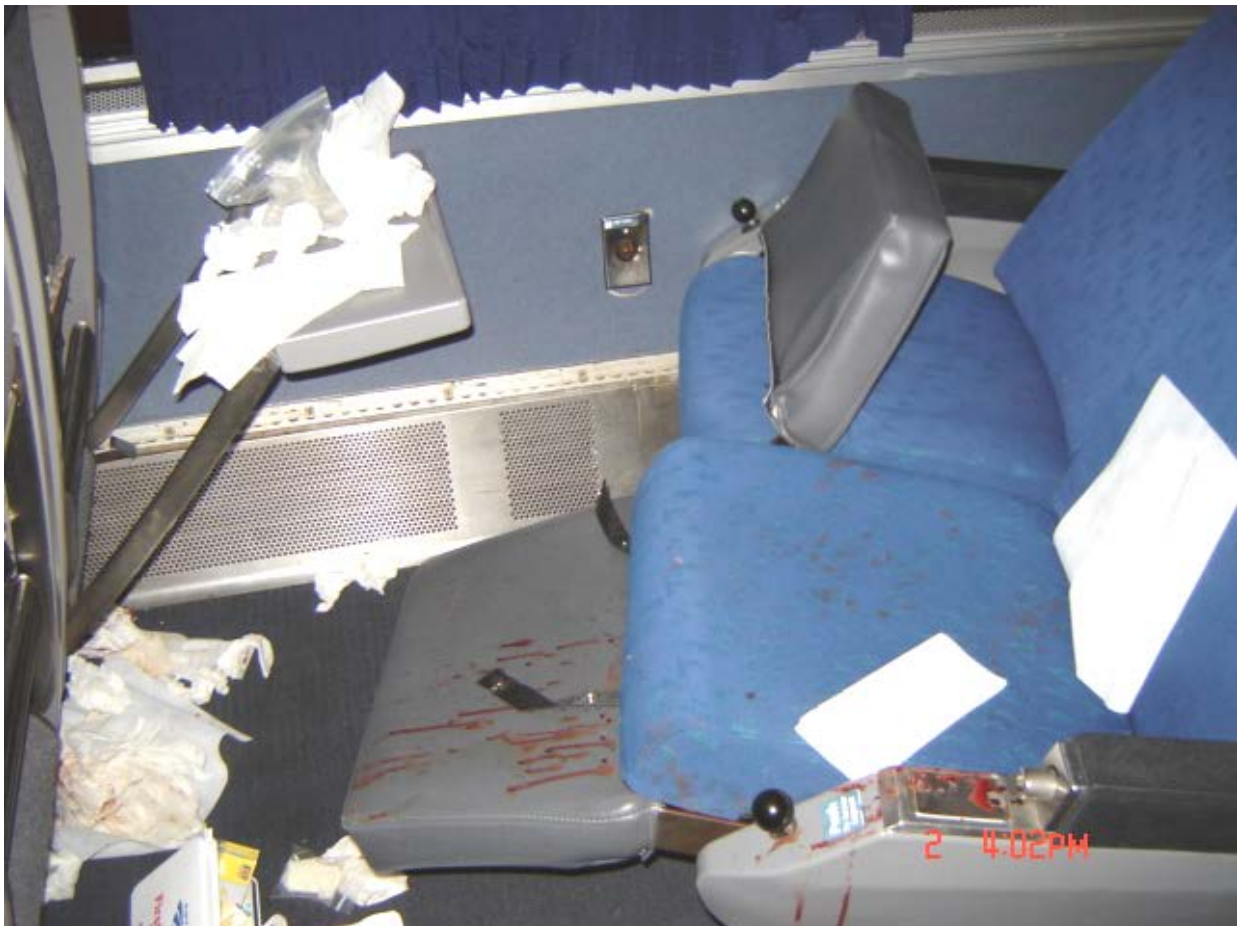
Figure 10. Rotated seat pair in third coach car.

The structural damage to the interiors of the coach cars was minor compared with the damage to the locomotive interior. All of the coaches were equipped with seat pairs that can be rotated 180 degrees to face either forward or backward. After the accident, two seat pairs in the first coach car, three seat pairs in the middle coach car, and three seat pairs in the last coach car were rotated with respect to their original positions. Although it appeared that the seat latches had failed to secure those seat pairs in the locked position, it was difficult to determine whether the collision had actually caused the seat latch failures. The seats may not have been latched properly prior to the collision. There is no positive feedback to suggest that the seat latch is engaged after the seat is rotated; the seat latches on the rotated seats may in fact not have been engaged at the time of the collision, allowing the force of the collision to rotate the seats out of position. Details on the seats and their locking mechanism can be found in Appendix D. Figure 10 shows one of the rotated seat pairs in the third coach car. The blood and other forensic evidence suggest that there was an injured passenger initially seated in the rotated seat. It is difficult to estimate what influence the rotating seat had on the injuries. Most of the injuries sustained by the passengers in the coach cars consisted of bloody noses, cuts, and bruises.

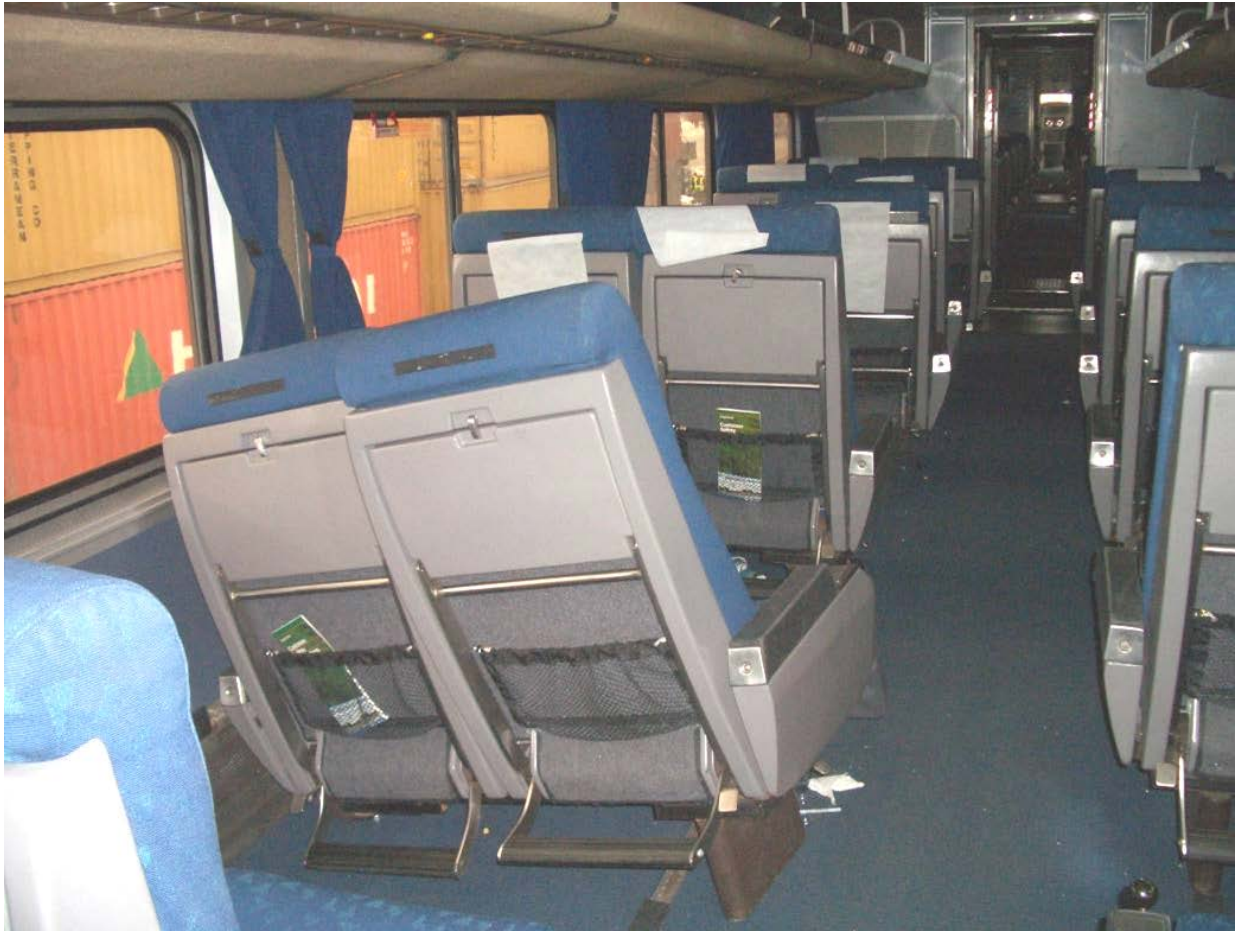
Figure 11. Failed seat pair in middle coach car.

In addition to the three rotated seat pairs, the middle coach car also had a seat pair that had separated from the wall and floor due to fastener failure, as shown in Figure 11. The interior damage is described in more detail with photographs in Appendix B.1.

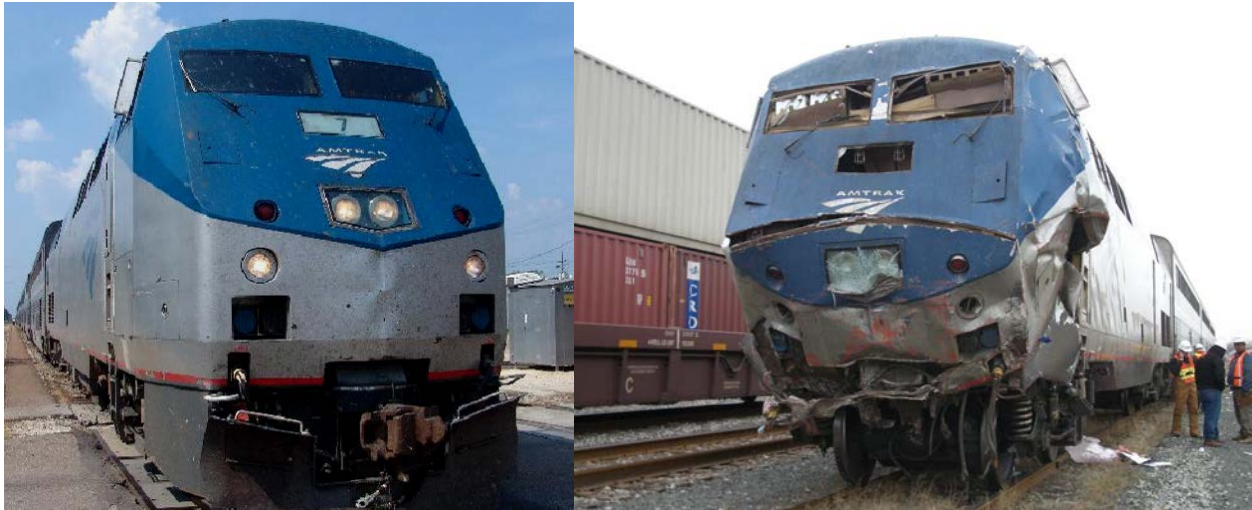
Figure A-1. Undamaged locomotive (left) [13] and locomotive involved in the accident (right).

The photograph on the left in Figure A-1 shows an undamaged locomotive very similar to the one involved in the accident. The photograph on the right in Figure A-1 shows the damage incurred by the locomotive as a result of the accident.

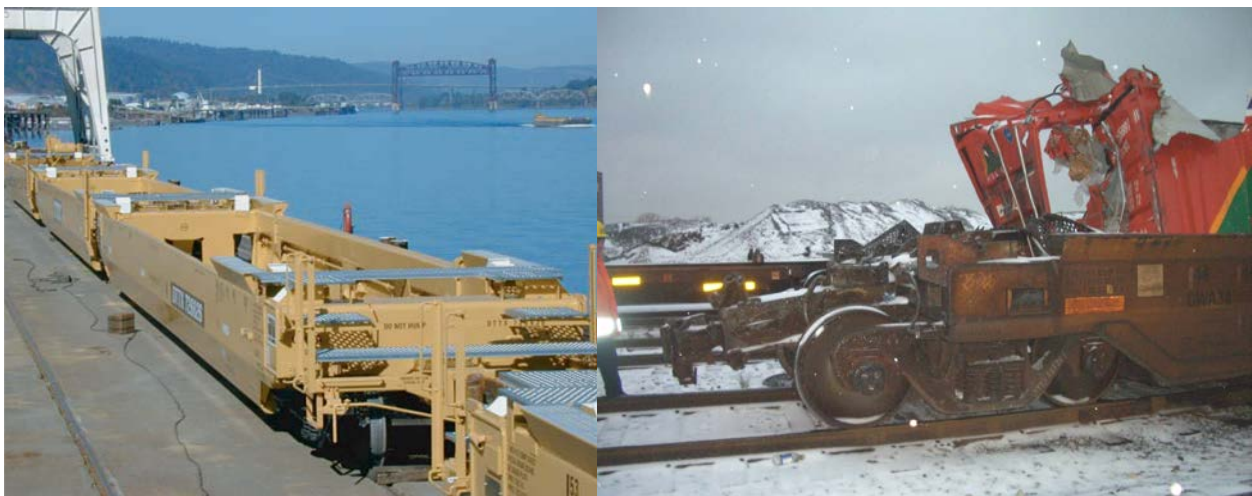
Figure A-2. Undamaged freight car (left) [14] and freight car involved in the accident (right).

The photograph on the left in Figure A-2 shows an undamaged freight car very similar to the equipment involved in the accident. The photograph on the right in Figure A-2 shows the damage incurred by the freight car as a result of the accident.

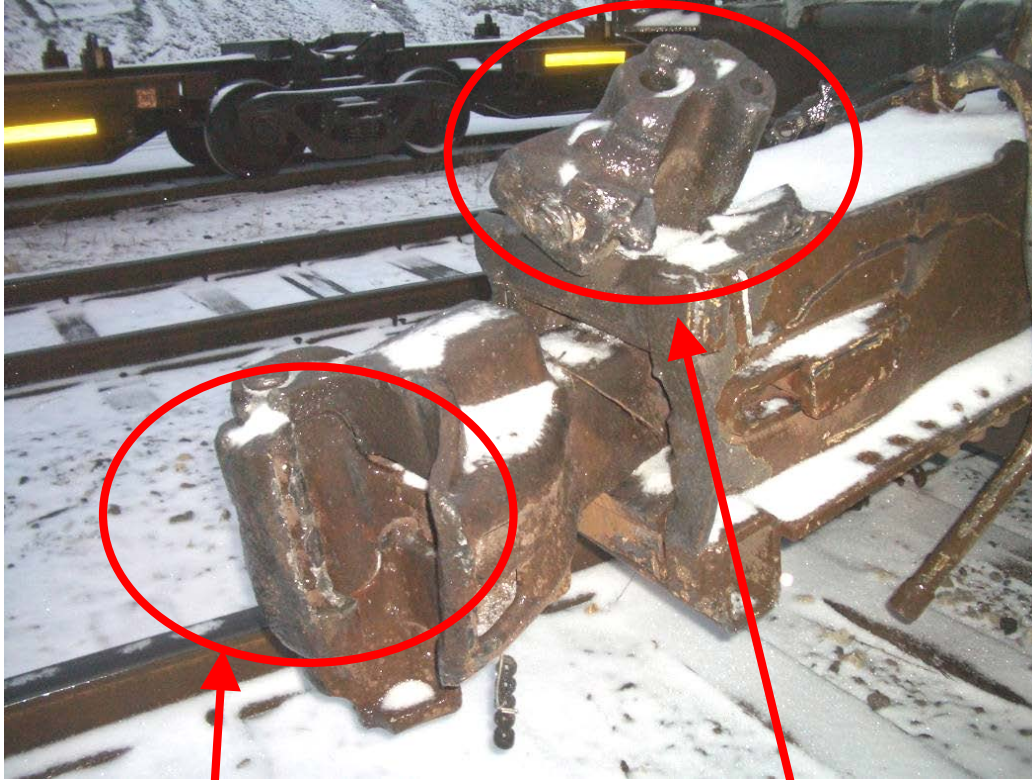
In Phase 1, there was knuckle-to-knuckle contact of both couplers, as shown in Figure A-4. The knuckle of the locomotive coupler broke off and a piece of the knuckle of the freight car also broke off. Figure A-5 shows what remained of both couplers after the accident.

Broken knuckle of freight car

Piece of broken knuckle of locomotive

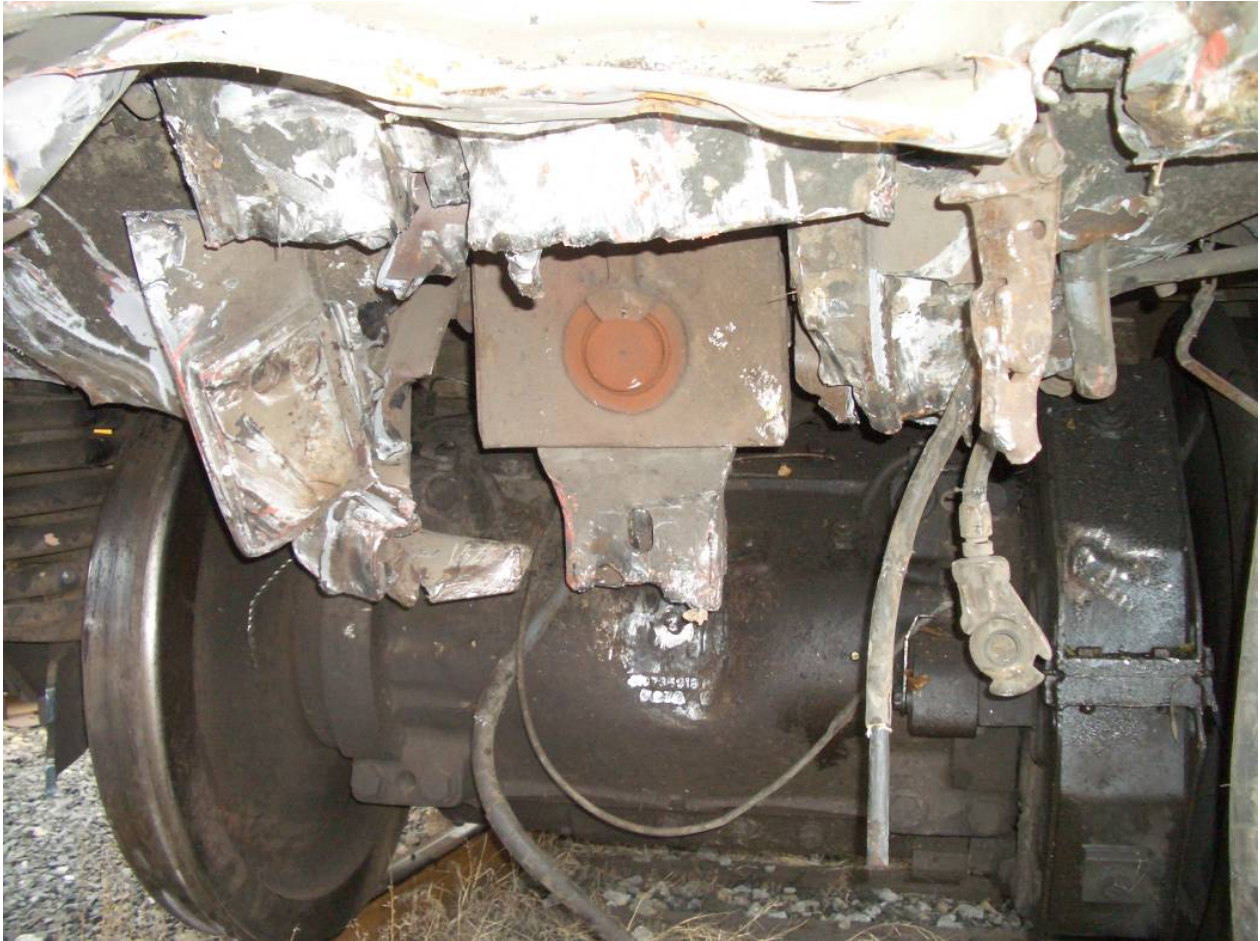
Figure A-6. Deformed locomotive draft gear housing and coupler.

In Phase 2, the locomotive and the freight car couplers moved straight back and both draft gears bottomed out, as shown in Figure A-4. Both couplers remained in line and did not swing out laterally. There is little damage to either bellmouth. This was instrumental in keeping both trains mostly in line during the collision sequence. Had either of the couplers swung out, it is very likely that the passenger train would have derailed laterally. This lateral motion would have caused the passenger train to collide with the trains passing by on the adjacent tracks, resulting in a much more severe accident. Figure A-6 shows the broken coupler shank of the locomotive.

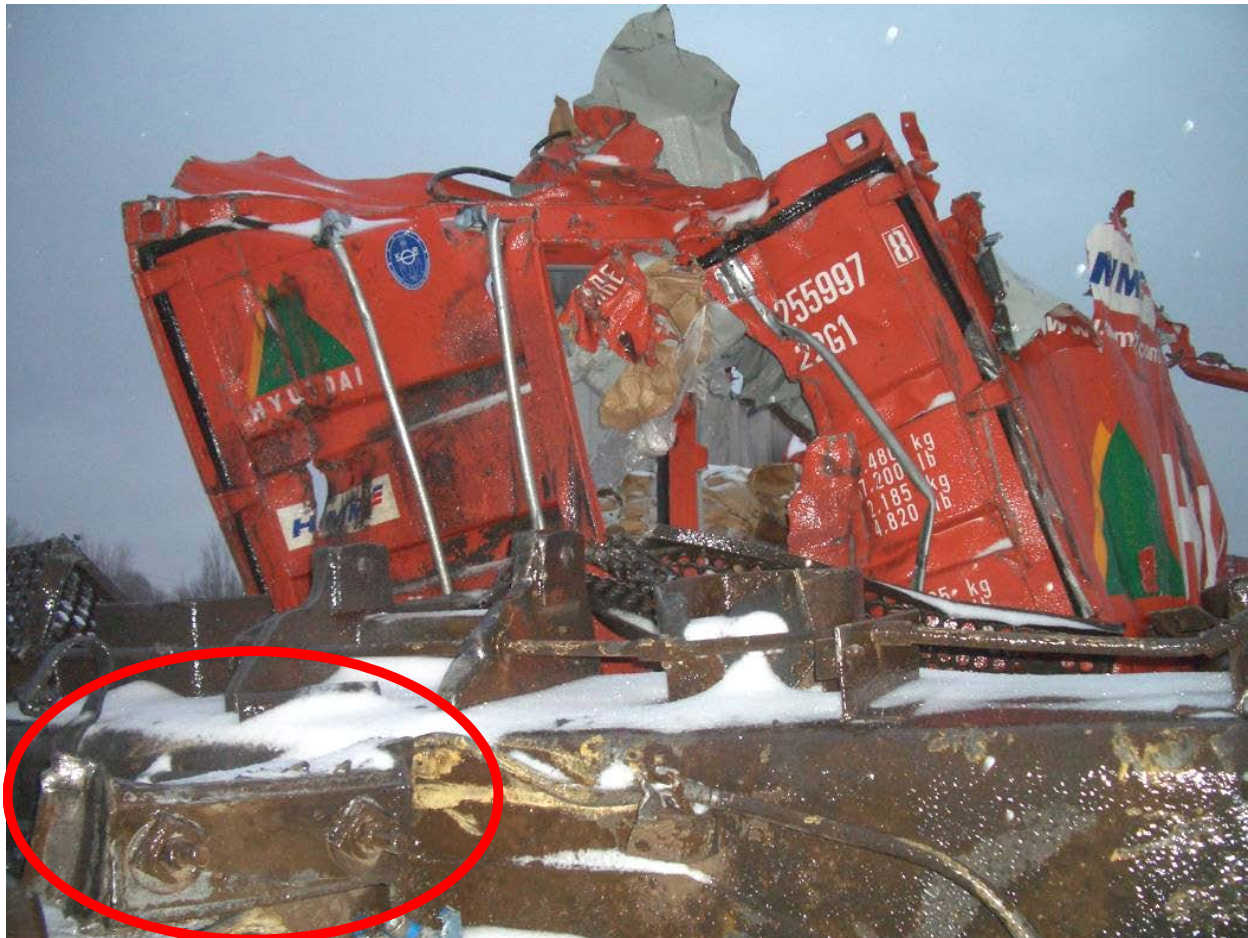
Figure A-7. Failed locomotive coupler carrier shown on top of freight car.

In Phase 3, the locomotive coupler carrier failed and the draft sill of the freight car deformed downward. Figure A-7 shows the failed coupler carrier on top of the deformed draft sill of the freight car. The deformed draft sill effectively acted as a ramp to enable the locomotive to begin to climb the freight car, as shown in Figure A-4. Figure A-8 shows the freight car draft sill deformed downward at an angle. The locomotive climbed the freight car, which allowed the trains to remain in line. Had the cars sawtoothed or zigzagged with respect to each other and derailed, it is possible that the train would have collided with the trains running on both adjacent tracks, resulting in more severe injuries and possibly fatalities in all of the trains involved.

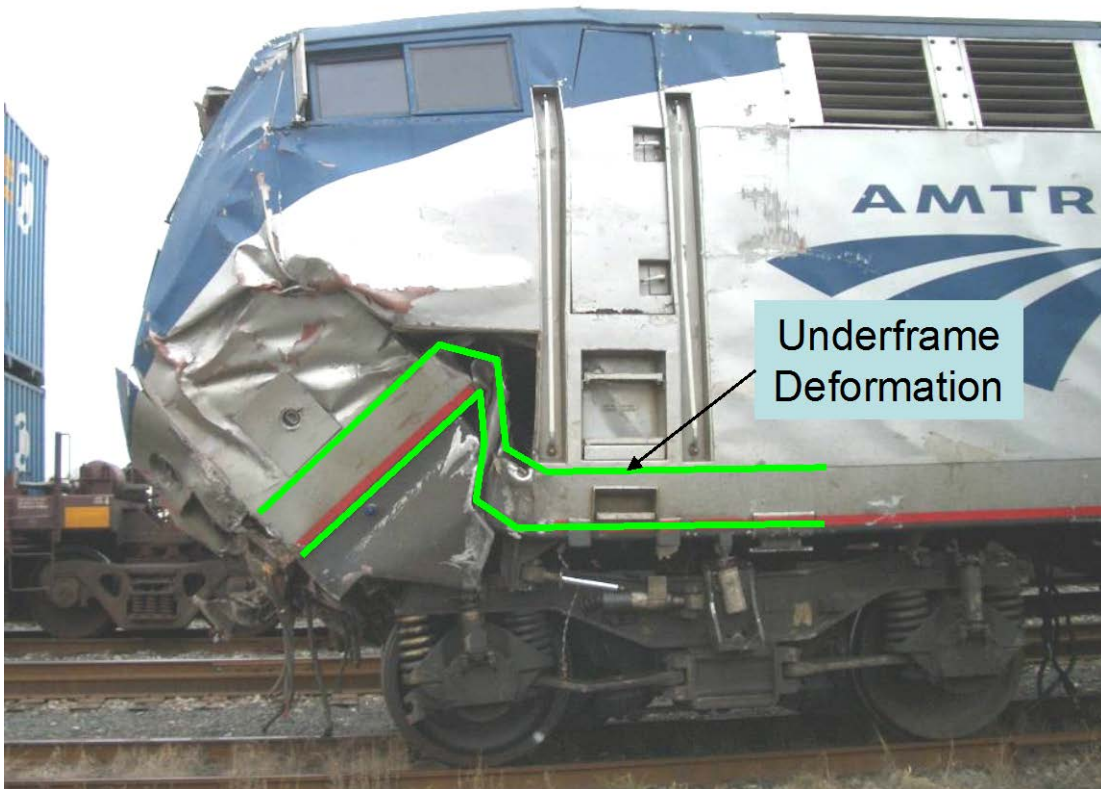
Figure A-9. Locomotive nose and underframe deformed inward and upward.

In Phase 4, the locomotive draft gear housing crushed back and up and the locomotive lead truck engaged the freight car. Figure A-6 shows the broken coupler shank of the locomotive and the fractured sides of the draft gear pocket. Figure A-6 also shows the indentation that the coupler shank left on the front truck of the locomotive. The coupler shank was most likely pinned between the lead truck of the locomotive and the rear of the freight car. The deformation of the locomotive draft gear housing caused the nose of the locomotive to roll under and push up towards the operator's cab compartment, as shown in Figure A-9. Figure A-9 also illustrates the resulting deformation of the underframe, which caused a loss of occupant volume in the cab compartment. The nose rolling under also caused the desktop components of the cab to roll forward and push through the front windows, as shown in Figure A-10. Again, the majority of the motion and deformation was in the longitudinal direction, with very little motion or deformation laterally.

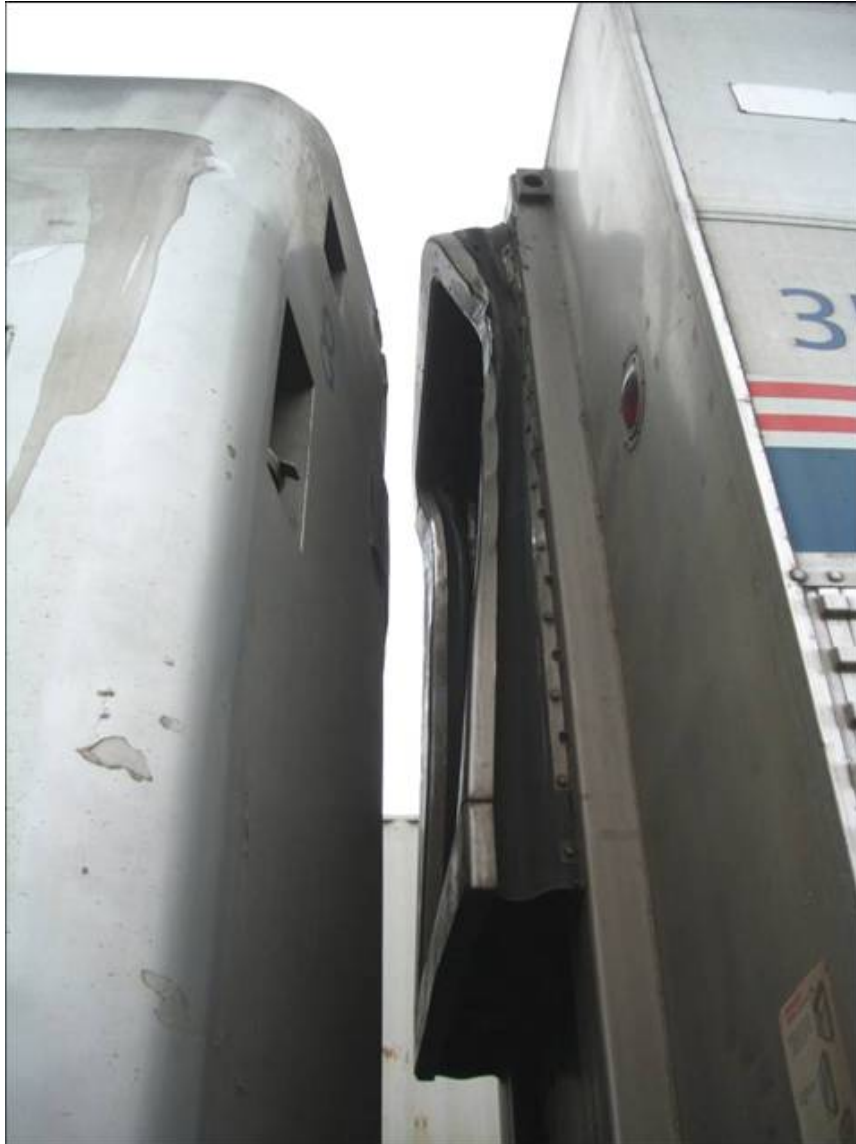
Figure A-11. Damage to diaphragm of first passenger car.

In Phase 5, the locomotive striker engaged the freight car bolster, the lead truck of the locomotive was sheared off, and the rear of the roof of the locomotive engaged the lead passenger car collision posts as the locomotive tilted in its climb. The damage to the diaphragm of the first passenger car is shown in Figure A-11. This was the extent of the exterior damage incurred by the coach cars; there was no other exterior damage. The coach cars and their couplers stayed in line for the duration of the accident with no damage occurring at the coach car interfaces.

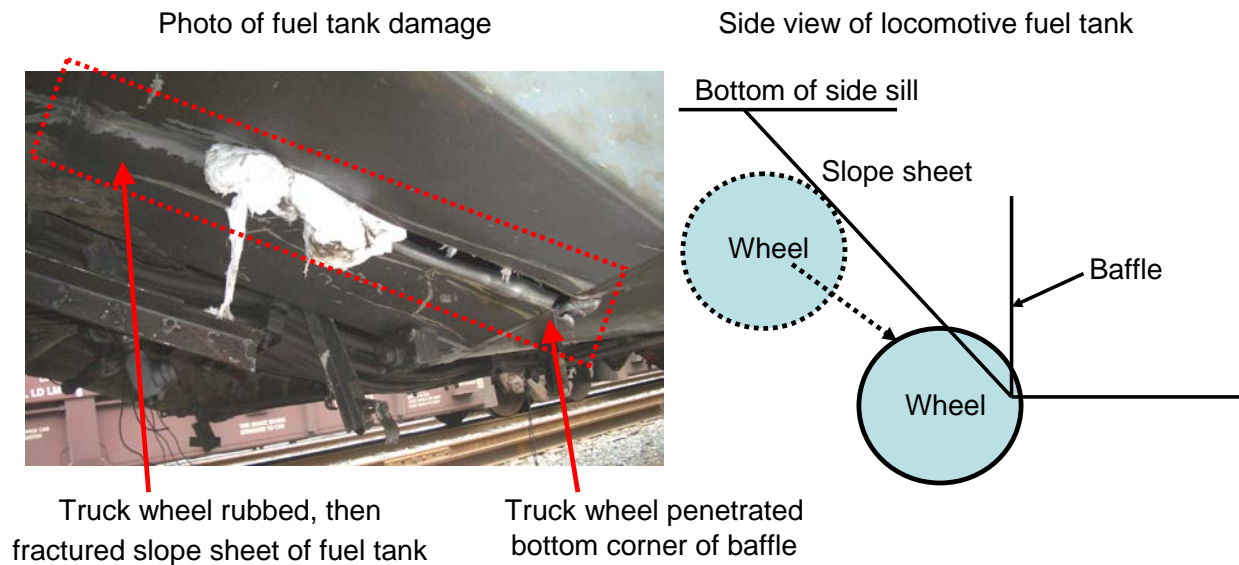
Figure A-12. Fuel tank damage.

In this phase, the locomotive fuel tank was damaged by the rear wheel of the front truck as the locomotive climbed the freight car. The damage to the fuel tank, along with a diagram depicting how the damage occurred, is shown in Figure A-12. The rear wheel of the locomotive front truck was still spinning when it contacted the slope sheet of the fuel tank. As the locomotive climbed the freight car, the spinning wheel fractured the slope sheet then penetrated the corner of the fuel tank baffle. Approximately 300 gallons of diesel fuel spilled from the tank as a result [1].

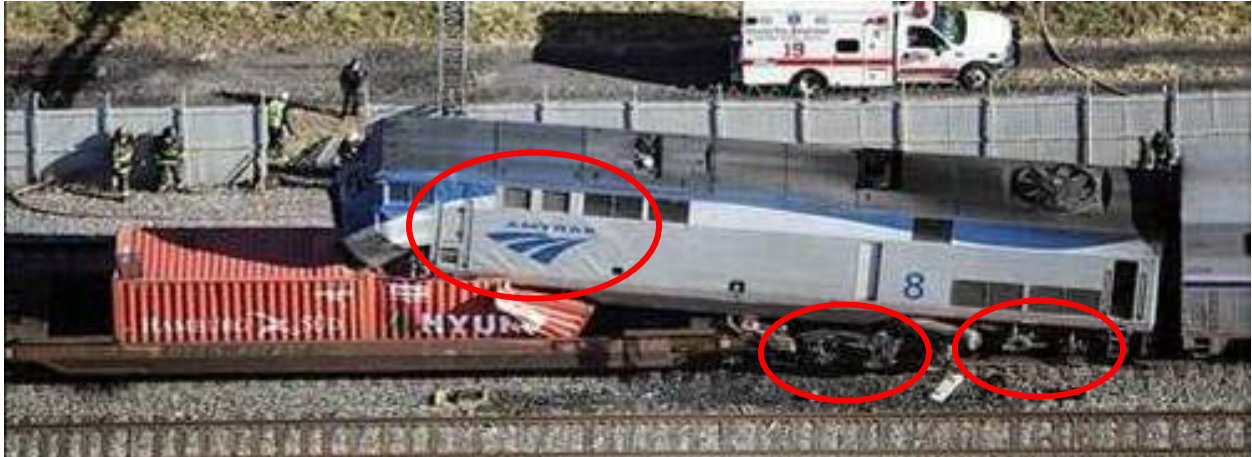
Figure A-13. The locomotive lead truck was sheared off and left behind.

The post-impact locations of the lead and rear trucks of the locomotive are indicated by the two small red circles in Figure A-13. The lead truck was left behind as the locomotive climbed over the rear of the freight car. The photograph shows the lead truck of the locomotive located underneath the locomotive, just in front of the rear truck.

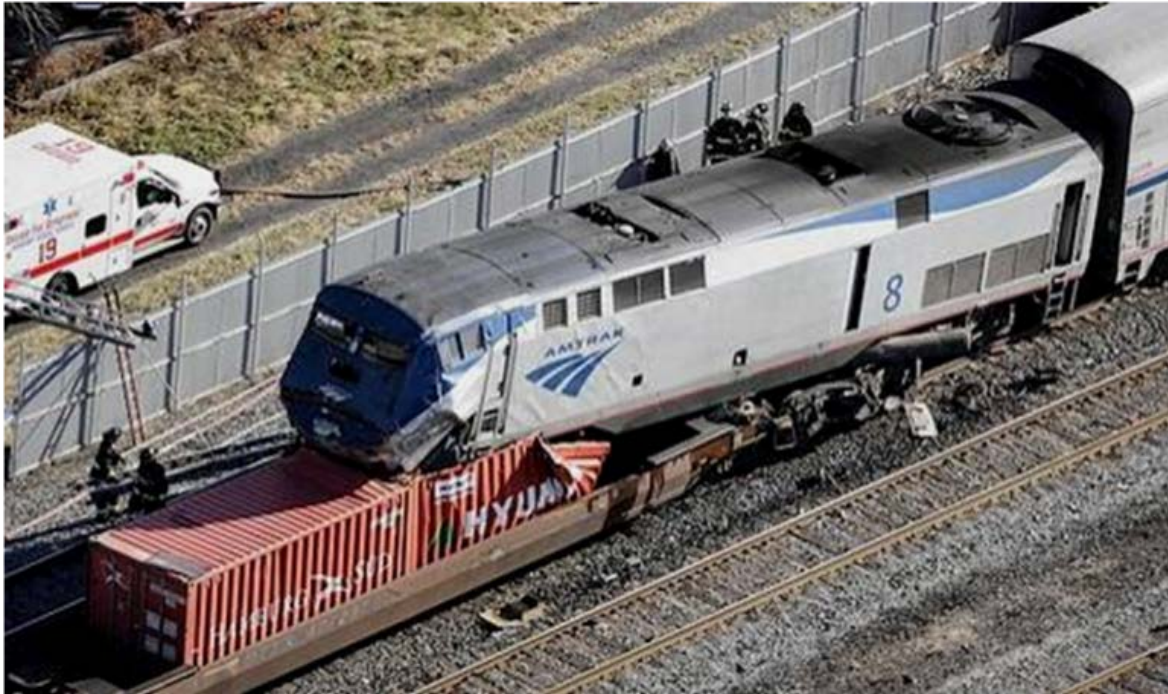
Figure A-14. The locomotive came to a stop on top of the freight car [4].

Figure A-14 shows the adjacent tracks on both sides of the trains involved in the collision. At the time of the collision, there were trains running on both adjacent tracks. Had the passenger train not climbed the freight car, the couplers would have caused the cars to sawtooth laterally. This lateral buckling is typical and if it had occurred in this accident, the passenger train could have impacted the trains running on both adjacent tracks, resulting in a more severe accident.

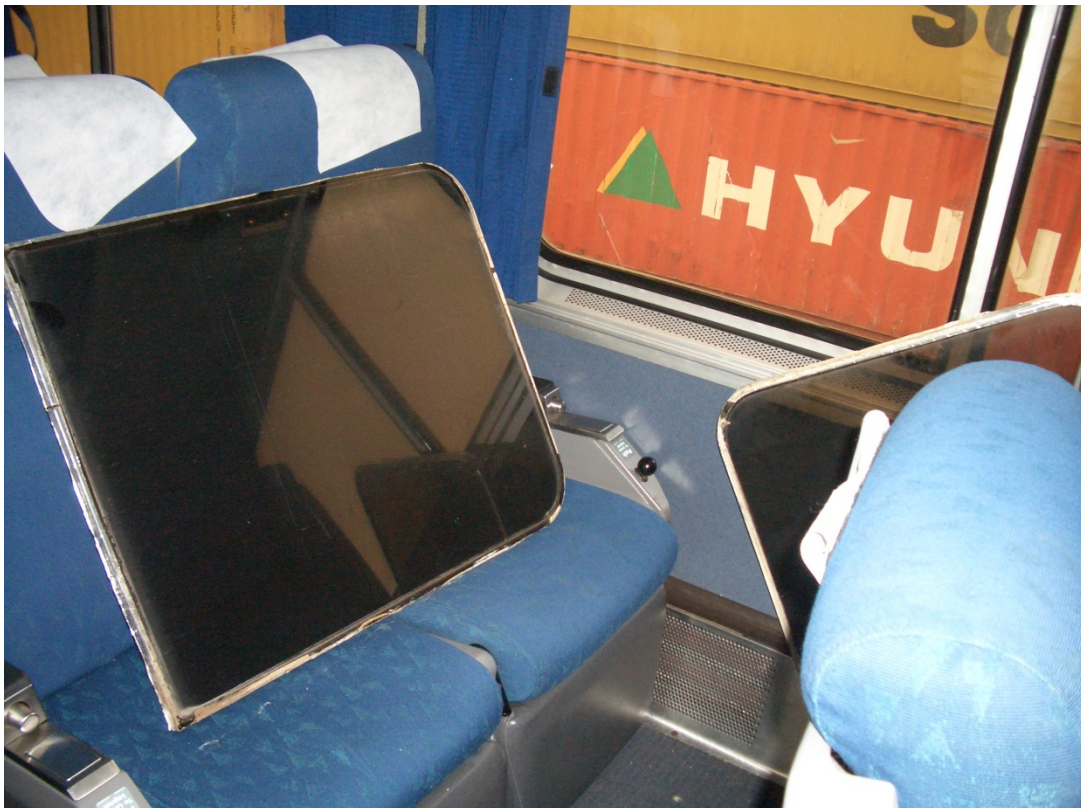
Figure A-15. Emergency windows pulled in first coach car.

Since the passenger cars remained upright throughout the impact, most of the passengers were able to exit through the doors with no difficulty. However, a total of four emergency windows were pulled, with at least one pulled in each coach car. Figure A-15 shows evidence of the two emergency windows pulled in the first coach car, Figure A-16 of the emergency window pulled in the second coach car, and Figure A-17 of the emergency window pulled in the third coach car. The egress situation was very different for the two engineers located within the locomotive cab. Despite the large upward displacement of the locomotive cab floor, the engineers were not pinned within the cab. However, the position of the locomotive on top of the freight car made rescue more difficult. Because of the damage to the locomotive, the rescue crew was unable to open the doors on either side of the cab at the front of the locomotive, but was able to gain access through the rear left side door. Since the right-side cab window was broken, the relief engineer climbed out through this window and climbed down the emergency ladder. The operating engineer walked back through the engine room to the door at the rear of the locomotive. He was helped into a rescue basket and lowered to the ground. Details of their experience in the cab and the injuries they sustained can be found in the phone interview information of Appendix B.2.

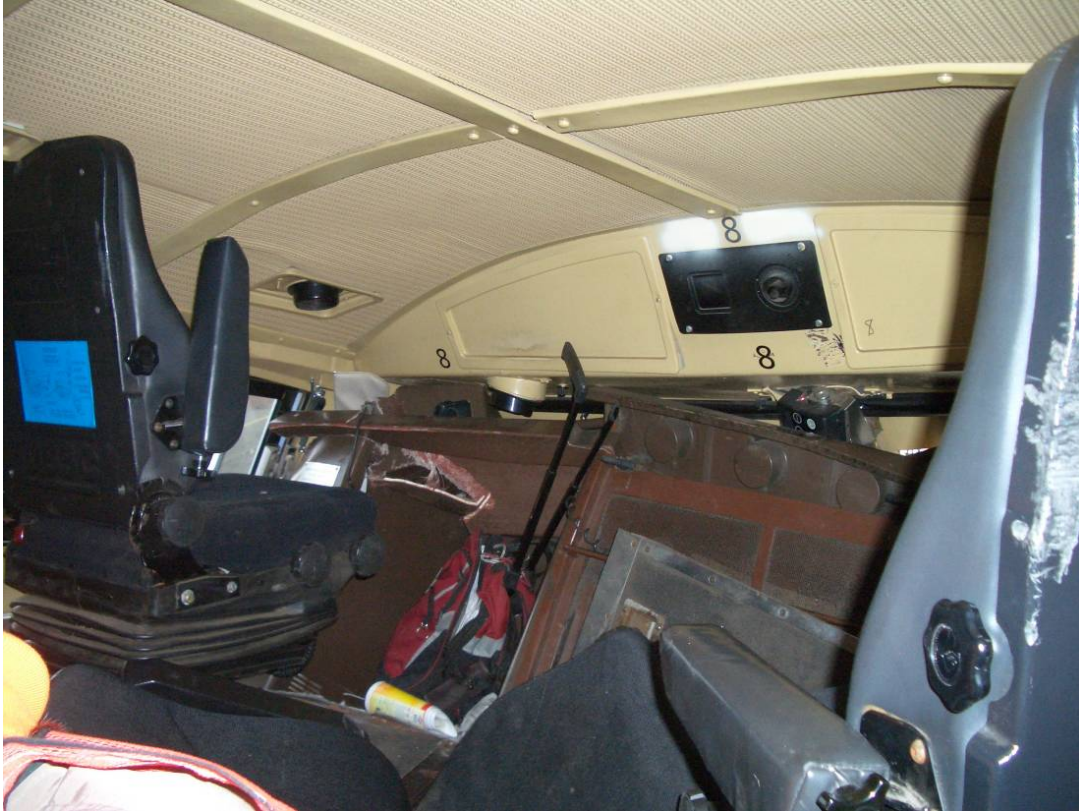
Figure A-18. Locomotive interior cab damage and raised floor from impact.

The impact between the locomotive and the freight car caused the nose of the locomotive to roll under and push upward, resulting in the underframe buckling upward towards the operator's cab. This deformation caused the desktop components of the cab to roll forward and push through the front windows of the cab compartment, as shown in Figure A-10. The deformation of the underframe also caused failure of the floor of the cab, resulting in the floor and the seats in the cab being pushed upward. Figure A-18, Figure A-19, and Figure A-20 are photos of the cab interior that show the desktop components pushed through the windows, the raised floor of the cab, the operating engineer's desk and seat, and the relief engineer's seat displaced upward and pushed into the ceiling of the cab. The broken right-side cab window shown in Figure A-19 is the window through which the relief engineer climbed to exit the cab.

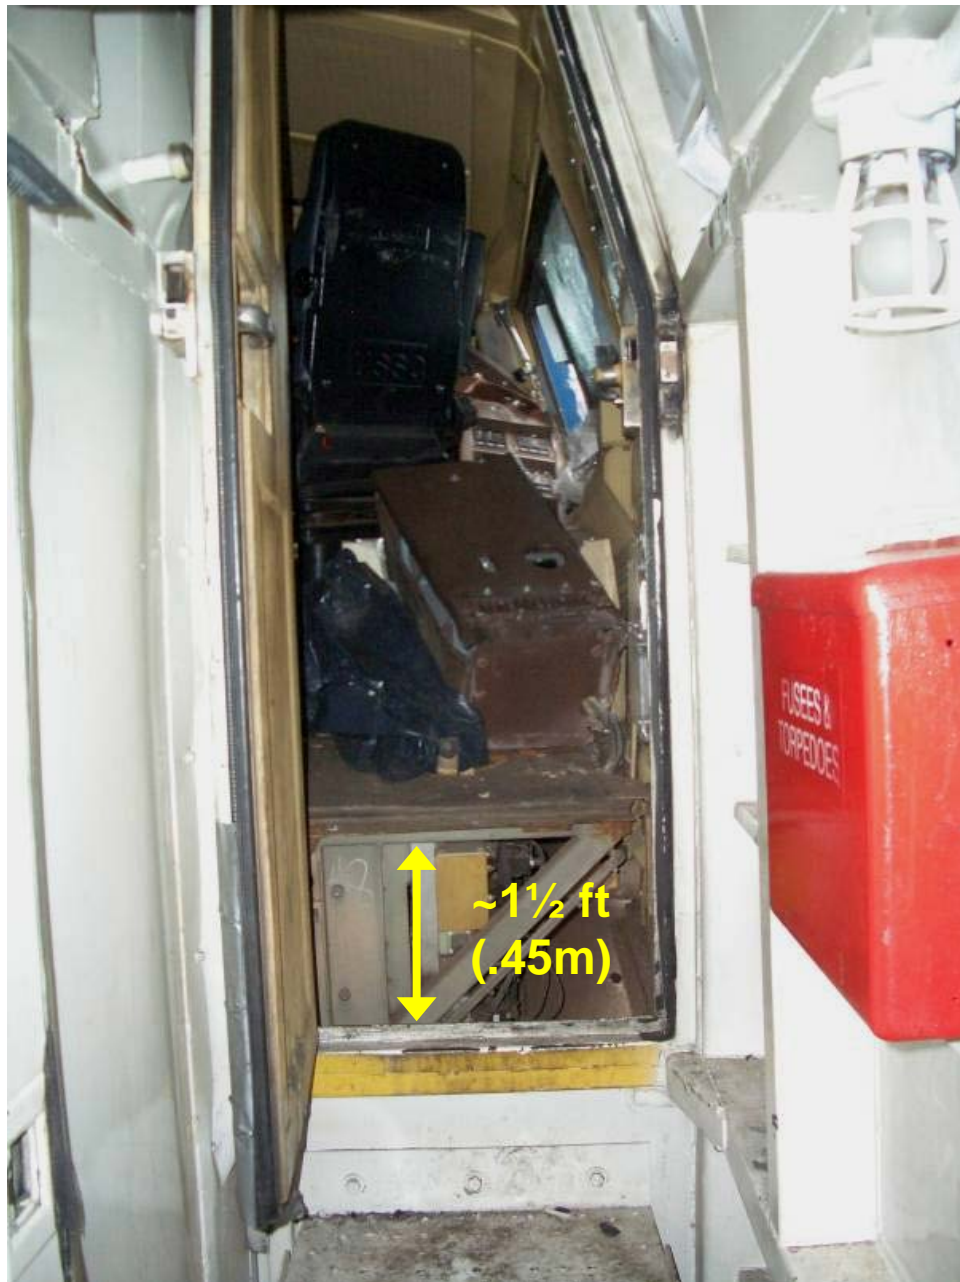
Figure A-21. Side view of raised floor of locomotive cab interior.

Figure A-21 shows the distance, approximately 1½ ft (0.45 m), the floor of the cab was raised at the location of the door. Measurements taken of the cab interior indicated that the floor was raised approximately 27 in on the left side and 24 in on the right side. Figure A-22 shows a wrinkle in the floor of the locomotive engine room. The longitudinal position of this wrinkle corresponds to the position of the wrinkles in the side walls of the locomotive seen earlier in Figure A-13. Details of the operating and relief engineers' injuries can be found in the phone interview information of Appendix B.2.
