Federal Railroad
Administration

Collision of Amtrak Passenger Train and Norfolk Southern Freight Train—November 30, 2007, Chicago, Illinois

1. AGENCY USE ONLY (Leave blank)		2. REPORT DATE October 2013		3. REPORT TYPE AND DATES COVERED Final Report
4. TITLE AND SUBTITLE Collision of Amtrak Passenger Train and Norfolk Southern Freight Train— November 30, 2007, Chicago, Illinois			5. FUNDING NUMBERS

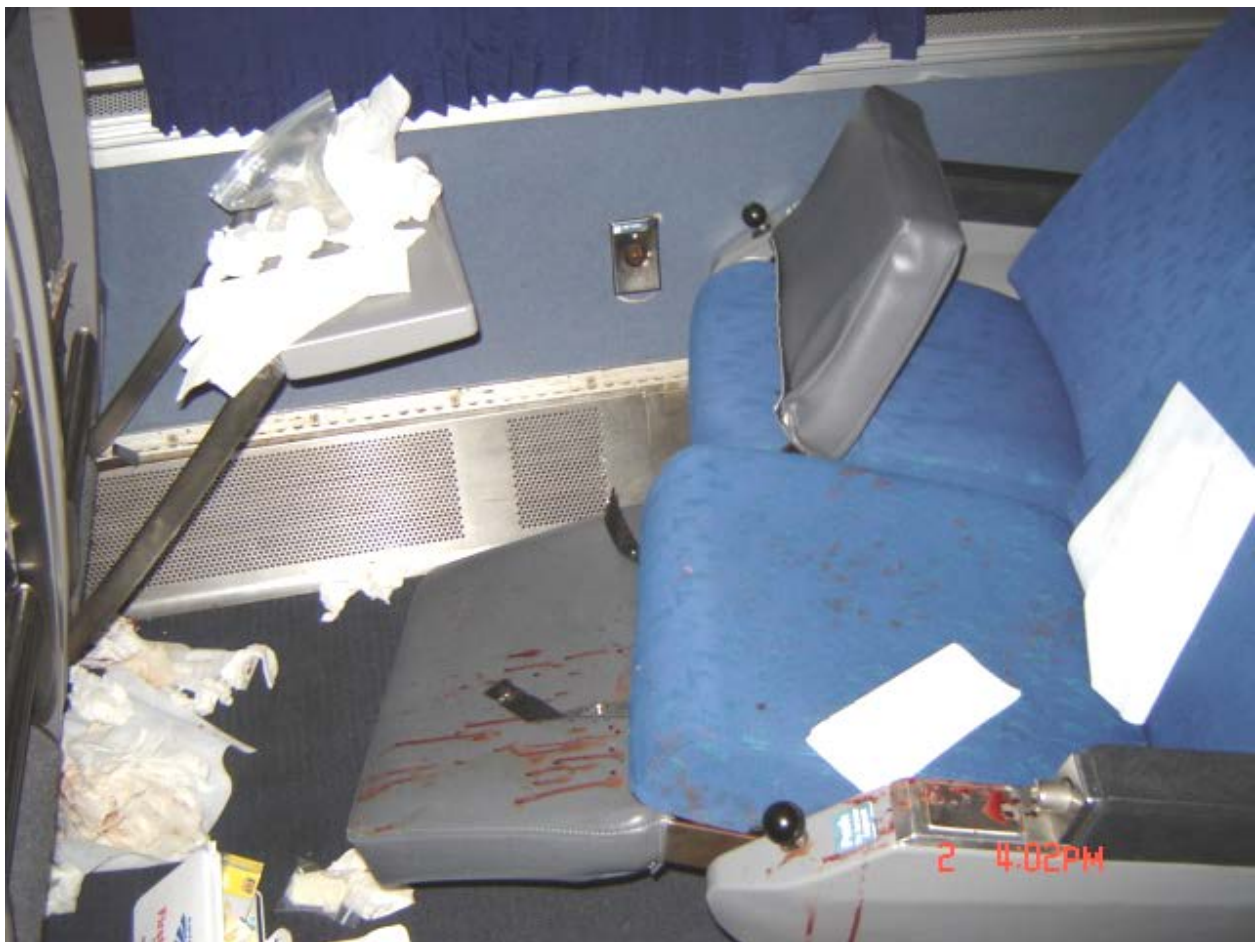
Figure A-23. Rotated seat pair in third coach car.

The structural damage to the interiors of the coach cars was minor compared with the damage to the locomotive interior. All of the coaches were equipped with seat pairs that can be rotated 180 degrees to face either forward or backward. After the accident, two seat pairs in the first coach car, three seat pairs in the middle coach car, and three seat pairs in the last coach car were rotated with respect to their original positions. It appeared that the seat latches had failed to secure the seat pairs in the locked position. However, it is difficult to determine if the collision actually caused the seat latch failures. There is no positive feedback to suggest that the seat latch was engaged after the seat rotated; therefore, the seat latches on the rotated seats may not have been engaged at the time of the collision, allowing the force of the collision to rotate the seats out of position. Details on the seats and their locking mechanism can be found in Appendix D. Figure A-23 shows one of the rotated seat pairs in the third coach car.

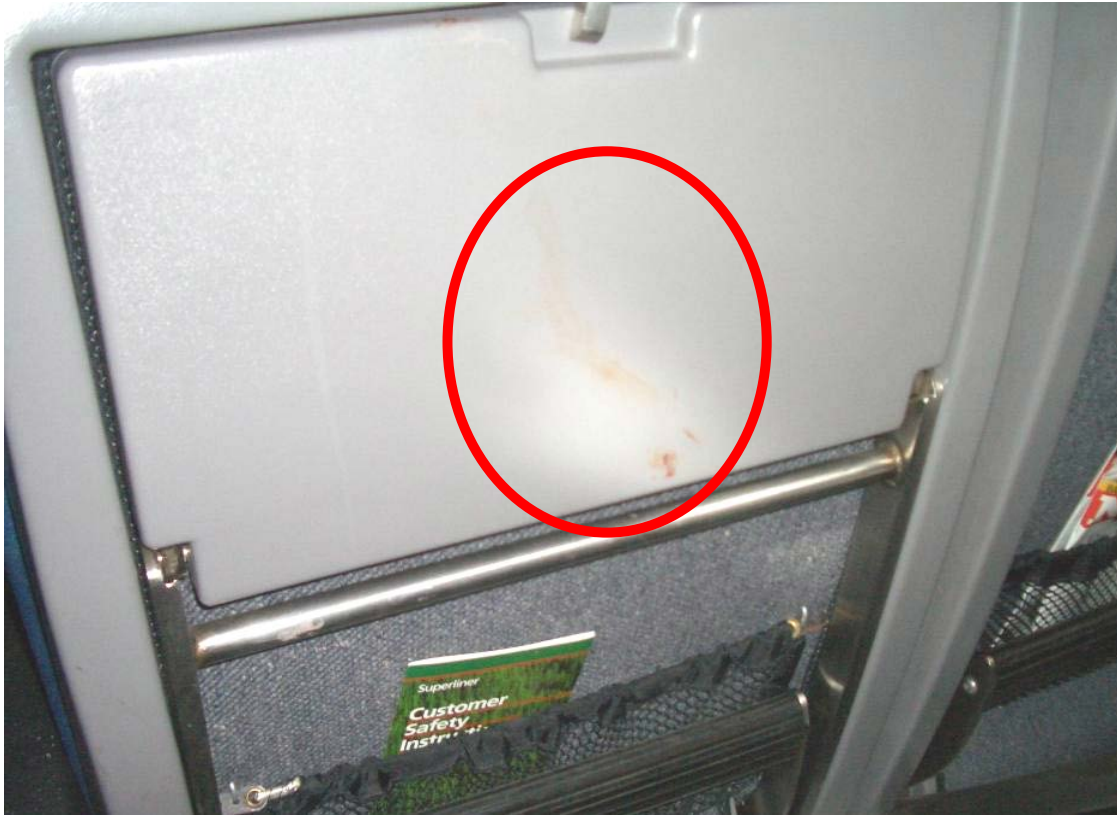
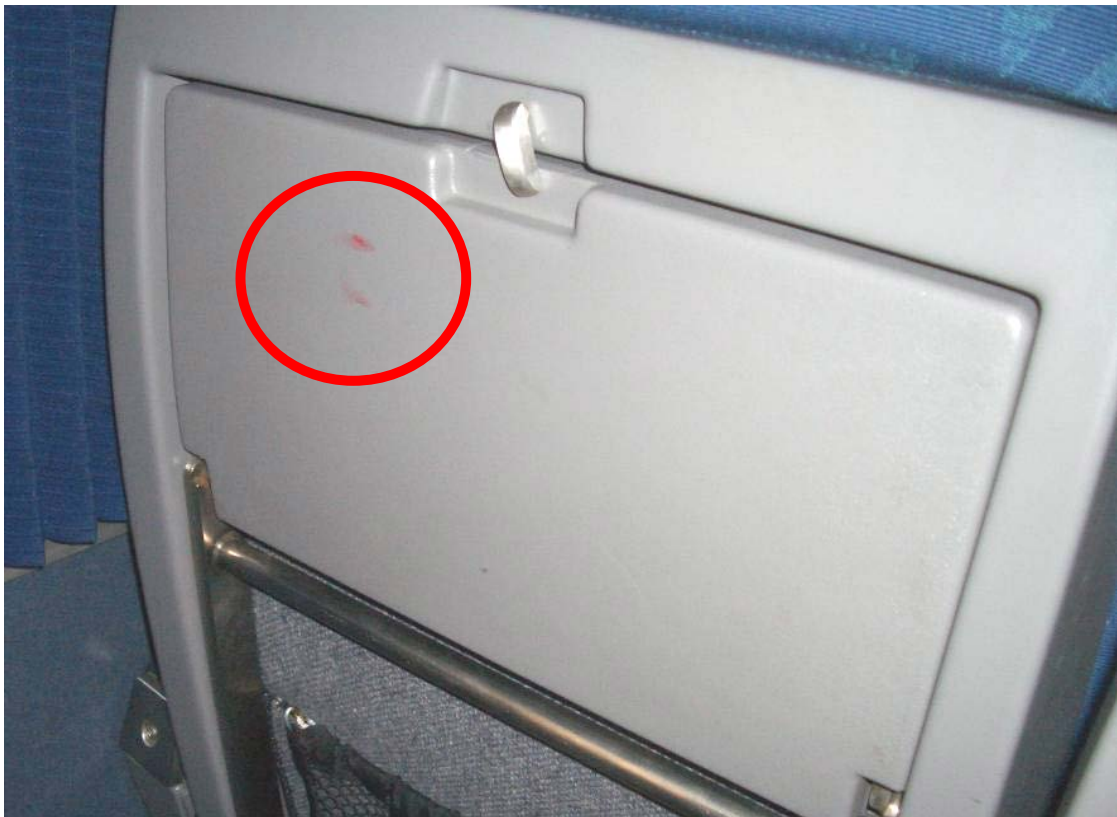
Figure A-25. Evidence of passenger injuries from impact with seat backs.

The injuries of the passengers in the coach cars consisted mostly of bloody noses, small cuts, and bruises. Figure A-25 shows evidence of passenger facial impacts with seat backs (circled in red) in the third coach car, and Figure A-23 shows evidence of a bloody nose injury, also in the third coach car;
