U.S. Department of  
Transportation  
**Federal Railroad  
Administration**

## Alternative Occupied Volume Integrity (OVI) Tests and Analyses

1. AGENCY USE ONLY (Leave blank)		2. REPORT DATE October 2013		3. REPORT TYPE AND DATES COVERED	
4. TITLE AND SUBTITLE Alternative Occupied Volume Integrity (OVI) Testing and Analyses				5. FUNDING NUMBERS RR28A1/JG343 RR28A2/JL649 RR28A2/KL649

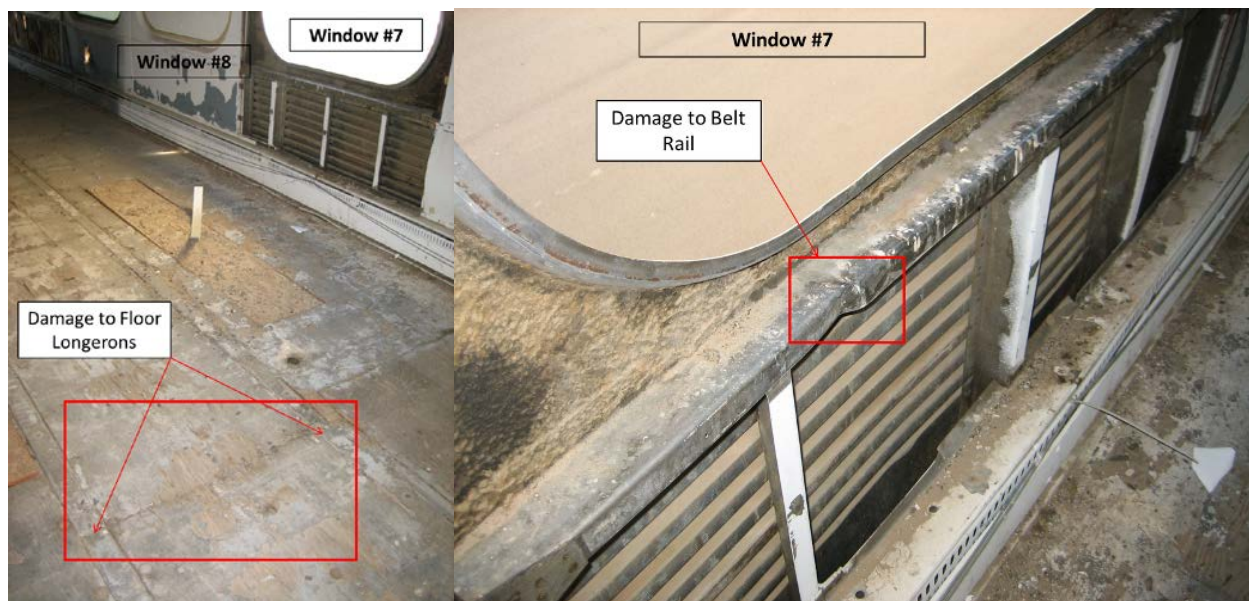
Both Car 244 and Car 248 were inspected prior to the beginning of this test program. Damage was found in several longitudinal members in Car 248. Damage to the two floor longerons was readily apparent during a walkthrough of the car and is noted on the left side of Figure 34. These two channels run the length of the occupant volume and both have an observable dent caused by high longitudinal loading in the previous impact tests. The floor damage is located in the vicinity of the sixth window from the live end of Car 248.

**Figure 34. Pretest Damage to Occupied Volume in Car 248**

In the same area as the deformed longerons, the belt rail on the left side of the car had an observable wrinkle in it adjacent to the seventh window from the live end of the car. This damage was also likely caused by high longitudinal loading during the previous impact testing program. This damage is shown on the right side of Figure 34.

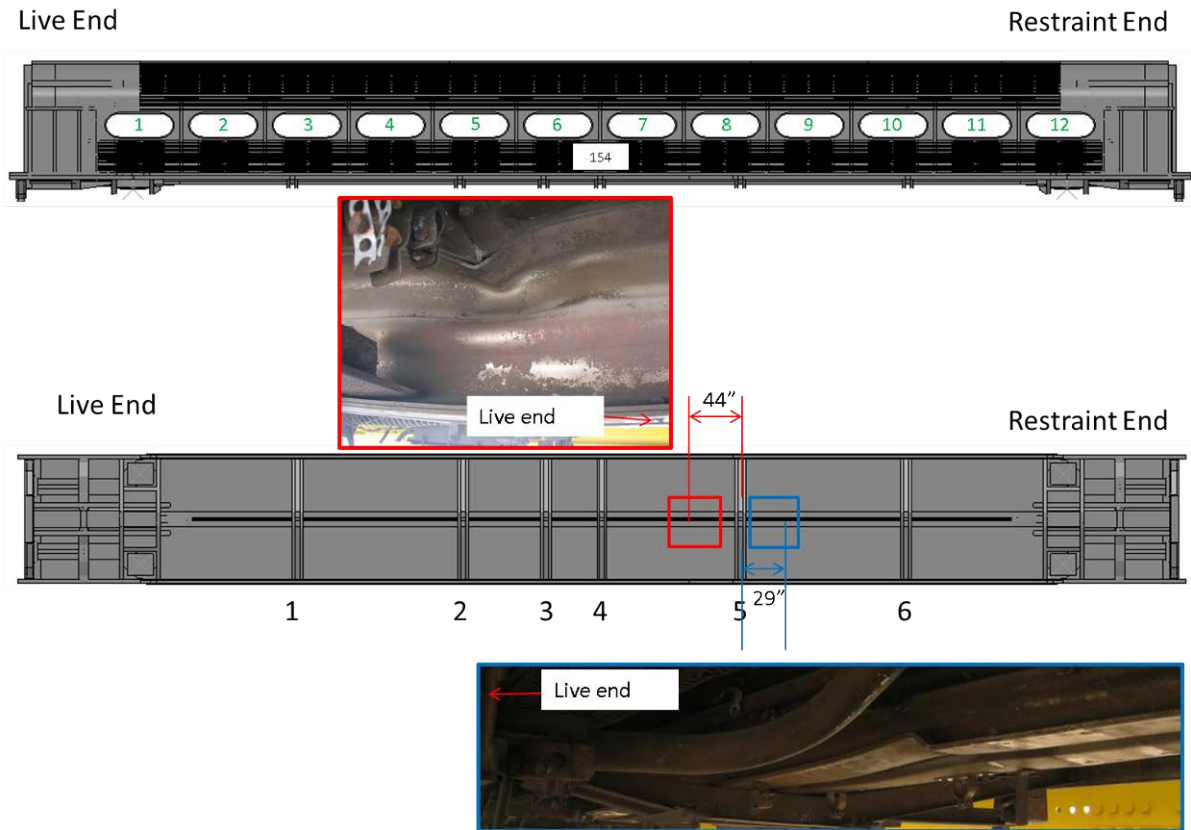
**Figure 47. Damage to Underframe of Car 248**

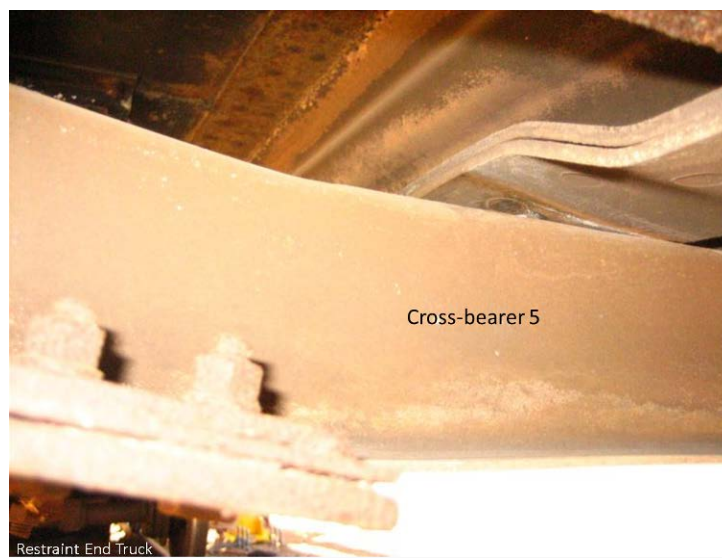
**Figure 48. Buckle and Failed Welds in Center Sill at Cross-Bearer 5, Car 248**

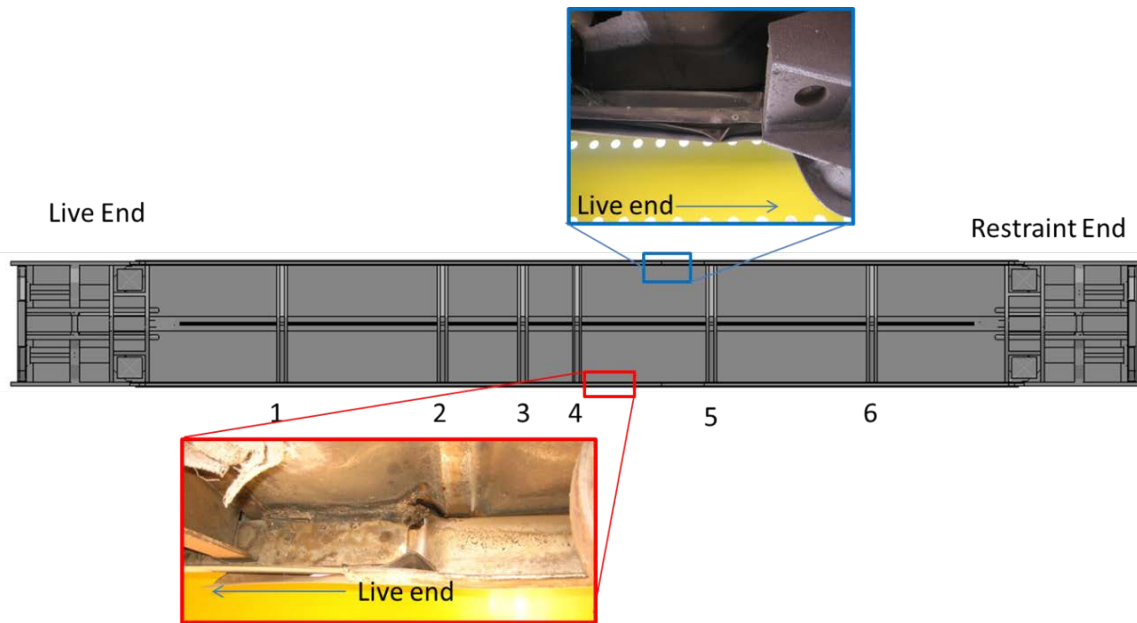
**Figure 49. Damage to Sides Sills of Car 248**

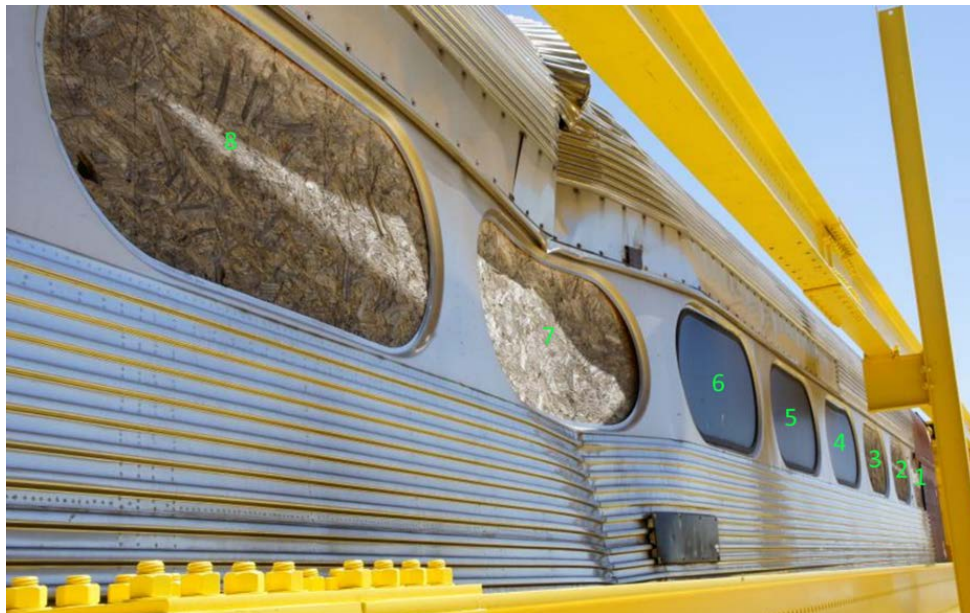
**Figure 50. Damage to Right Sidewall, Car 248**

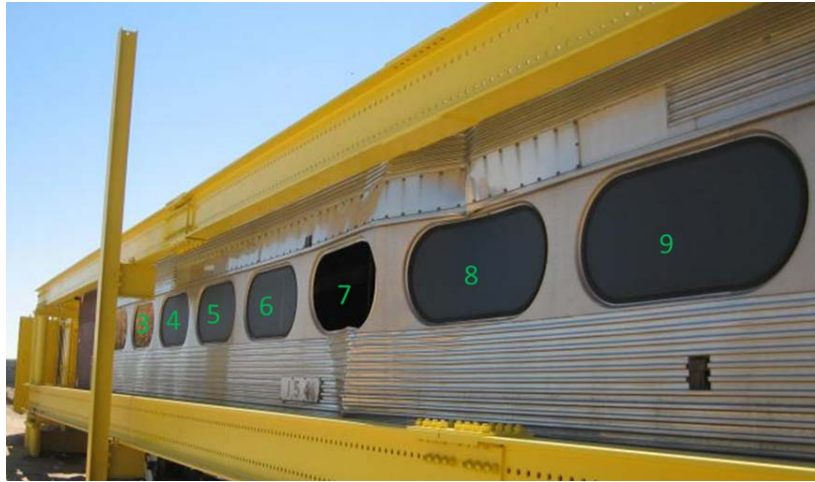
**Figure 51. Damage to Left Sidewall, Car 248**

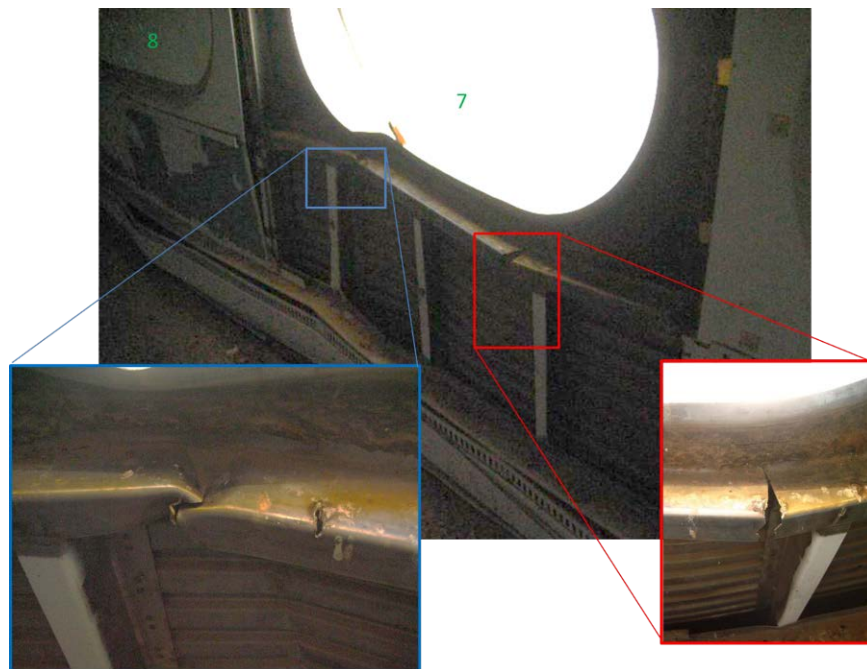
**Figure 52. Fractured Left Belt Rail, Car 248**

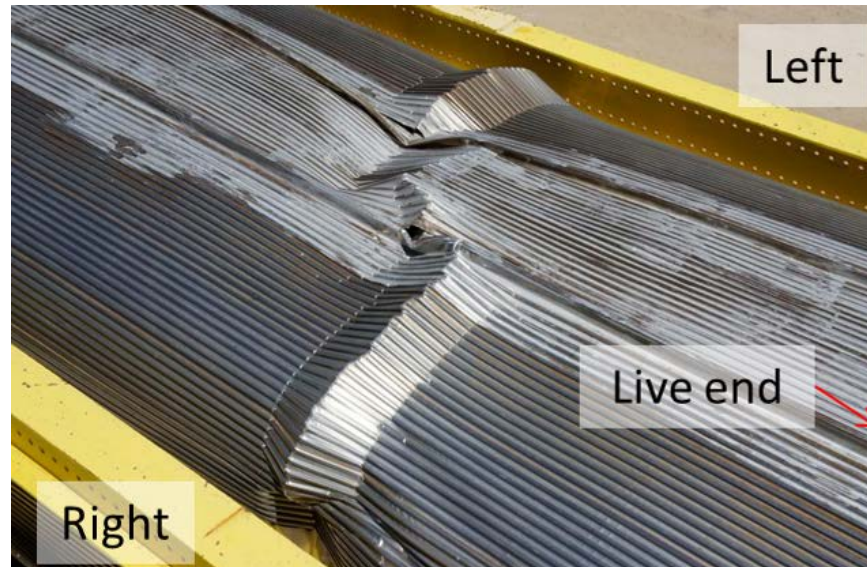
**Figure 53. Buckled Roof, Car 248**

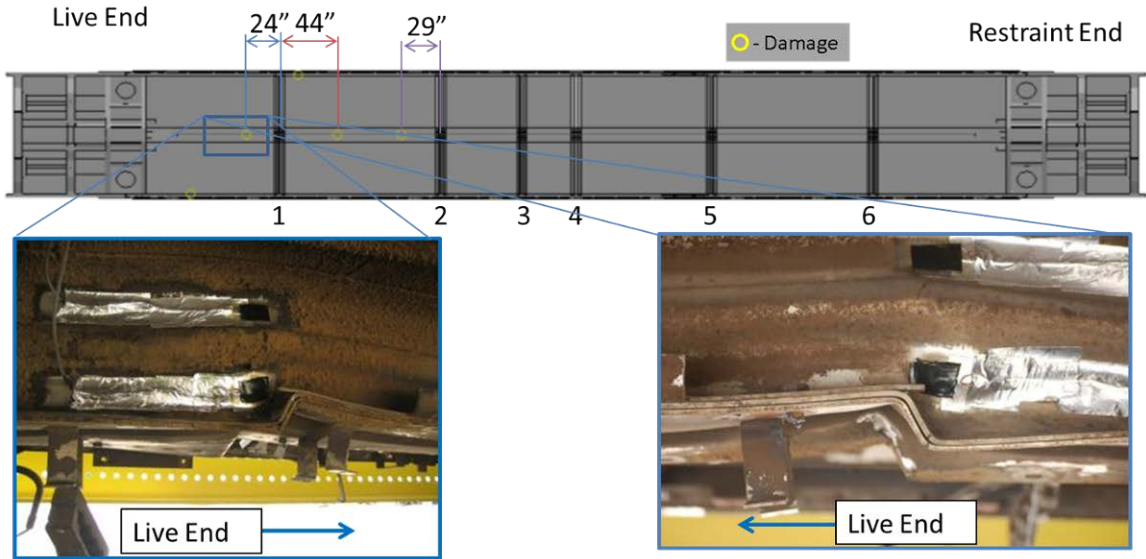
**Figure 59. Damage to Car 244 Center Sill (1)**

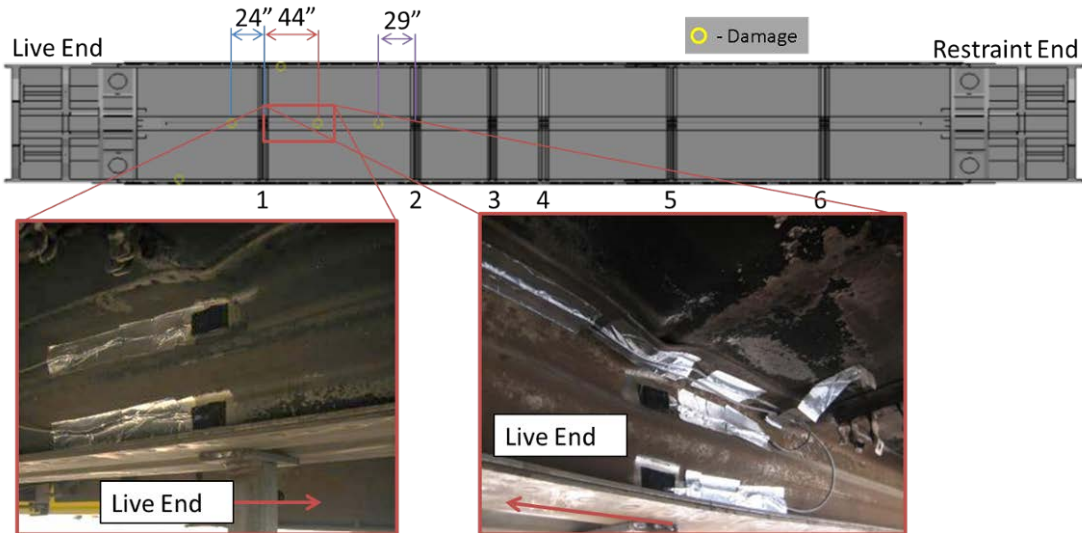
**Figure 60. Damage to Car 244 Center Sill (2)**

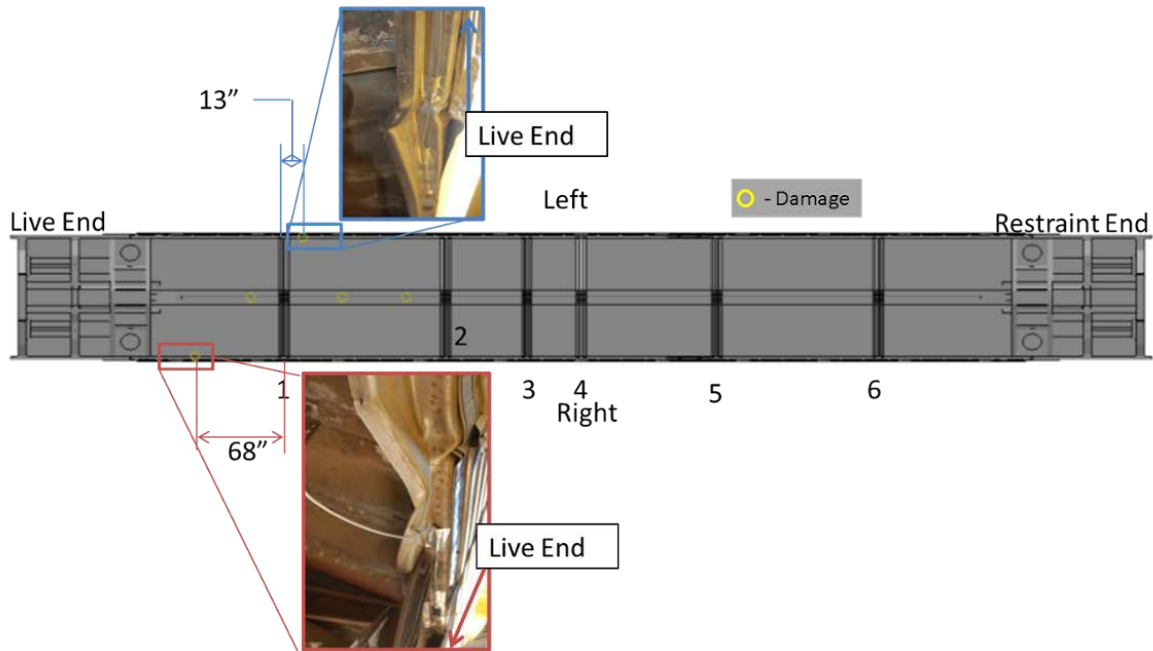
**Figure 61. Damage to Car 244 Side Sills**

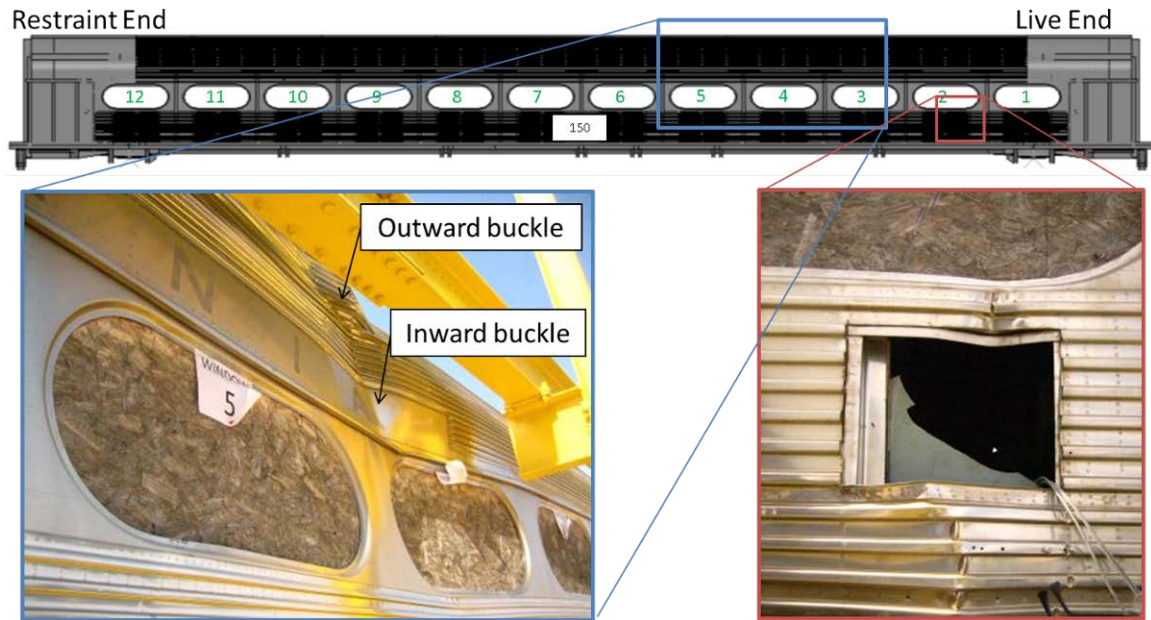
**Figure 62. Damage to Right Side of Car 244**

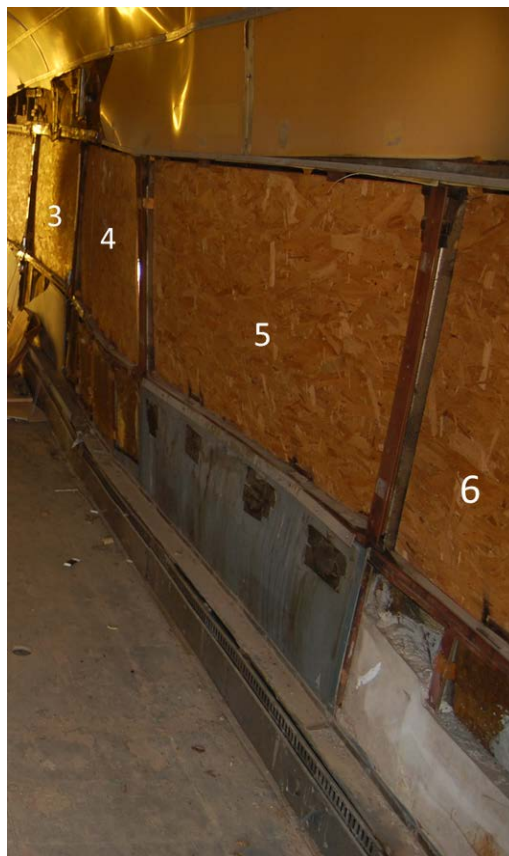
**Figure 63. Damage to Right Side Interior of Car 244**

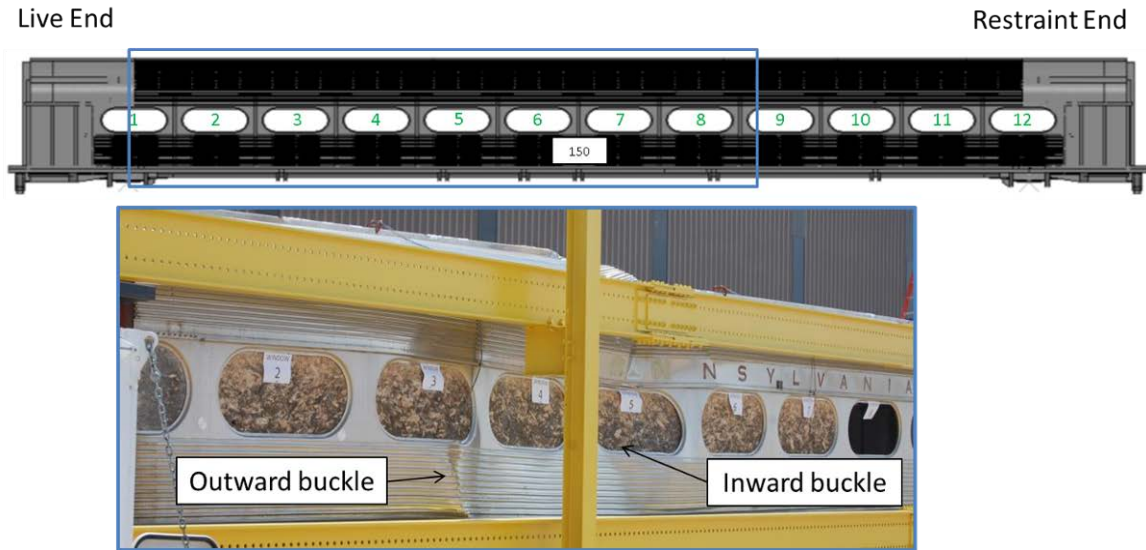
**Figure 64. Damage to Left Side of Car 244**

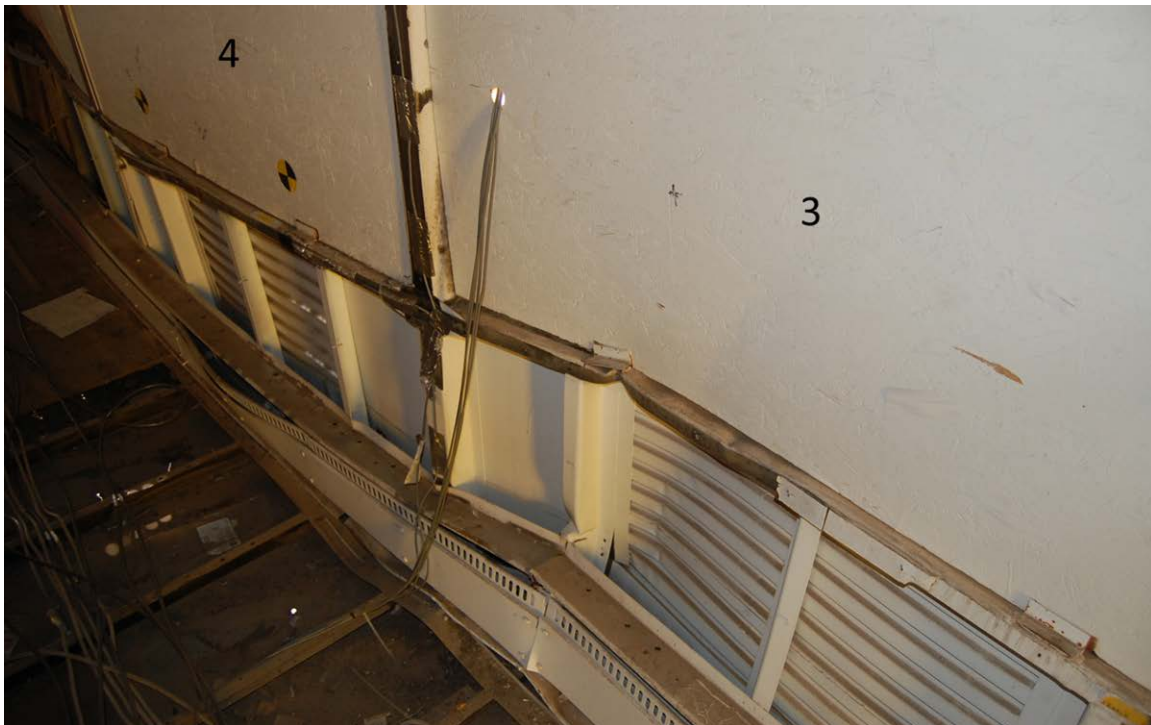
**Figure 65. Damage to Left Side Interior of Car 244**

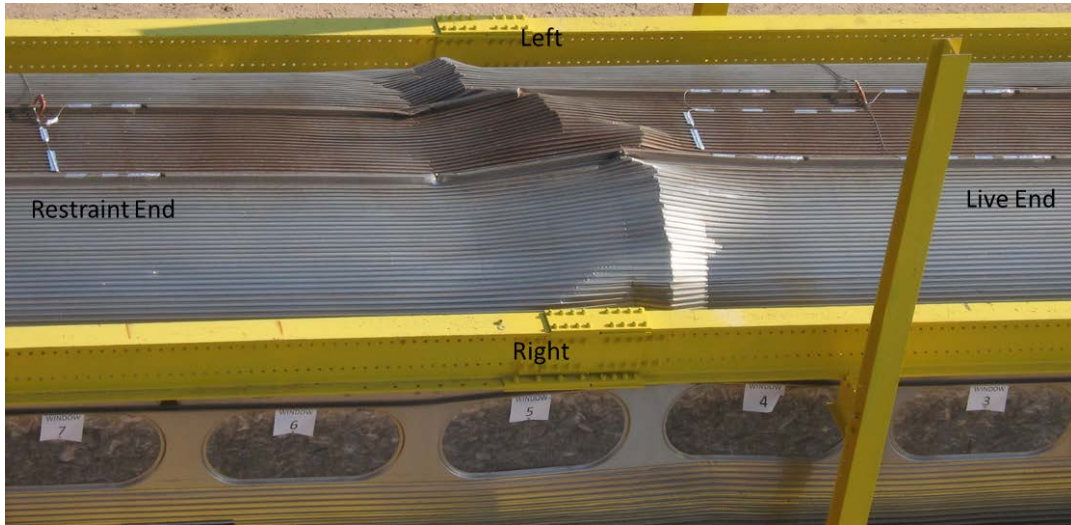
**Figure 66. Roof Buckle in Car 244**

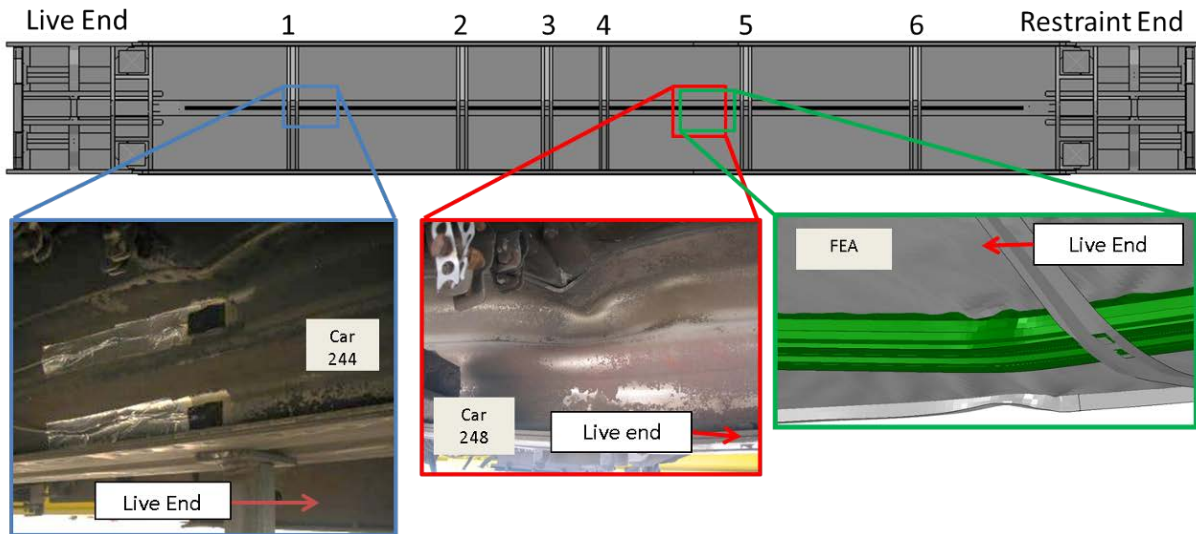
**Figure 80. Center Sill Upper Flange Buckle in Car 244, Car 248, and FEA Result**
