***Federal Railroad Administration
Office of Safety
Headquarters Assigned
Accident Investigation Report
HQ-2011-34***

***BNSF Railway Company (BNSF)
Great Falls, MT
July 19, 2011***

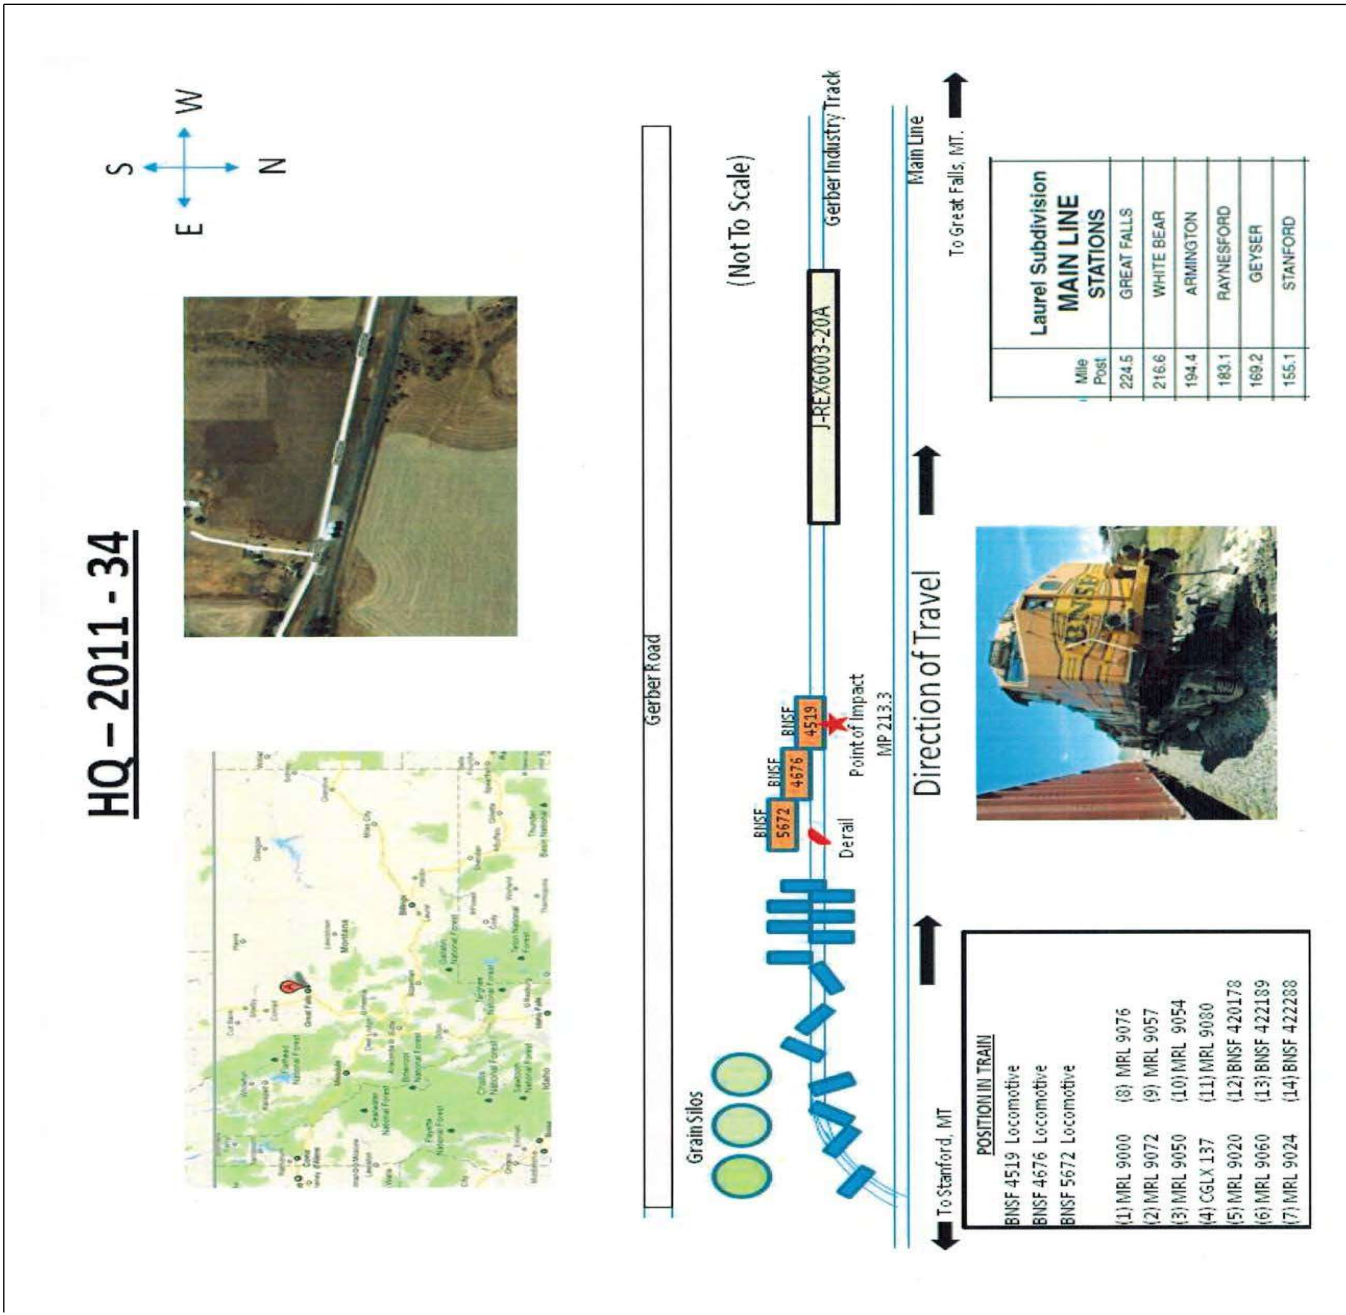
136. DRAW A SKETCH OF ACCIDENT AREA INCLUDING ALL TRACKS, SIGNALS, SWITCHES, STRUCTURES, OBJECTS, ETC., INVOLVED.

On July 19, 2011, at approximately 9:20 p.m. (MDT) northbound BNSF Railway Company freight train M-LAUSHM1-18 collided with the rear end of standing, unoccupied, contract Maintenance Of Way (MOW) train J-REX6003-20A. The collision occurred, at milepost 213.3, on the BNSF's Montana Division, Laurel Subdivision, at Gerber, Montana (MT). Gerber is located, in Cascade County, approximately 10 miles geographically southeast of Great Falls, MT. The MOW train had been tied-up, by its crew, earlier that day on the Gerber Industrial Run-Around Track, and the crew had failed to restore the south switch to its normal position. The switch was lined for movement into the run-around track; rather than for movement on the main track.

The probable cause of this accident/incident was the failure of the EIC to restore the south switch, of the Gerber Industrial Run-Around Track, to its normal position for movement on the main track rather than for movement into the siding (FRA Accident/Incident Cause Code H702).
