***Federal Railroad Administration
Office of Safety
Headquarters Assigned
Accident Investigation Report
HQ-2012-21***

***BNSF Railway Company (BNSF)
Mesa, WA
July 2, 2012***

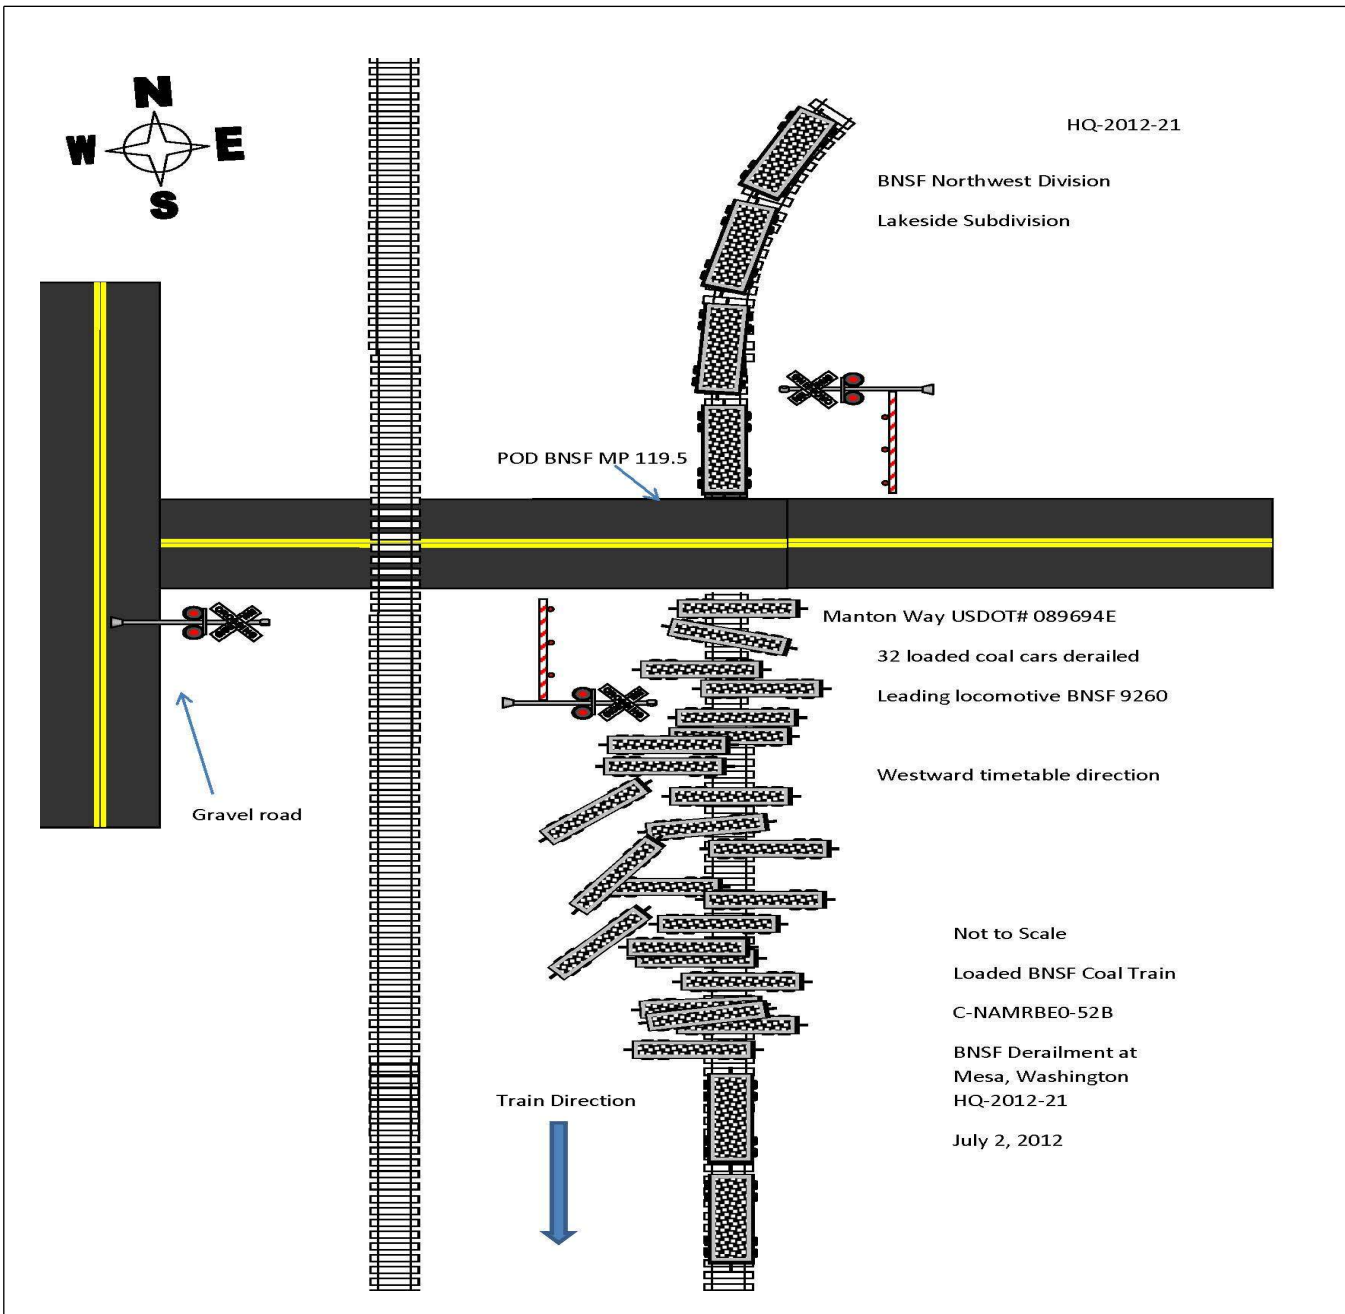
136. DRAW A SKETCH OF ACCIDENT AREA INCLUDING ALL TRACKS, SIGNALS, SWITCHES, STRUCTURES, OBJECTS, ETC., INVOLVED.

The investigation revealed that the lead locomotives and the first 62 loaded coal cars traversed over the irregular track alignment and remained on the track. The 63rd rail car then derailed at the misalignment location which had quickly accelerated into a severe a track buckle under the impact of the loaded coal train. This action caused the following railcars (63rd through 94th) to also derail resulting in the cars rolling onto their sides, spilling their coal, and piling up west of the grade crossing. The point of derailment was noted on the grade crossing where car wheels derailed into both the gage and field side of the track and continued to be pulled for another 900 feet before the train came to a stop.

A field track inspection of the accident site identified a couple concrete ties at the track buckle as being deteriorated and worn more than 50% of their thickness on the underside. The defective ties were obvious and evident by the white discoloration on the track caused by concrete dust and scaling from excessive wear and deteriorating crossties. Inspection of the bottom of the adjacent concrete ties revealed that the other concrete ties were not as severely worn down resulting in an uneven and unstable contact between the base of the ties and the top of the subgrade. This unstableness in the track resulted in a floating track structure and was evident by the vertical pumping and lateral movement indentation marks at the outer edge of the ties approaching the crossing. Also noted were 1 inch longitudinal scratch marks on the top of the base of the rail made by the McKay rail clip fasteners a resulting in a longitudinal movement of the CWR westward towards and against the crossing.
