OFFICE OF RESEARCH & DEVELOPMENT

2012 R&D REVIEW

Rail Seat Abrasion

Federal Railroad
Administration

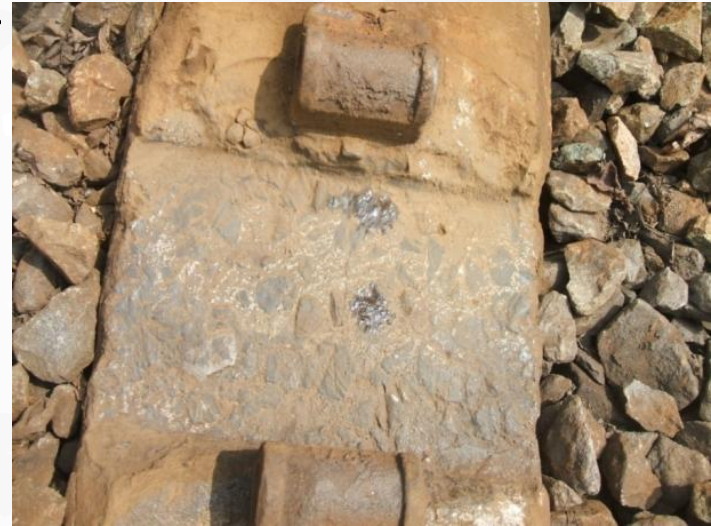
- Rail Seat Abrasion (RSA) is loss of material in the rail seat on concrete ties.
 - Loss of clip preload
 - Loss of proper rail cant
 - Gage widening

- Working Theory: Deep, wedge shaped abrasion can be caused by severe track geometry deviations. These deviations cause wheel rail forces that produce high stresses in the rail seat.

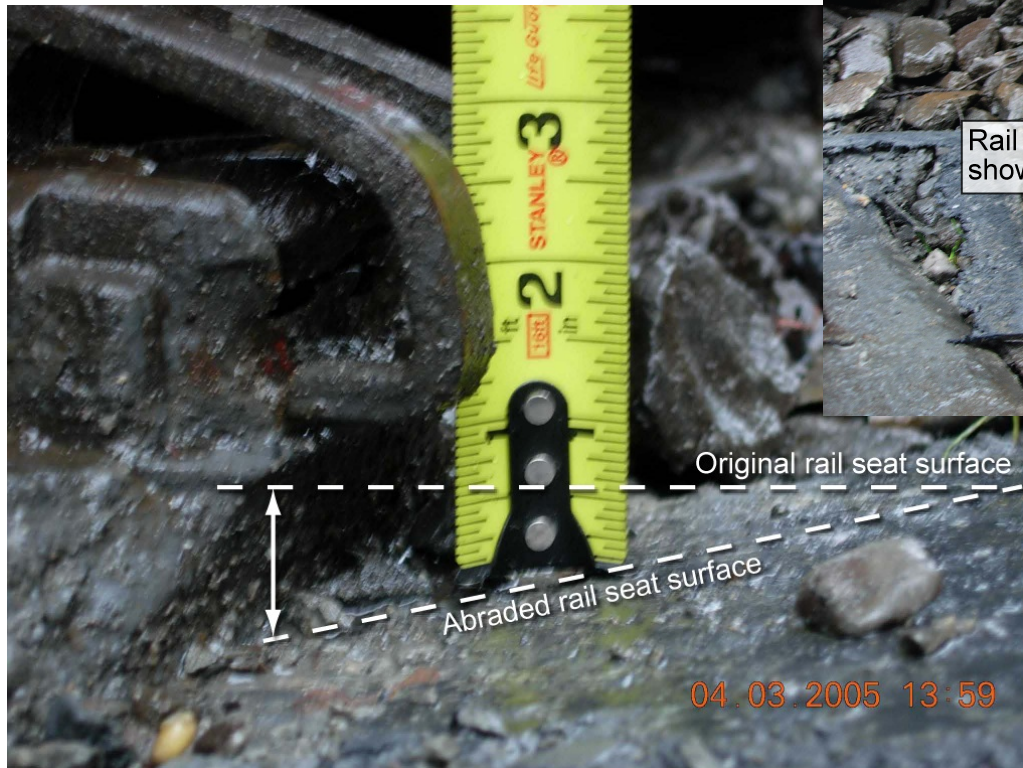
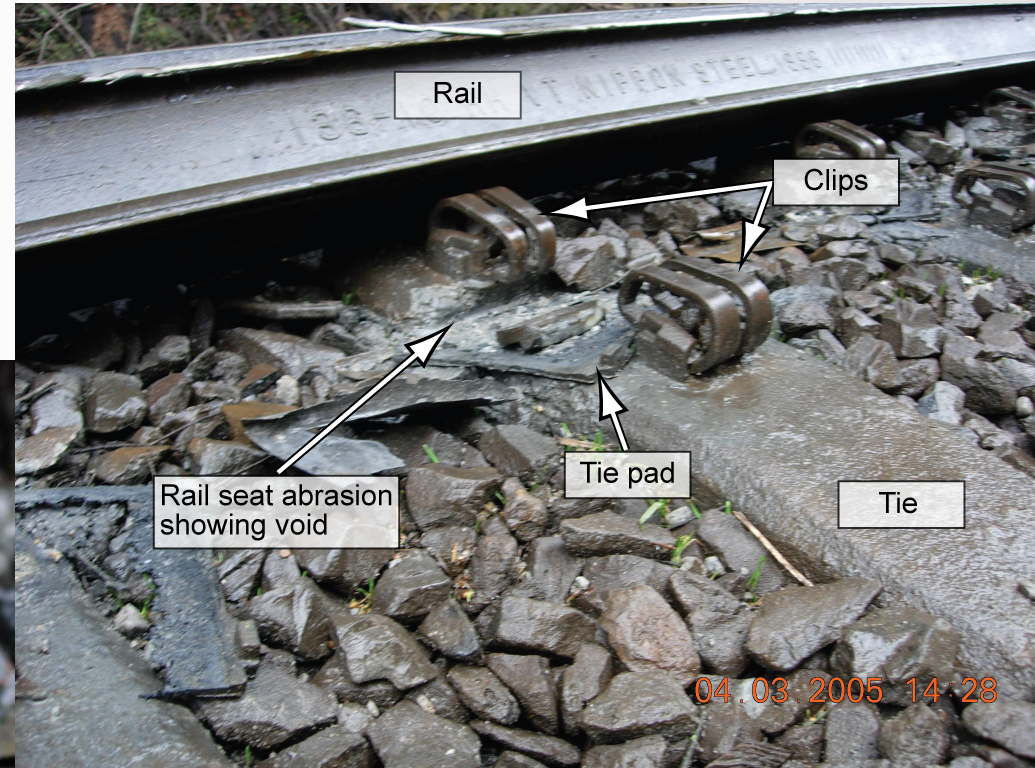
- Home Valley, Washington, Derailment
- Sprague, Washington, Derailment
- "...attributed to excessive concrete crosstie abrasion, which allowed the outer rail to rotate outward and create a wide gage track condition."

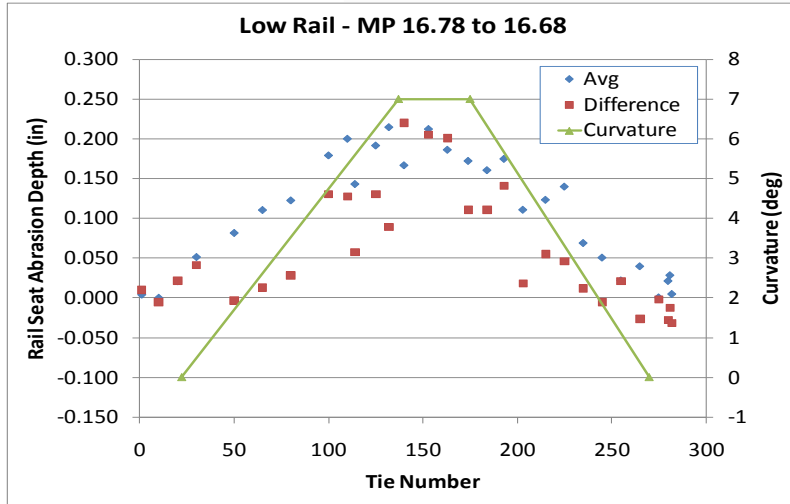
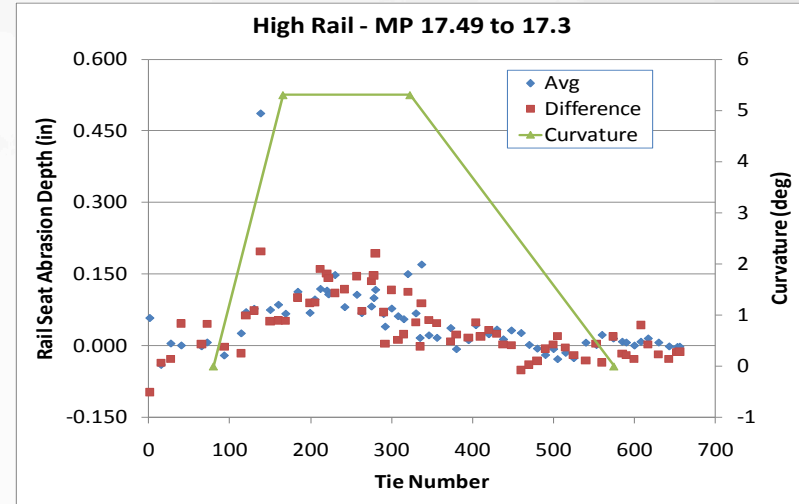
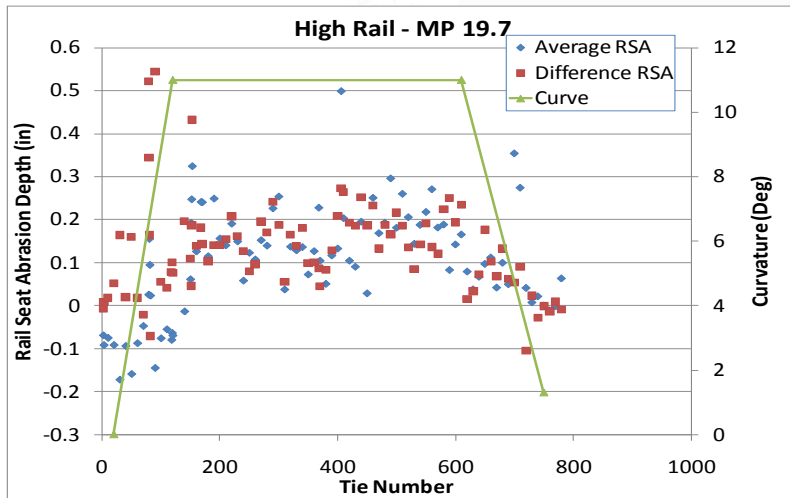
Results: CSX – significant abrasion

- These 3 curves were measured with manual gage
- An automatic system used initially had much more scatter than manual gage
 - See first 208 ties of 19.7

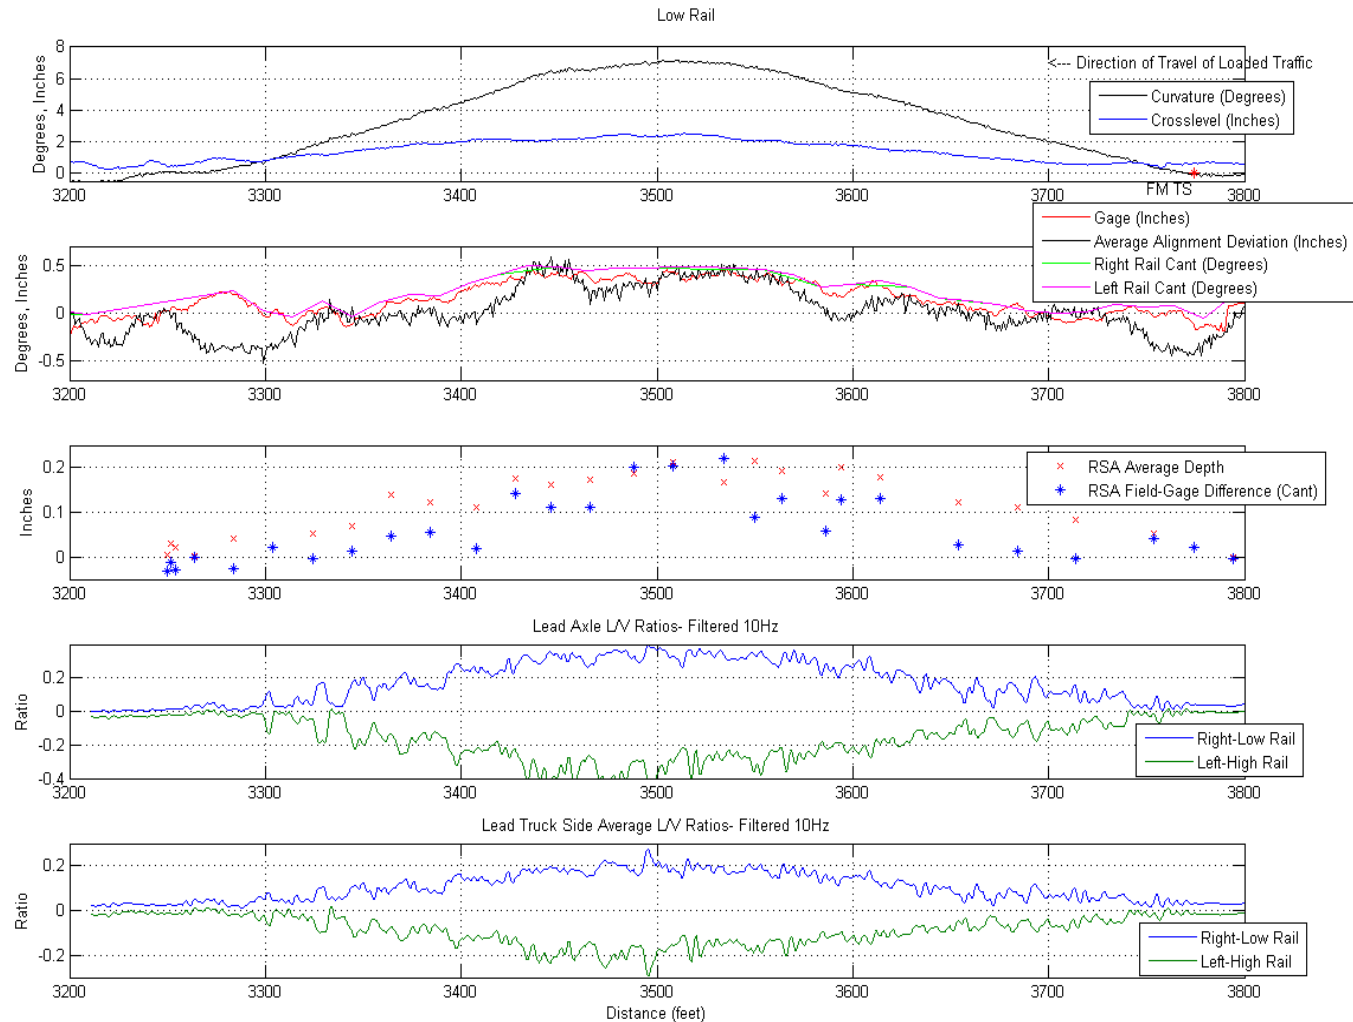
Results – CSX MP16

- Sample results for the CSX site. Curve at MP16 on the Coal River Subdivision near St. Albans, WV
- Simulation L/V results generally match the pattern of abrasion
- No distinct peaks in track geometry, lateral force or abrasion to indicate localized geometry induced abrasion

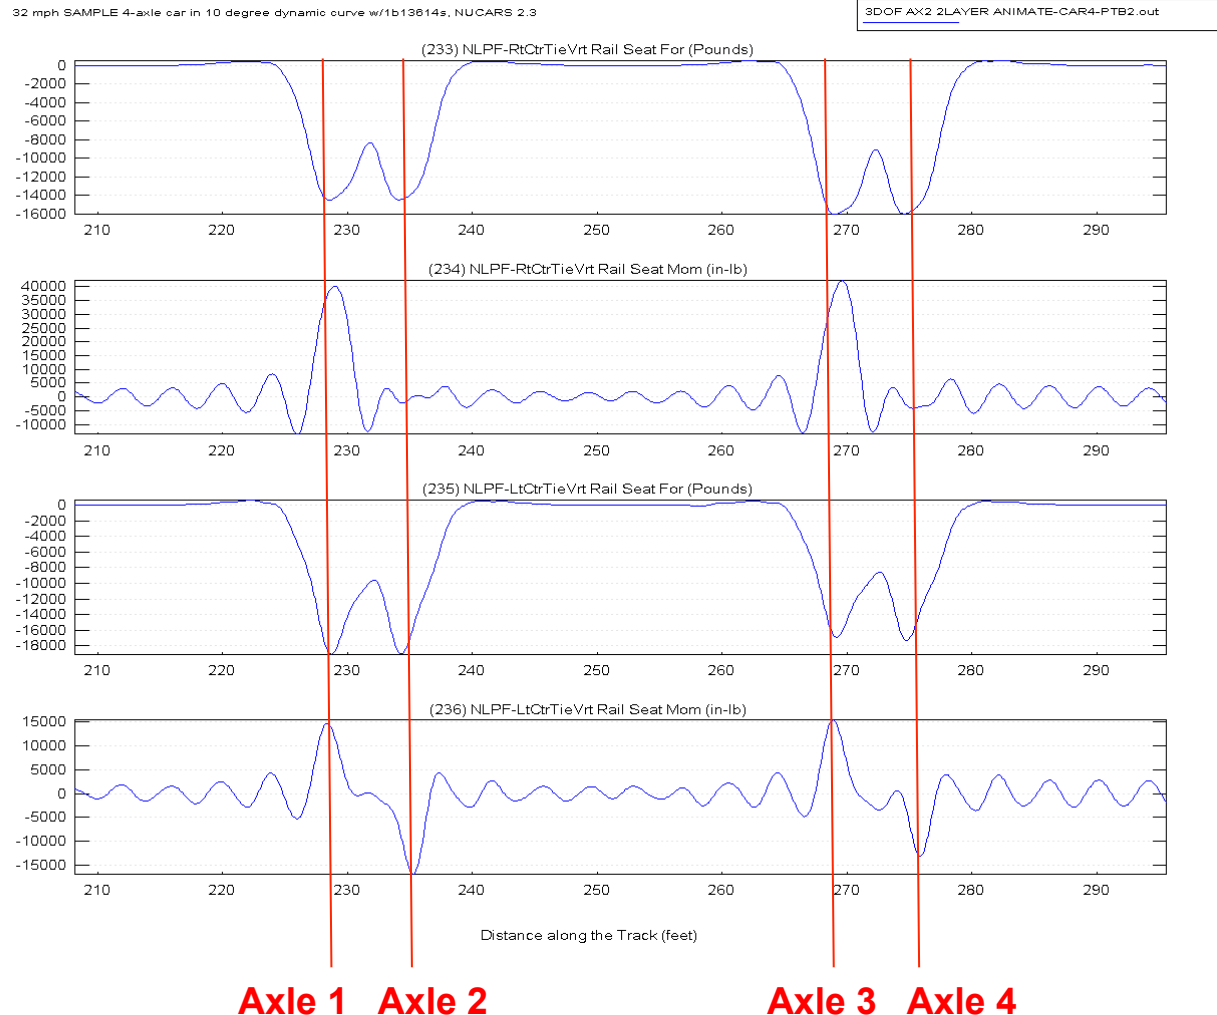
- Simulation data shows the load and moment between the rail and crosstie as the axles of a car pass over it.
- Negative forces indicate compression of the rail seat. Positive moments are toward the field side.
- These forces are for a tie in the entry spiral

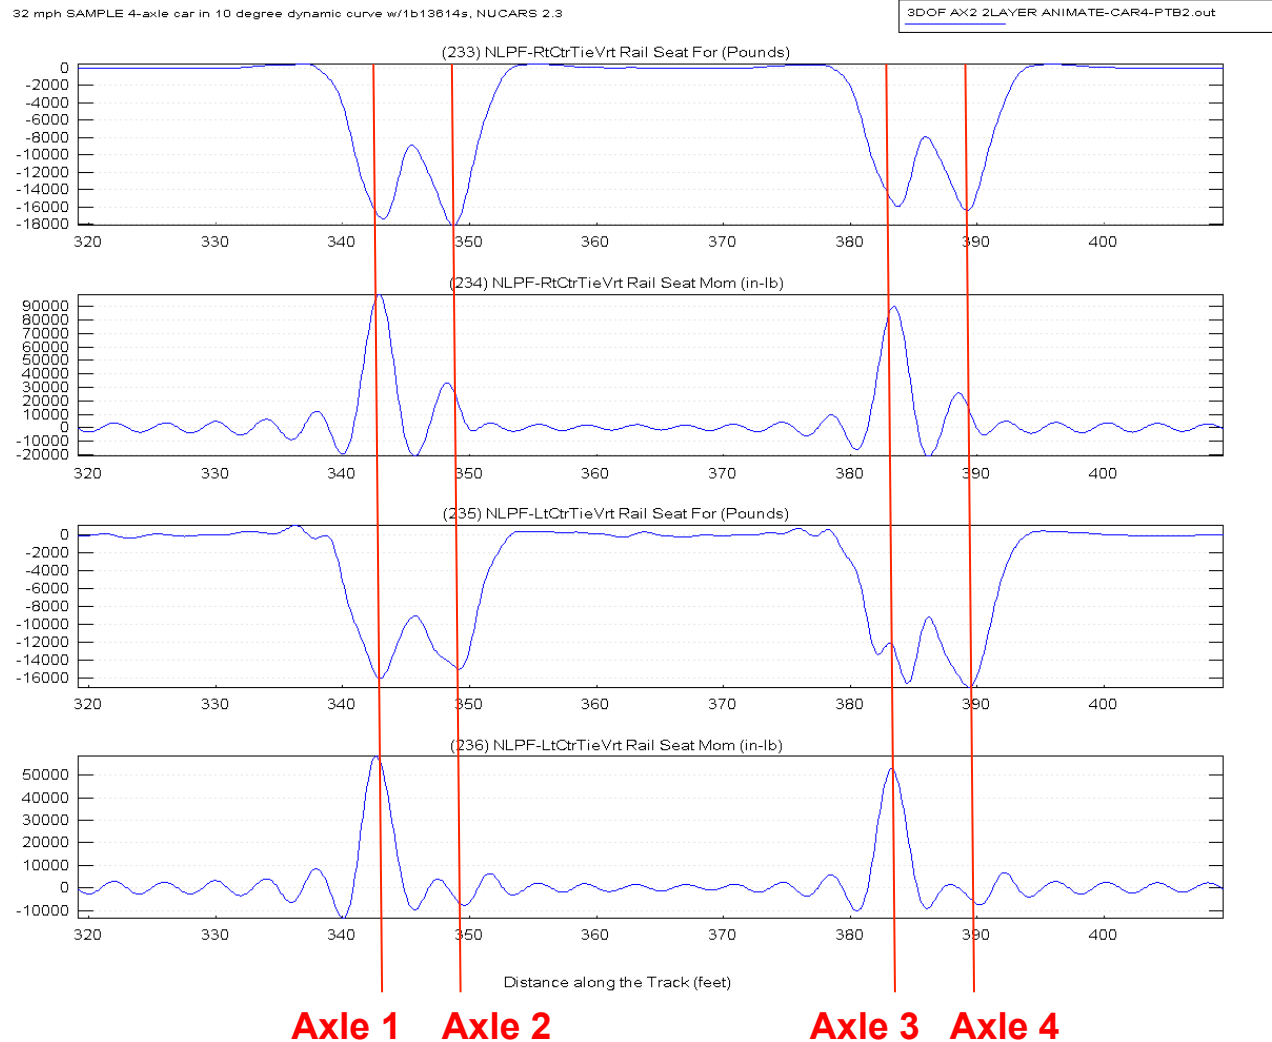
- These forces are for the exit spiral in the simulation.
- Note that at this location both axles of a truck cause positive moments on the rail seat.

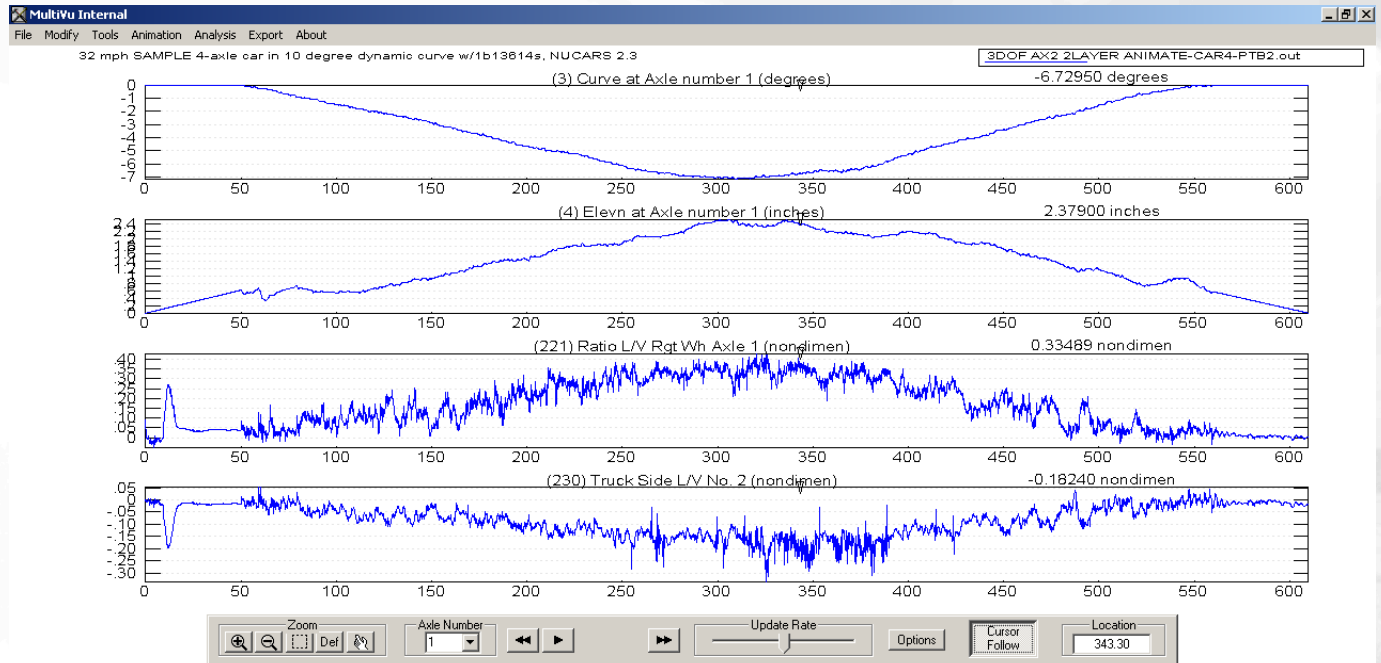
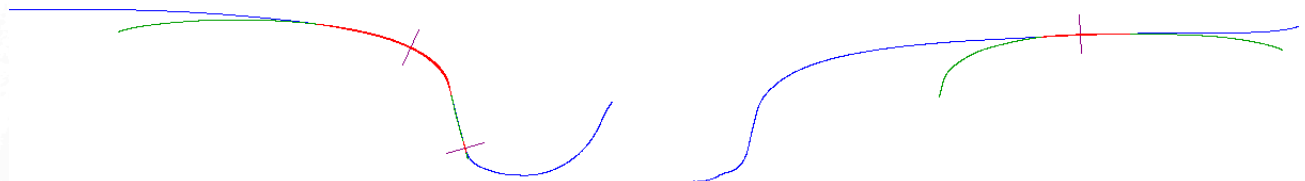
- Wheel-rail contact condition on axle 1
- Contact in the flange root and a second point of contact at the flange tip.

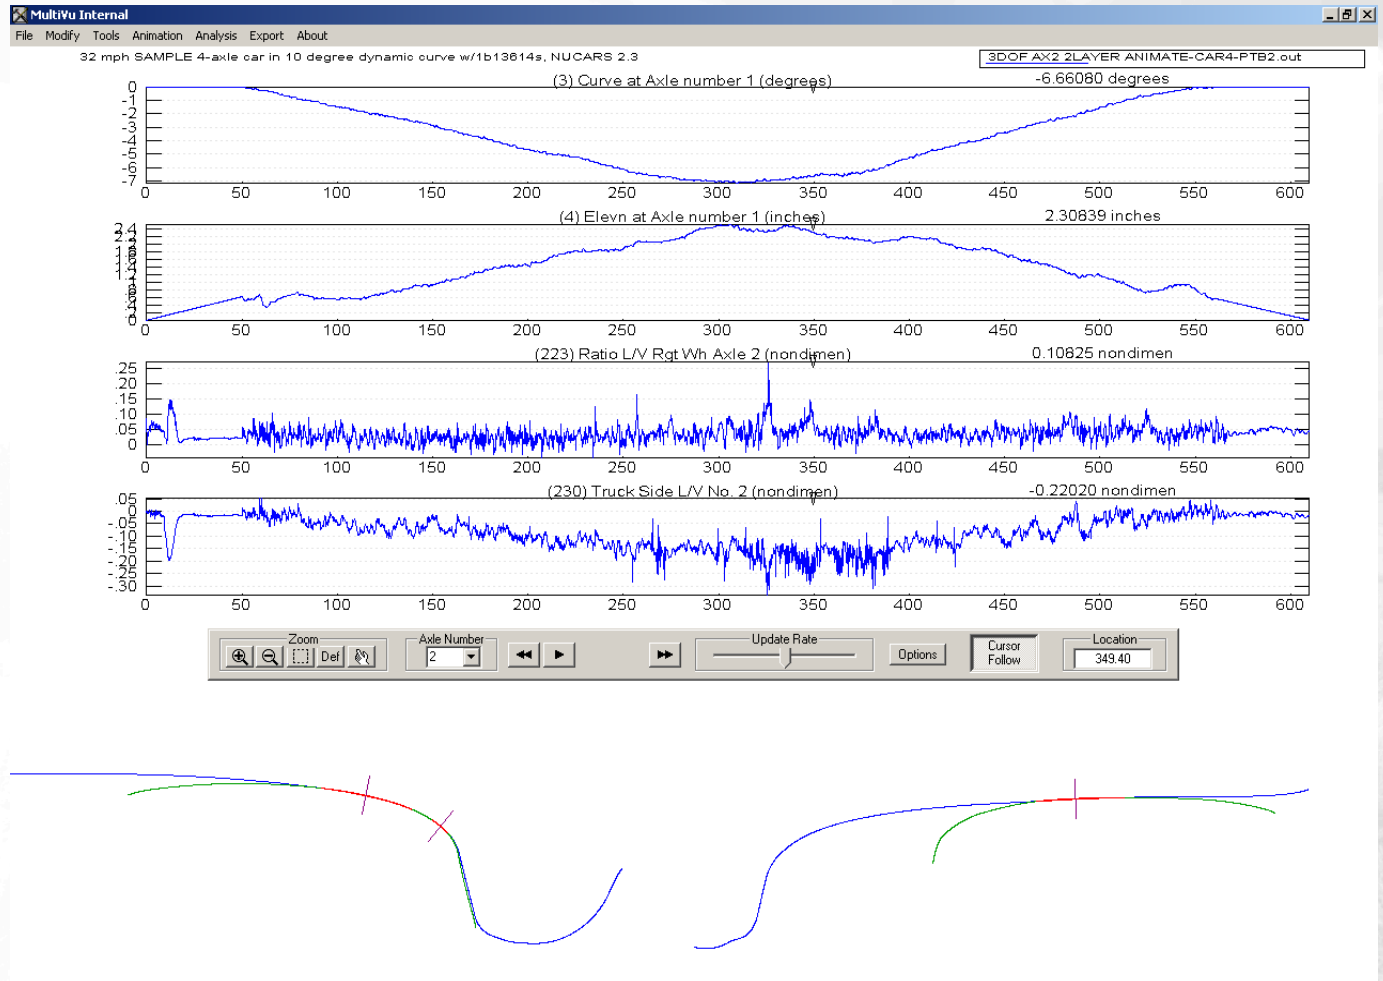
- Wheel-rail contact condition on axle 2
- Contact is only in the flange root.
- The location of the contact points affects the moment transferred to the rail seat.

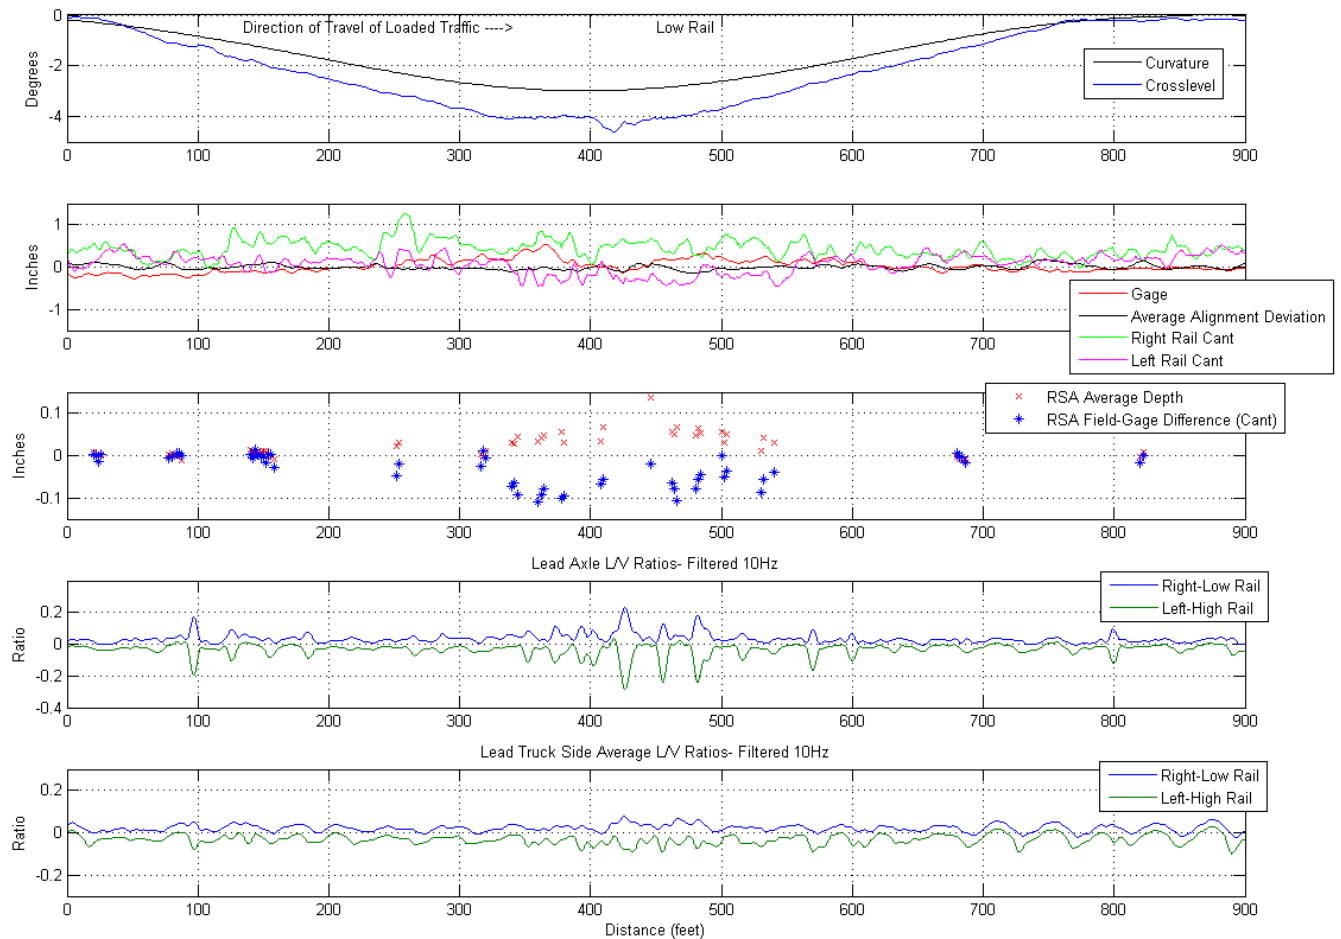
Results – BNSF Needles MP584

- Sample results for the only BNSF site with significant abrasion. Curve at MP584 near Needles.
- Simulation L/V results much lower than CSX but generally match the pattern of abrasion
- No distinct peaks in track geometry, lateral force or abrasion to indicate localized geometry induced abrasion

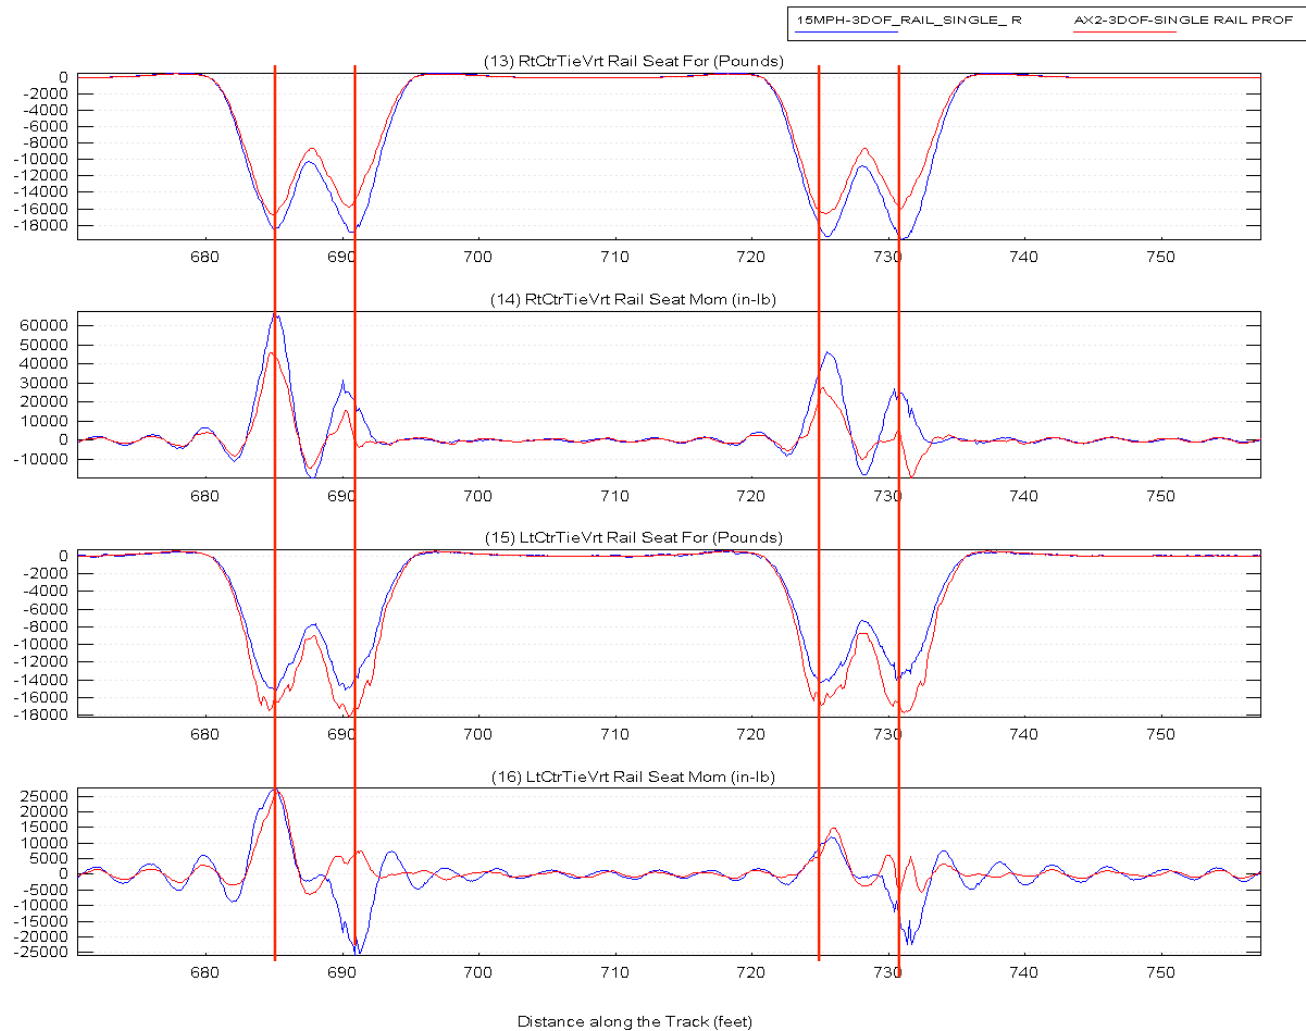
Effect of speed on rail seat forces

- East and west bound traffic at site have two distinct operational speeds at site:
 - Red = 50 mph
 - Blue = 15 mph
- Simulation is for 4-axle 100 ton loaded freight car. General traffic at site is mixed, including large amount of intermodal multi-platform cars, with smaller amount of heavy haul.

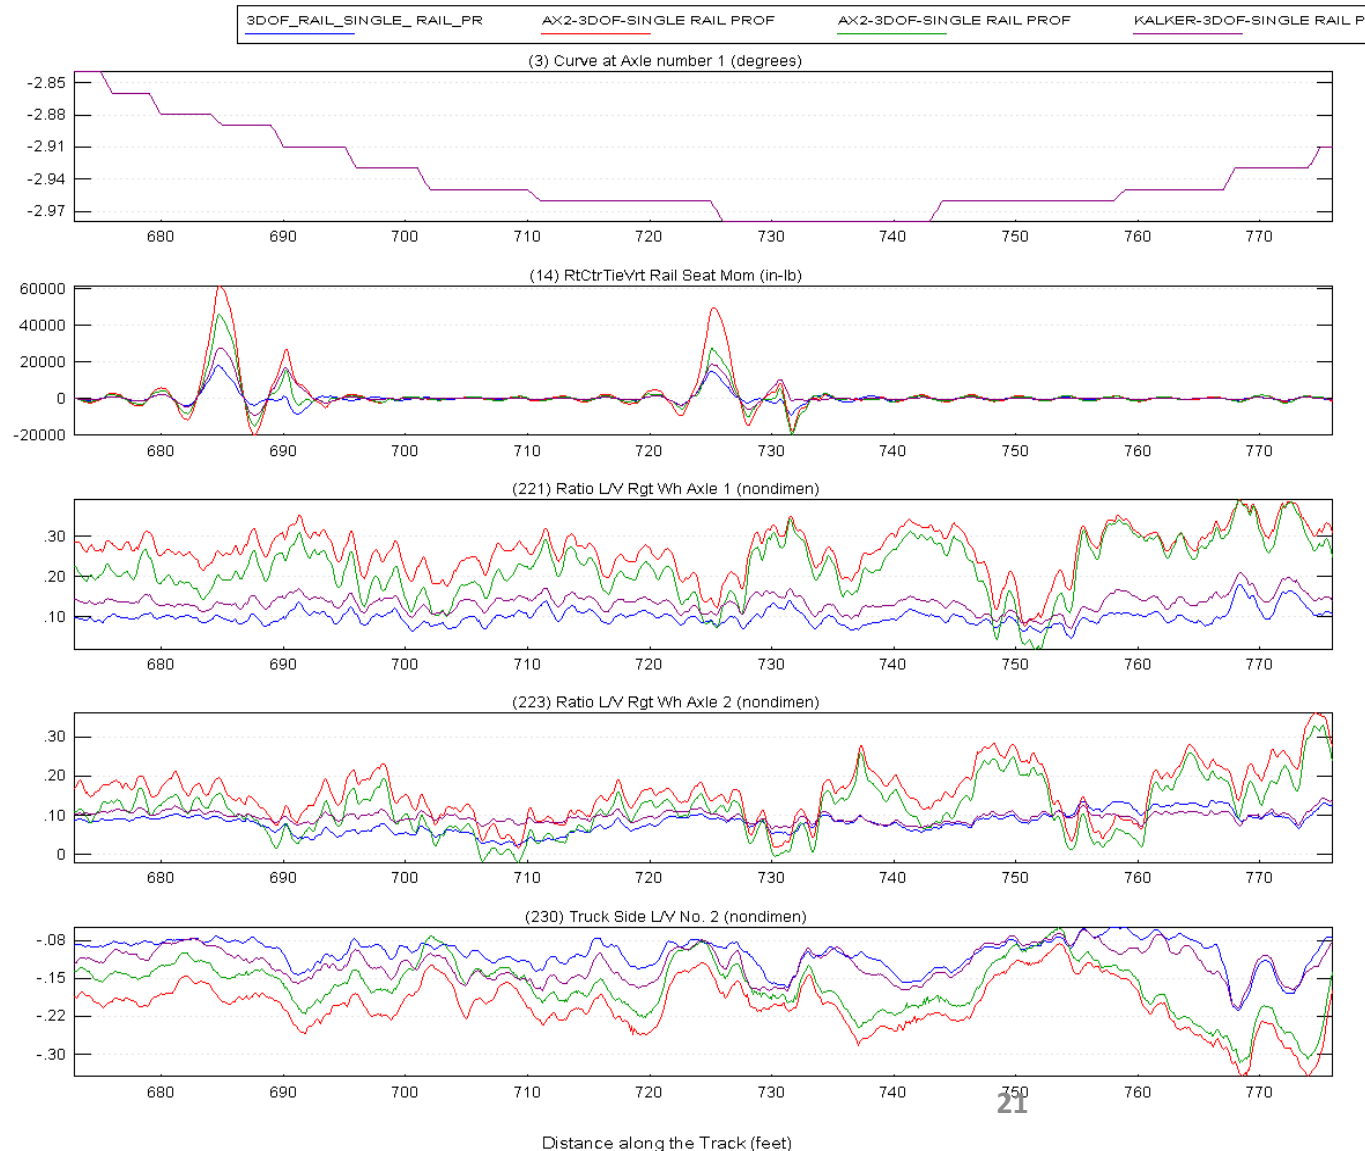
Effect of W/R friction on simulation results

Evidence of lubrication found at site. However friction coefficient and type of lubricant was not measured.
