***Federal Railroad Administration
Office of Safety
Headquarters Assigned
Accident Investigation Report
HQ-2010-08***

***CSX Transportation (CSX)
Providence, VA
February 15, 2010***

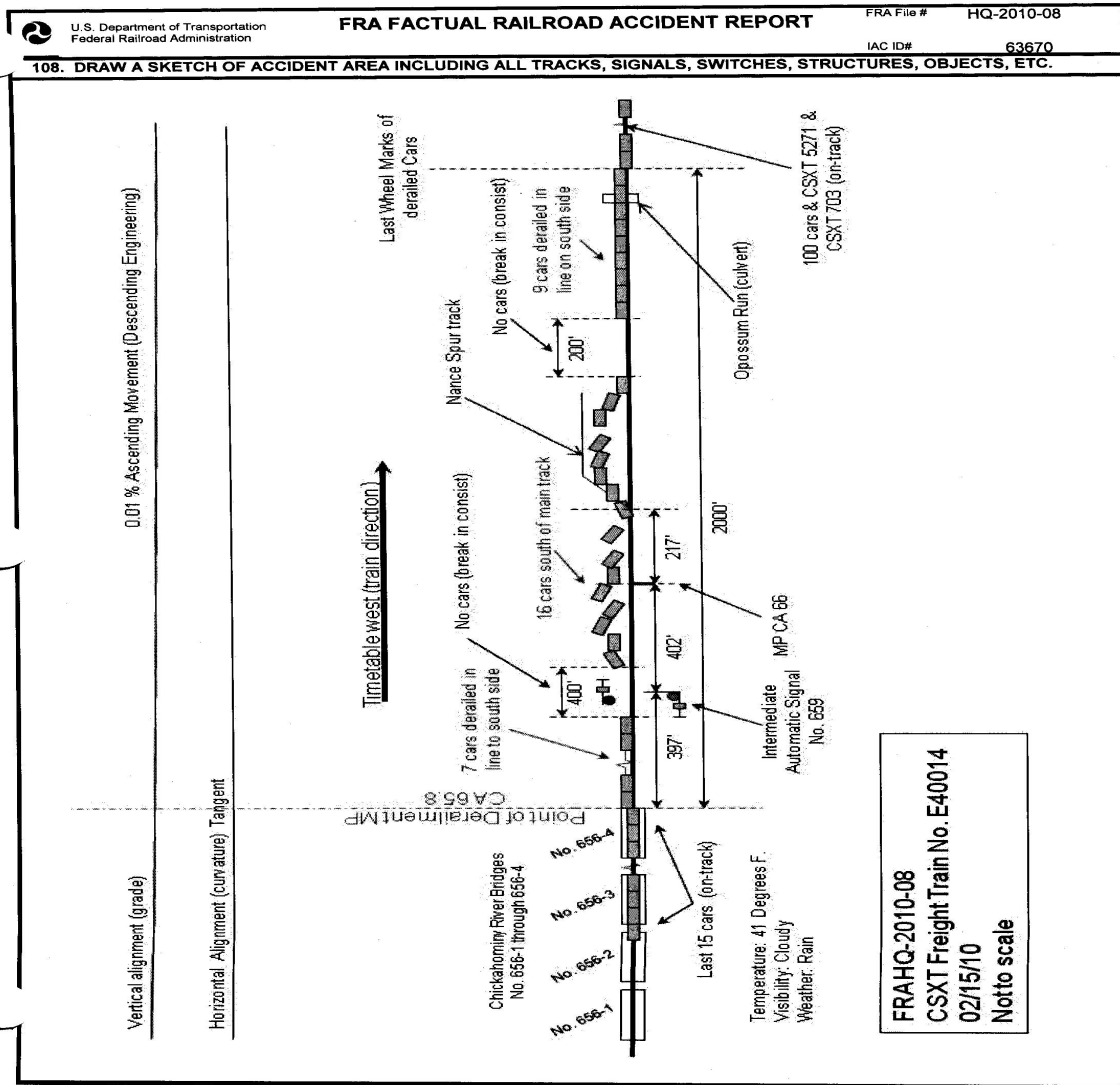
136. DRAW A SKETCH OF ACCIDENT AREA INCLUDING ALL TRACKS, SIGNALS, SWITCHES, STRUCTURES, OBJECTS, ETC., INVOLVED.

The probable cause of this accident was a broken rail joint in continuous welded rail (CWR) joint at the west abutment of the Chickahomony River Bridge # 656-4.
