***Federal Railroad Administration
Office of Safety
Headquarters Assigned
Accident Investigation Report
HQ-2010-10***

***Burlington Northern Santa Fe (BNSF)
Keene, CA
February 20, 2010***

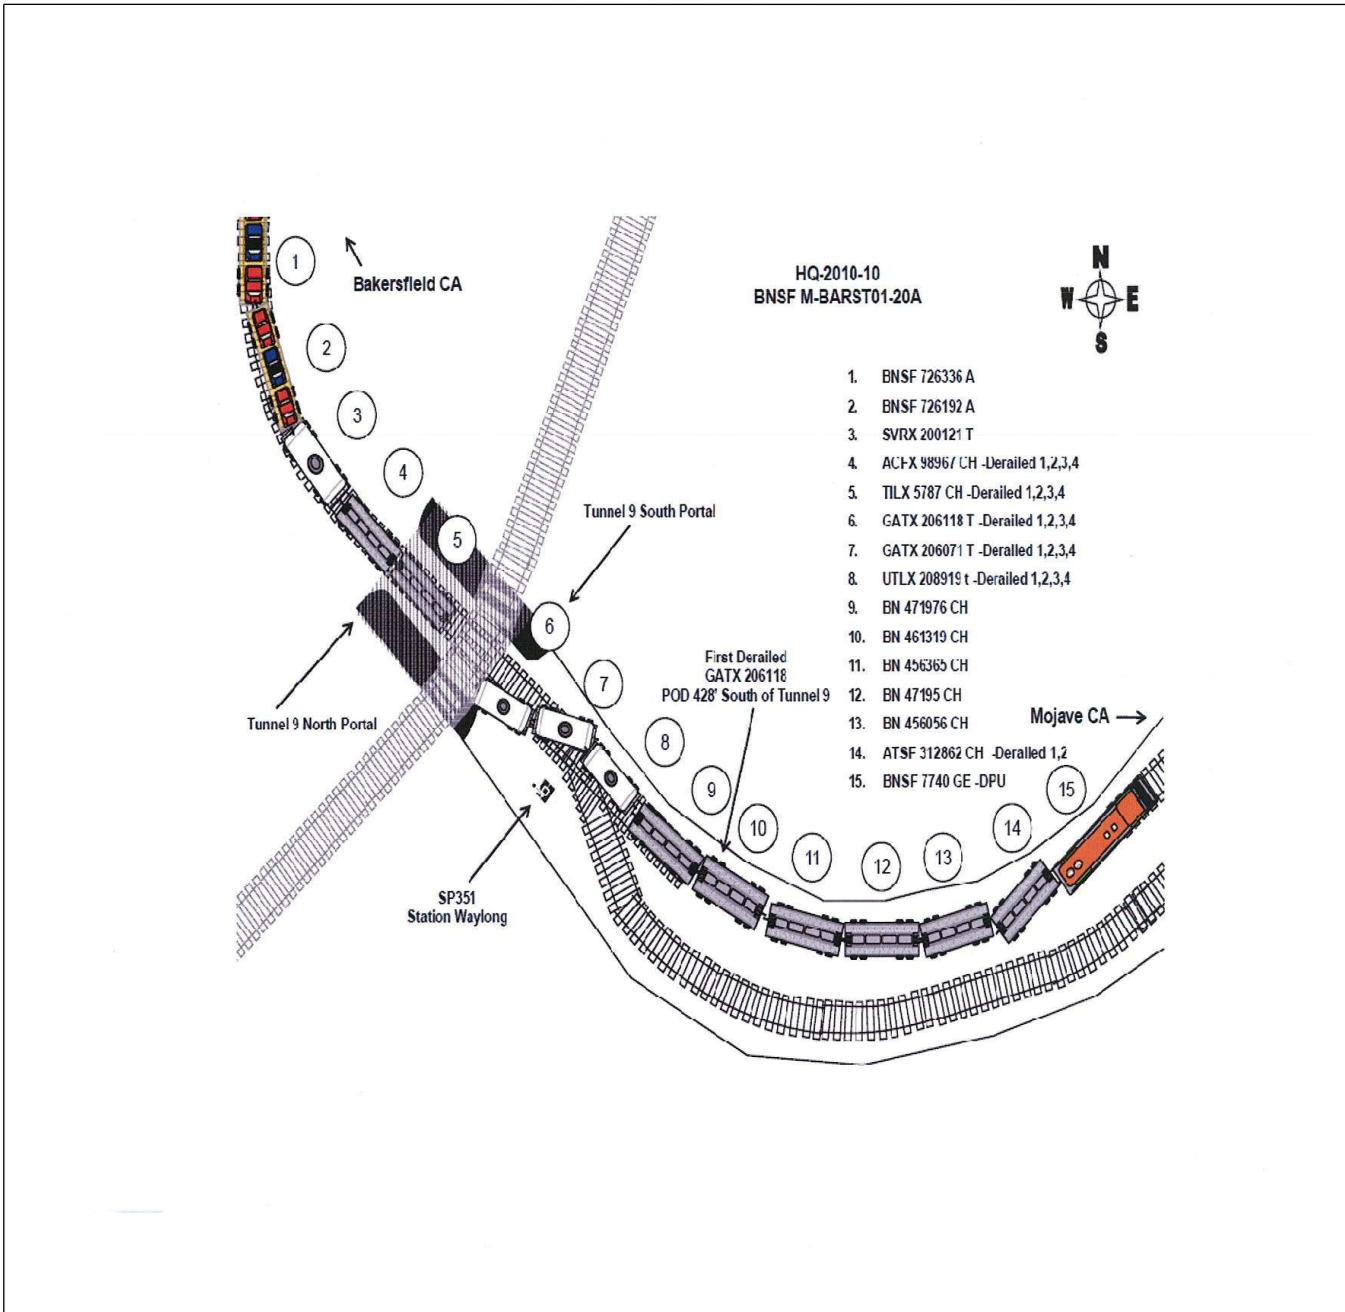
136. DRAW A SKETCH OF ACCIDENT AREA INCLUDING ALL TRACKS, SIGNALS, SWITCHES, STRUCTURES, OBJECTS, ETC., INVOLVED.

The derailment occurred at MP 351.17 in the body of a 10-degree right hand curve where the 56th car from the front of the train derailed; the car, identified as GATX 206118, was transporting Alcohol, N.O.S. The car traveled on the field side of the rail 495 feet while still coupled into the train before impacting the southwest portal of Tunnel 9. The impact caused the train to separate between cars listed as lines 55 and 56 on the train consist. Upon impacting the south portal, the alcohol tank was breached, caught fire, and released approximately 28,500 gallons of product. The fire spread through the tunnel and ignited two hopper cars containing dry corn kernels and plastics. An additional three cars derailed. The derailed cars were listed on the consist as lines 54 through 58 and line 64. The 64th car derailed the rear set of trucks and sustained no damage. After it was re-railed the BNSF removed it along with the unaffected portion of the train back to Bakersfield. This was completed prior to FRA's arrival at the scene.
