***Federal Railroad Administration
Office of Safety
Headquarters Assigned
Accident Investigation Report
HQ-2009-07***

***Union Pacific (UP)
Plaquemines, LA
March 7, 2009***

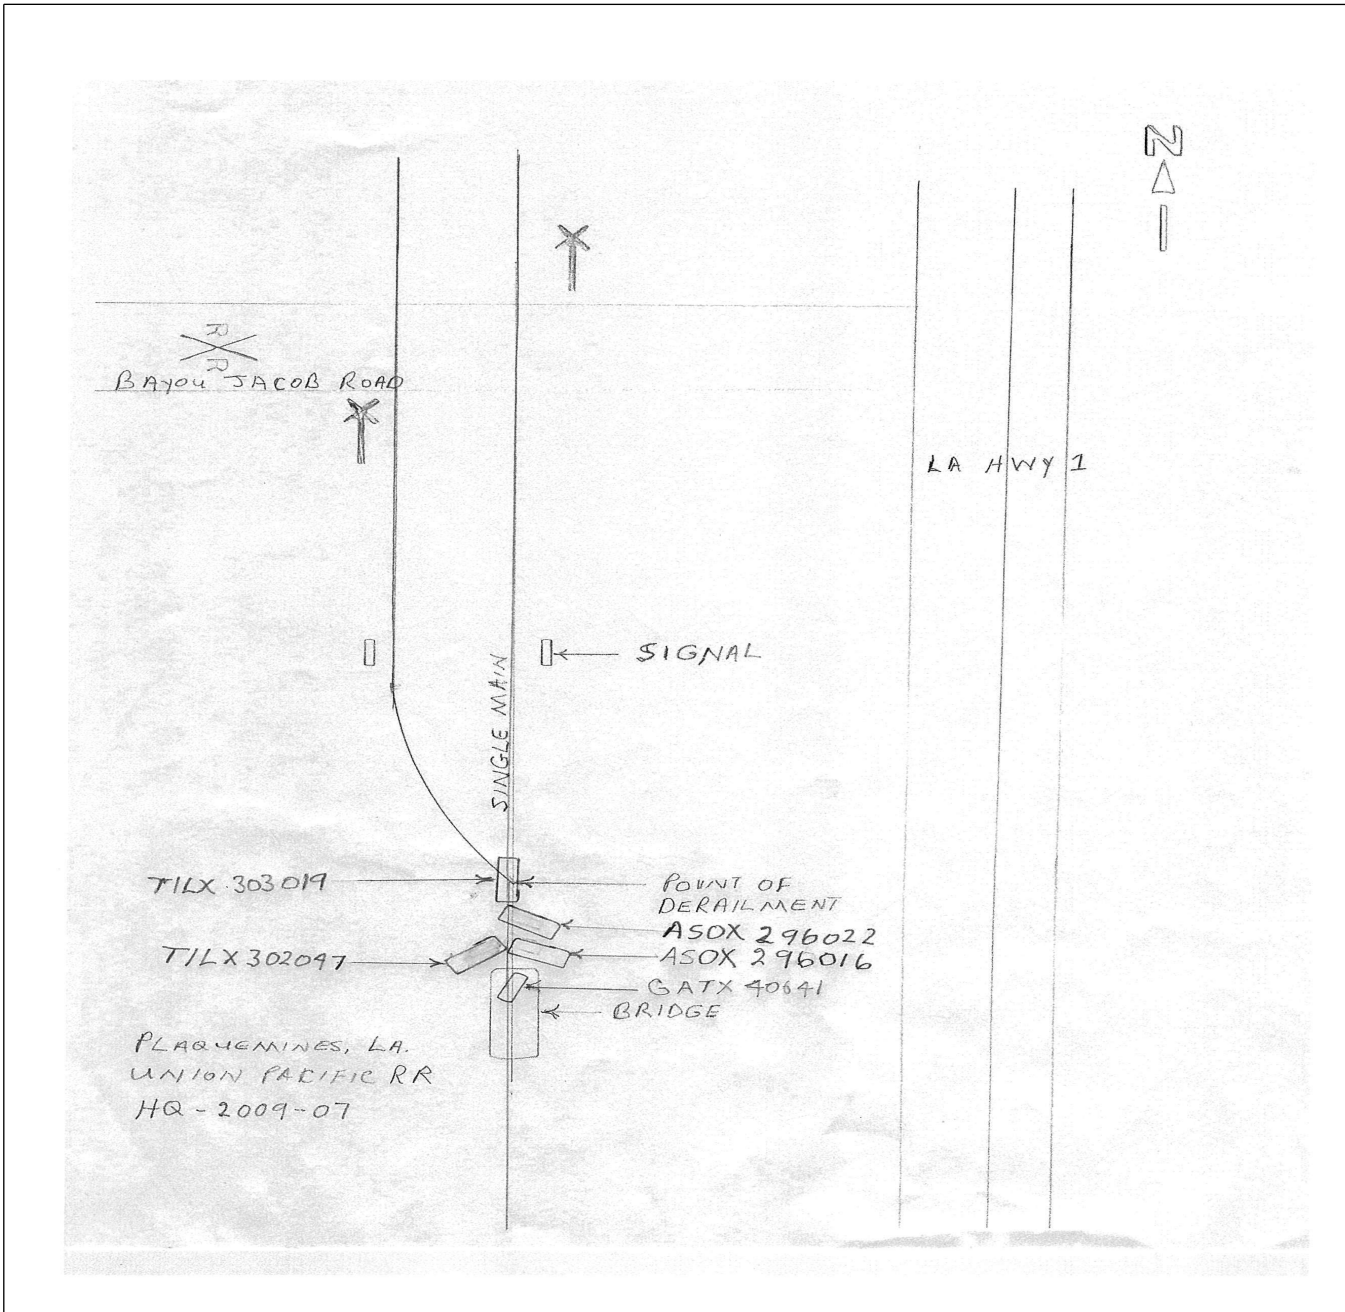
136. DRAW A SKETCH OF ACCIDENT AREA INCLUDING ALL TRACKS, SIGNALS, SWITCHES, STRUCTURES, OBJECTS, ETC., INVOLVED.

Southward UP mix freight train LLL66-06 departing Livonia Yard derailed five hazardous material cars at milepost 85.5 on the Livonia Subdivision in Plaquemine, Louisiana, at 4:45 a.m. CST on March 7, 2009. The train had two locomotives (UP 2260 in lead and UP 2483) with 7 loaded rail cars and 50 empty rail cars consisting 2,285 tons and was 3,448 feet including engines length.

Approaching the accident site from the north, the railroad track is tangent for 1,700 feet to the point of derailment and 300 feet beyond. The grade is practically level.

The track was last inspected on March 5, 2009 with no defects discovered. The investigation of the derailment determined that the initial point of the derailment was at milepost 85.5 near the south siding track access switch. No exceptions were taken by the Union Pacific Railroad Manager of Track maintenance at this location.
