***Federal Railroad Administration
Office of Safety
Headquarters Assigned
Accident Investigation Report
HQ-2009-44***

***Burlington Northern Santa Fe (BNSF)
St. Louis, MO
September 28, 2009***

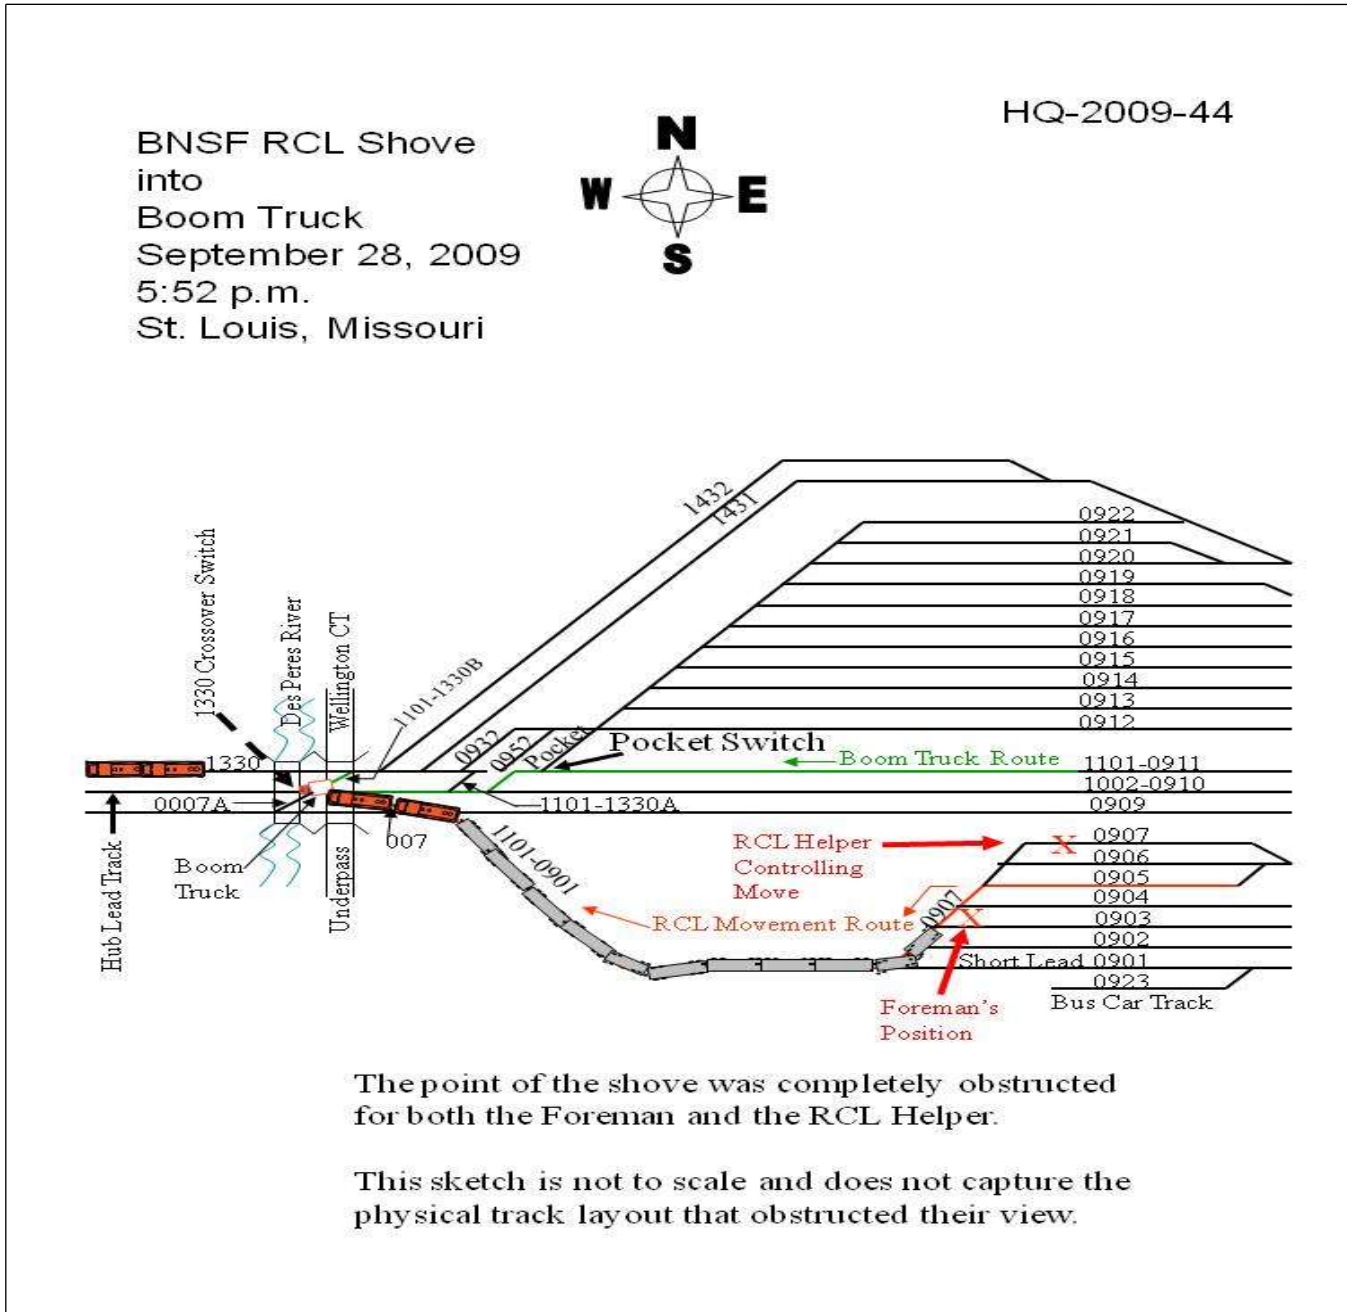
136. DRAW A SKETCH OF ACCIDENT AREA INCLUDING ALL TRACKS, SIGNALS, SWITCHES, STRUCTURES, OBJECTS, ETC., INVOLVED.

At 5:52 p.m. on September 28, 2009 a westbound Burlington Northern Santa Fe (BNSF) remote controlled locomotive (RCL) switcher consisting of 2 locomotives and 23 cars (9 container cars) struck the rear of an eastbound BNSF maintenance-of-way (MOW) boom truck. The boom truck had backed eastward and was occupying the area of track extending between the switch points and the frog of the lead switch giving access to Track # 1330. There were two men seated in the front seat of the vehicle and a third man standing on the passenger side running board. The RCL movement was proceeding west at 10 mph on the Yard Lead Track when it impacted the rear of the truck. Upon impact the third man was thrown clear. The truck was then shoved 510 feet west into two stored locomotives on an adjacent track north of the lead. The boom of the truck raked the side of the two stored locomotives. It then wedged between the locomotives causing both to derail. The second locomotive became uncoupled from the first. The boom truck and second locomotive were shoved an additional 188 feet before the RCL finally stopped shoving.

There are no RCL Zones established in this yard. In spite of that fact, the westbound RCL shoving movement was being controlled by the remote control operator (RCO) helper, who could not see the point. He was using a vest-mounted remote control transmitter and was standing on the ground near the east end of the cut. He was told by his foreman via radio that the track was clear. The foreman's view of the point of the shove was also obstructed.

The cause of the accident is FRA Code H306 - Shoving movement, absence of man on or at leading end of movement.
