***Federal Railroad Administration
Office of Safety
Headquarters Assigned
Accident Investigation Report
HQ-2008-03***

***Norfolk Southern Corporation (NS)
Torrance, PA
January 4, 2008***

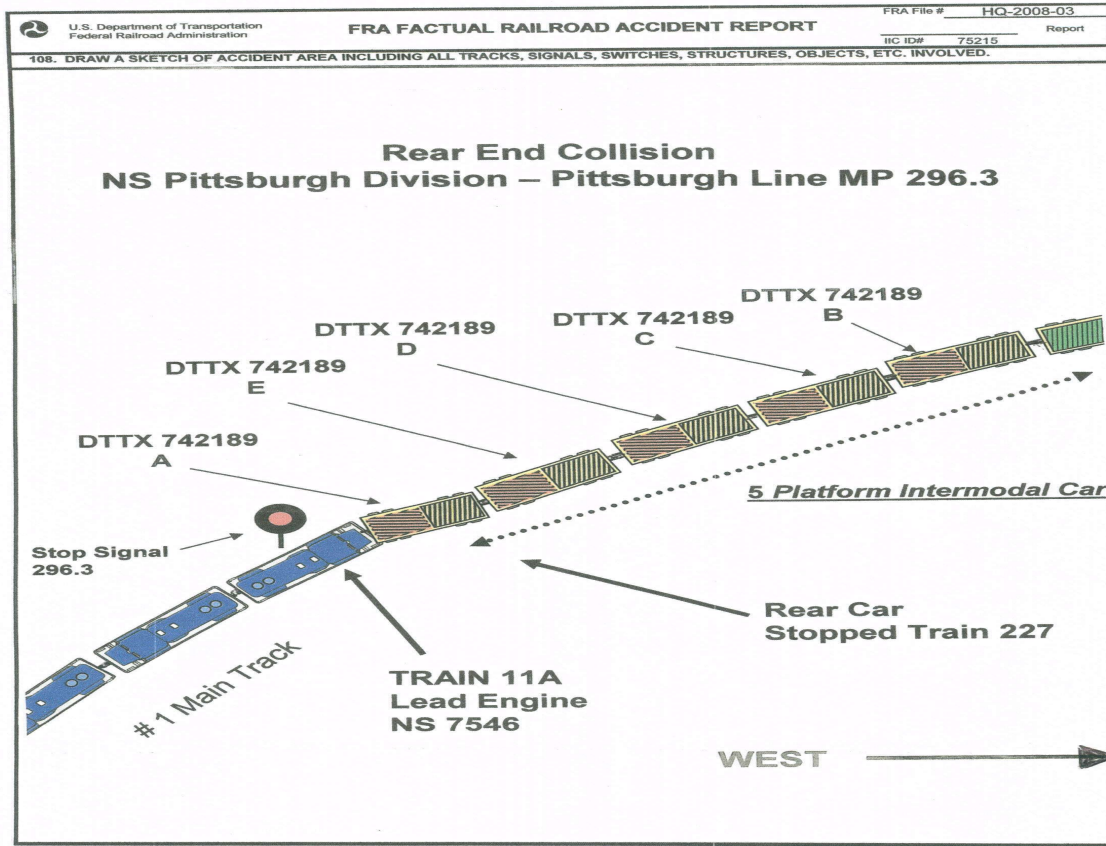
136. DRAW A SKETCH OF ACCIDENT AREA INCLUDING ALL TRACKS, SIGNALS, SWITCHES, STRUCTURES, OBJECTS, ETC., INVOLVED.

Westbound Norfolk Southern (NS) freight train 227C1-02, with assisting helper locomotives, collided with the rear of stopped NS train 11AC2-04. The rear end collision impact derailed the last car of the stopped train and the lead locomotive of the moving train. The rear end collision occurred at 12:30 pm EST, January 4, 2008 in a remote mountainous area of Pennsylvania between the communities of Bolivar and Torrance on the NS Pittsburgh Line at Milepost (MP) 296.3 in Westmoreland County.

The collision occurred in the full body of a 2 degree right hand curve with the super elevation measuring 2 1/2
