***Federal Railroad Administration
Office of Safety
Headquarters Assigned
Accident Investigation Report
HQ-2008-06***

***Burlington Northern Santa Fe (BNSF)
Augusta, KS
January 12, 2008***

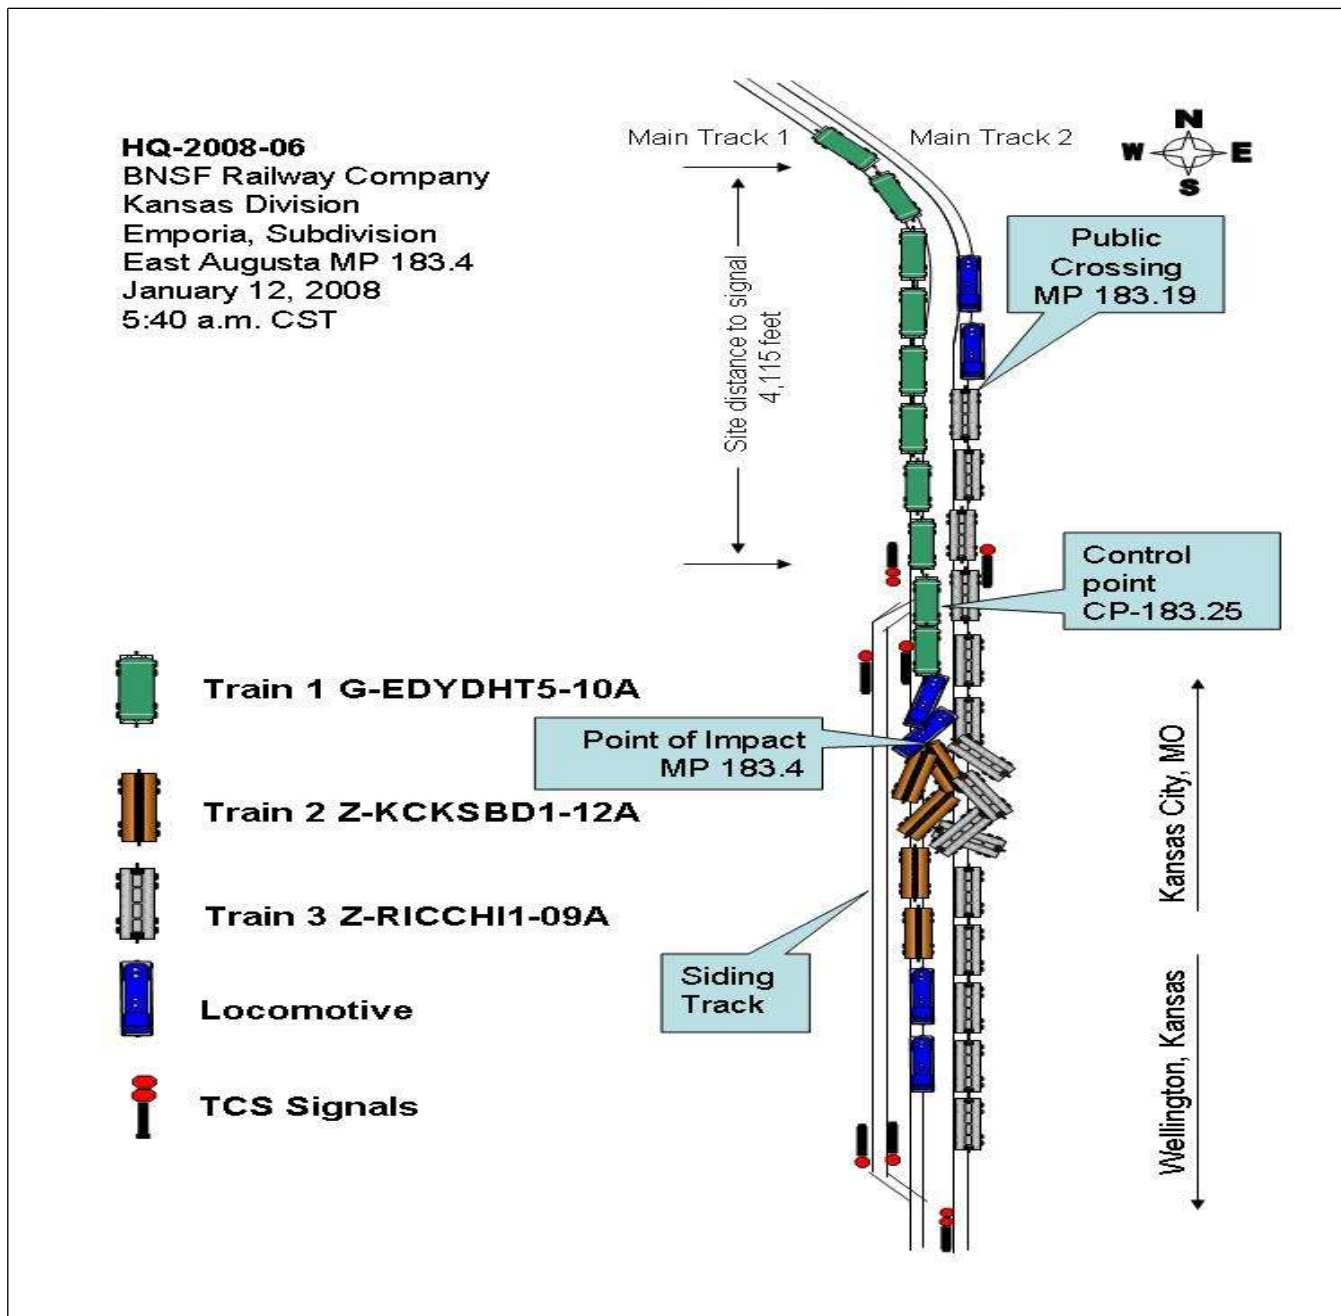
136. DRAW A SKETCH OF ACCIDENT AREA INCLUDING ALL TRACKS, SIGNALS, SWITCHES, STRUCTURES, OBJECTS, ETC., INVOLVED.

On January 12, 2008, at 5:40 a.m. CST, westbound Burlington Northern Santa Fe Railway Company (BNSF) freight Train G-EDYDHT5-10 collided with the rear end of westbound BNSF freight Train Z-KCKSBD1-12, which subsequently resulted in the derailment of eastbound BNSF freight Train Symbol Z-RICCH1-09. The accident occurred on the east edge of Augusta, Kansas at BNSF Milepost 183.4 on the BNSF Emporia Subdivision.

The accident was caused by the failure of westbound BNSF Freight Train G-EDYDHT5-10 to stop at a signal displaying a stop indication at BNSF Milepost (MP) 183.25.
