***Federal Railroad Administration
Office of Safety
Headquarters Assigned
Accident Investigation Report
HQ-2008-08***

***Burlington Northern Santa Fe (BNSF)
Melrose, IA
January 15, 2008***

Report No. HQ 2008-08
BNSF Railway Company
January 15, 2008

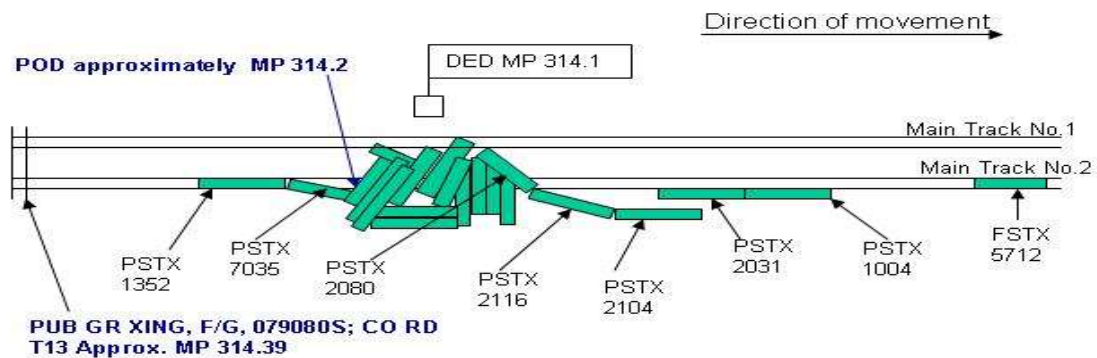
Note: Diagram not to scale.

Sketch based on photographs provided to FRA by BNSF and Iowa State Track Inspector.

Equipment had been moved from its derailed position before Federal Railroad Administration (FRA) inspectors arrived at the scene and BNSF did not provide a sketch. This sketch is based on photographs provided by BNSF and an Iowa State track inspector. FRA was unable to accurately represent all the car numbers and actual placement of the derailed equipment.
