***Federal Railroad Administration
Office of Safety
Headquarters Assigned
Accident Investigation Report
HQ-2008-35***

***Long Island Railroad (LIR)
Jamaica, NY
March 27, 2008***

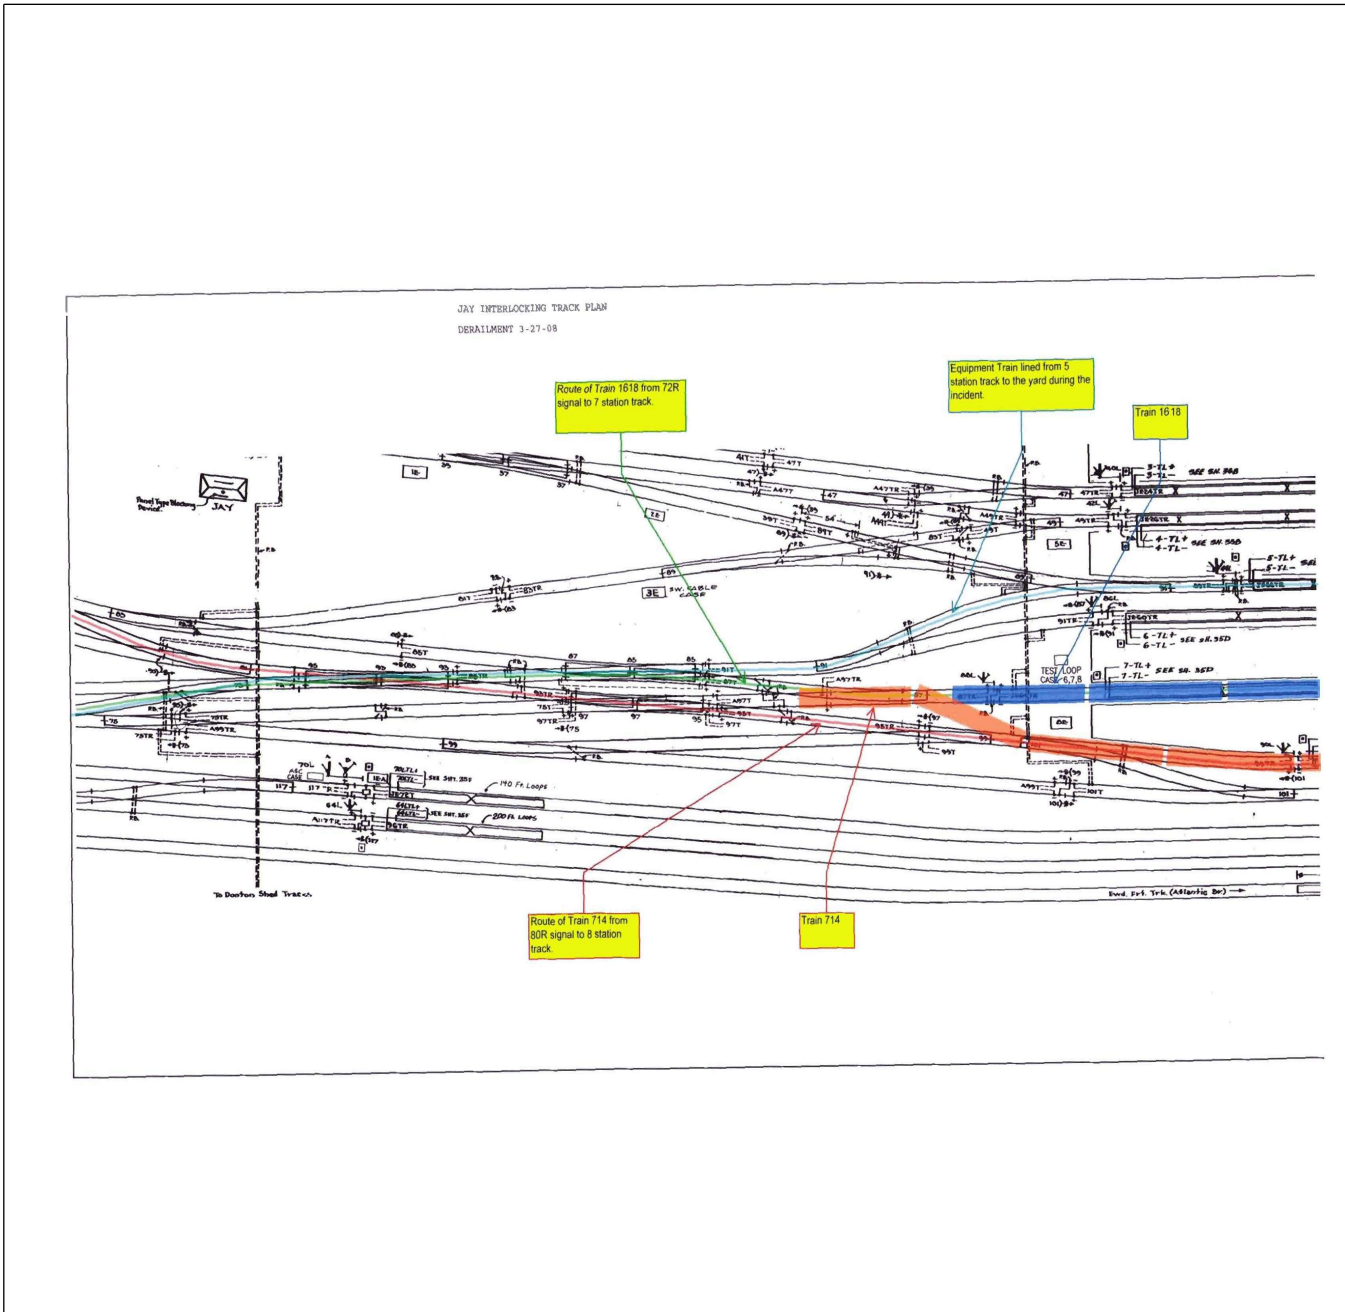
136. DRAW A SKETCH OF ACCIDENT AREA INCLUDING ALL TRACKS, SIGNALS, SWITCHES, STRUCTURES, OBJECTS, ETC., INVOLVED.

The second truck of the fifth car (7628) of train LIRR Commuter Train # 714 derailed north off Track # 8 and swung into the twelfth car (7773) of LIRR Commuter Train # 1618. The entire car then derailed but remained upright.

The Long Island Rail Road Signal Department conducted an investigation into the derailment. The investigation determined that LIRR Commuter Train # 714 was still in route when switches # 93, # 95, and # 97 were thrown normal under the train. These three switches were trailed through by LIRR Commuter Train # 714 and there were wheel markings over the frog area of # 97 switch indicating that passenger car # 7628 of LIRR Commuter Train # 714 derailed over the movable point frog of # 97 switch. All three switches would have been thrown normal for the next move requested by the train director, Five Station Track to the Hump Yard.

Signal policy dictates that when work is being performed on a new installation the battery and common buss are opened at the end of the day to prevent an undesirable feed from a buss back to the existing, working equipment. However, this policy actually contributed to the cause of the derailment. When the data log was analyzed it was determined that four indication wires were left closed at the end of the previous day. Additionally, the common energy buss was left open as per signal standards. This combination caused a back-feed of energy from the New Jay to the existing Jay Interlocking. Battery traveled through one of the indication wires, through the opened common buss, and back through the other indication wires. This back feed of energy caused the # 93TM and # 97TM relays to energize, thereby releasing the route locking circuits under LIRR Commuter Train # 714. When the lever-man for Jay Tower observed the apron light illuminate, he immediately threw the three switches needed for the next move. LIRR Commuter Train # 714 was not clear of the switches, and derailed over the # 97 switch.

The derailment was caused by the back feed of energy from the New Jay to the existing Jay Interlocking. This undesired energy caused the track repeaters to energize under the wheels of LIRR Commuter Train # 714, thereby releasing the route lock circuit, allowing the switches to be thrown under the train. LIRR Commuter Train # 714 derailed over the facing point of Switch # 97. Although the signal department followed normal signal procedures, the opening of the common buss in the New Jay Interlocking contributed to the cause of the derailment.

When the derailment occurred the Long Island Signal Department halted all testing on the New Jay pending resolution of the derailment. They hired a consultant to assist in formulating procedures which would allow for the continuation of testing in the safest manner possible. Together they comprised a list of recommendations to implement and allow for safe testing. On July 7, 2008 the Long Island Rail Road continued testing New Jay with these recommendations in force.
