***Federal Railroad Administration
Office of Safety
Headquarters Assigned
Accident Investigation Report
HQ-2008-49***

***CSX Transportation (CSX)
Gladstone, VA
May 27, 2008***

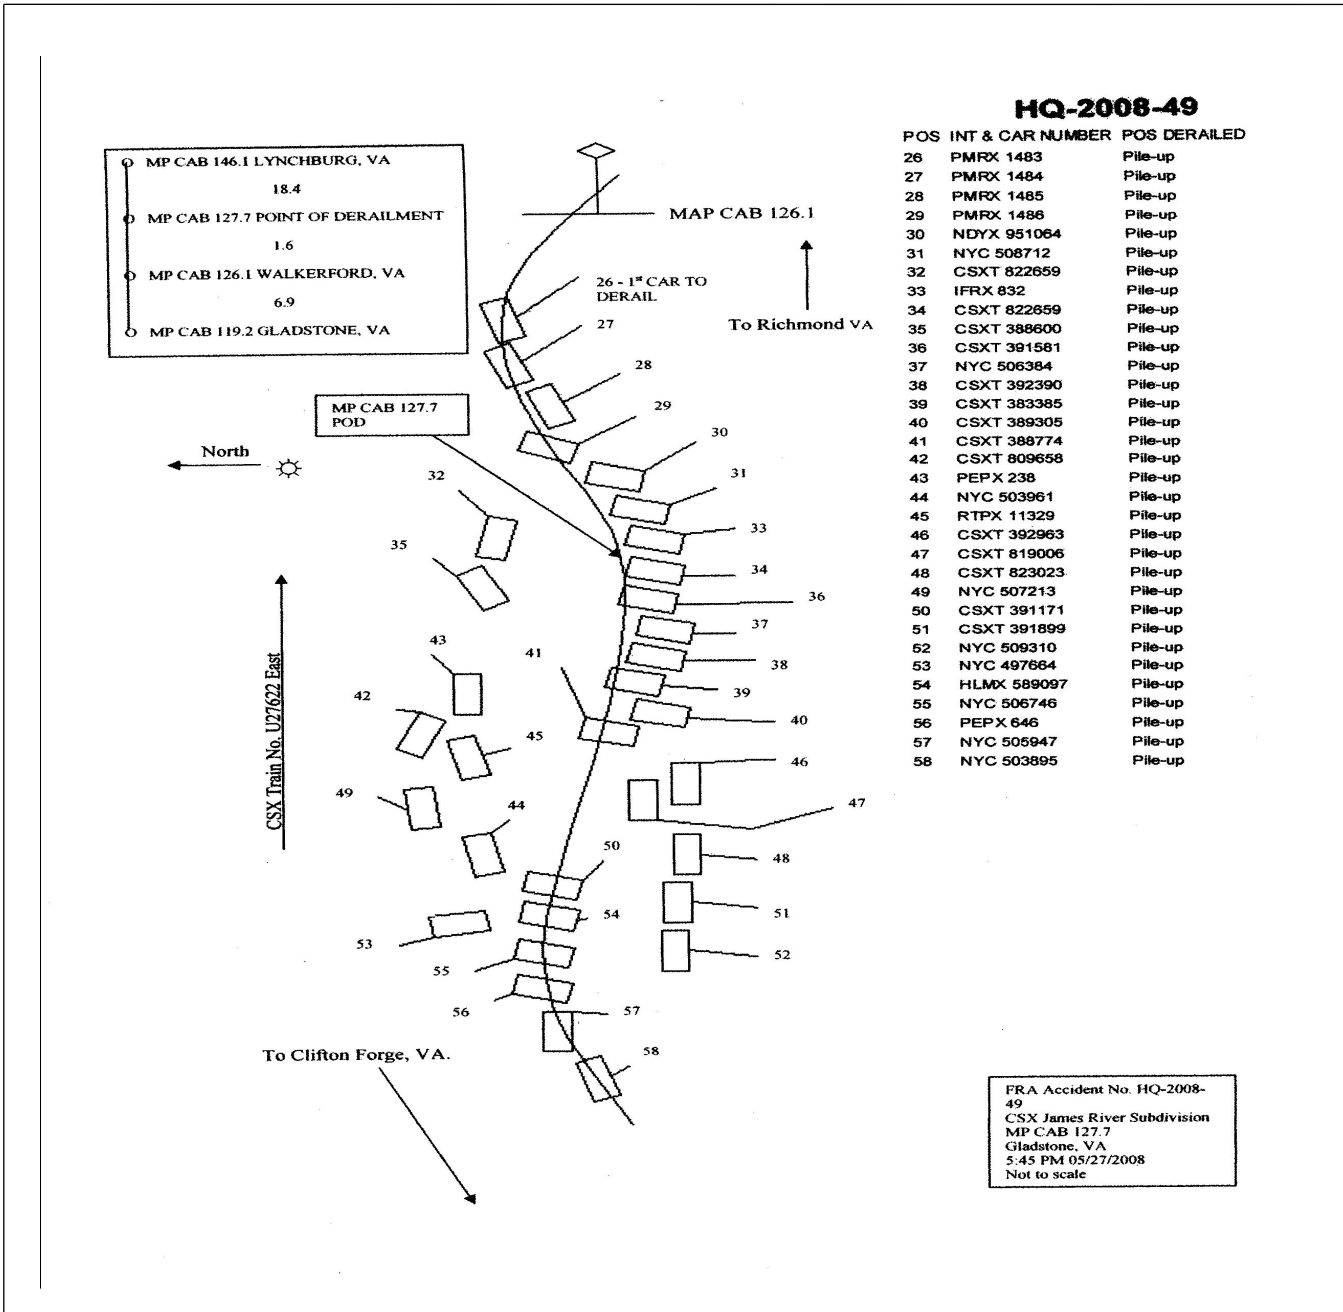
136. DRAW A SKETCH OF ACCIDENT AREA INCLUDING ALL TRACKS, SIGNALS, SWITCHES, STRUCTURES, OBJECTS, ETC., INVOLVED.

The FRA Inspectors and CSX officials discovered the Point of Derailment (POD) at CSX Milepost CAB 127.7. Further investigation revealed a broken north rail. The first car to derail was PMRX # 1483, hopper car loaded with coal.
