***Federal Railroad Administration
Office of Safety
Headquarters Assigned
Accident Investigation Report
HQ-2008-55***

***CSX Transportation (CSX)
Selkirk, NY
June 13, 2008***

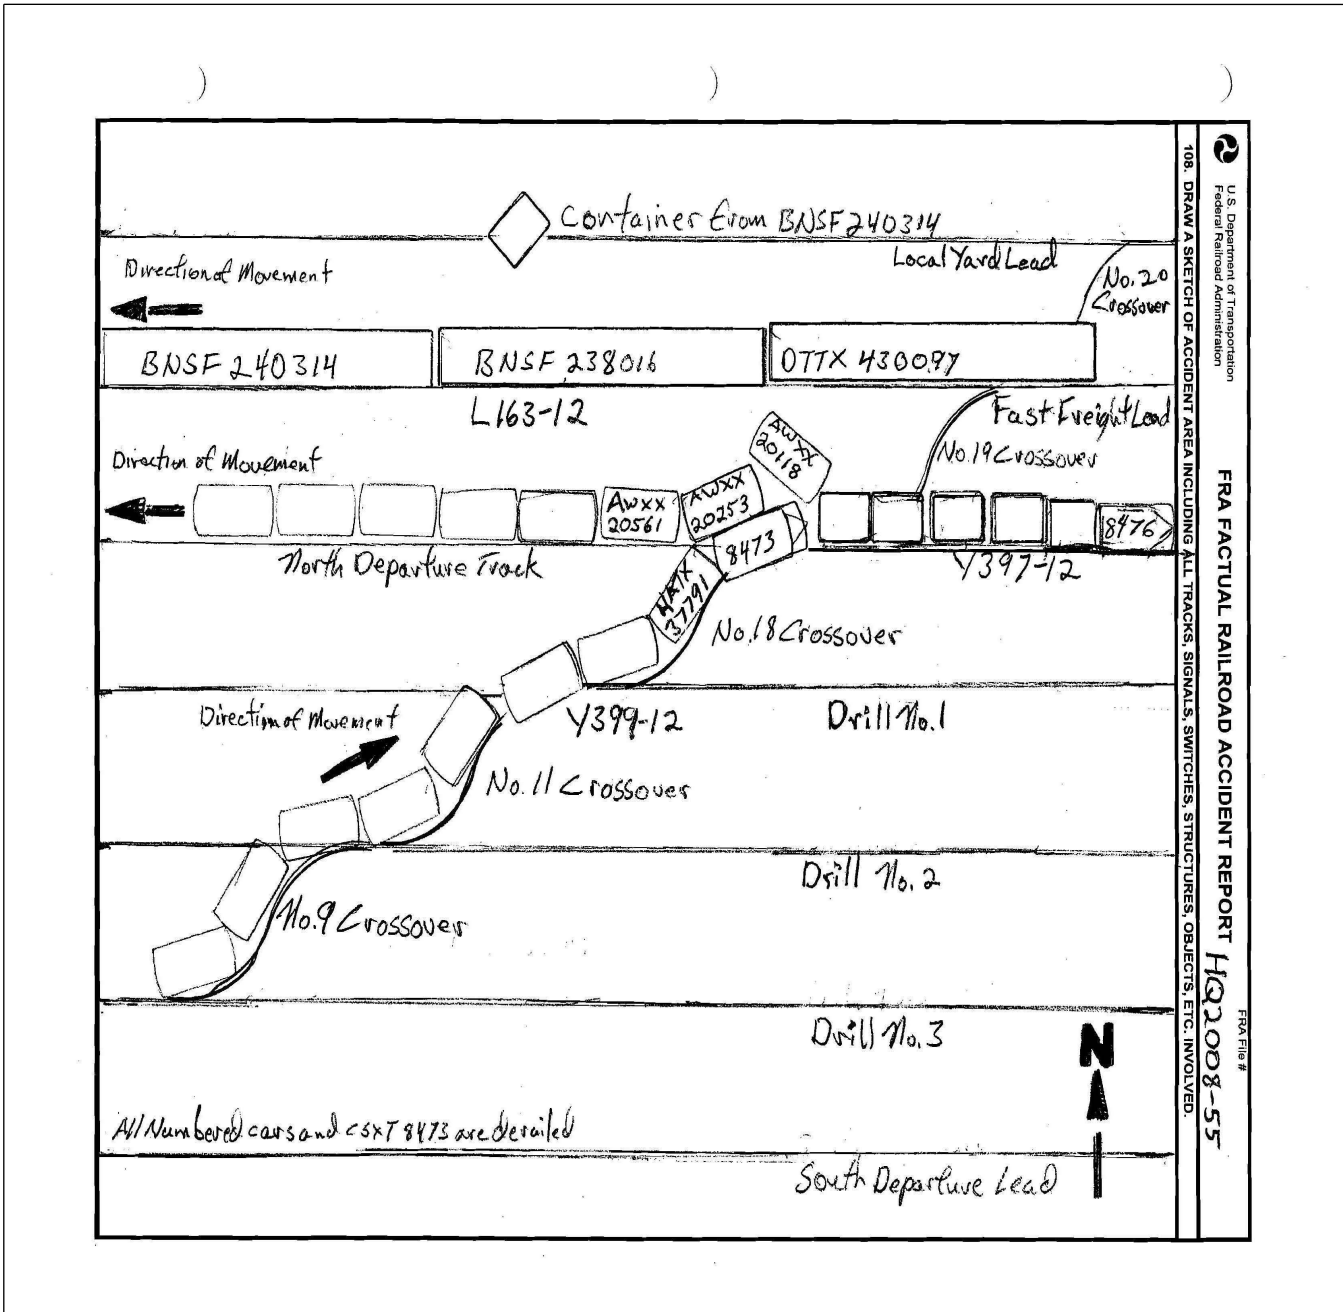
136. DRAW A SKETCH OF ACCIDENT AREA INCLUDING ALL TRACKS, SIGNALS, SWITCHES, STRUCTURES, OBJECTS, ETC., INVOLVED.

Eastward Remotely Controlled yard switching freight train Locomotive (RCL) collided with and derailed three cars in a westward RCL yard switching freight train, which subsequently impacted cars on a westbound freight train on an adjacent track, causing them to derail. This occurred on June 13, 2008 at 2:00 a.m. in Selkirk, NY near CSX milepost QG15.0, on the CSX Selkirk Subdivision. There were no injuries to any of the train crew members or yard crew members. The RCL of the eastbound train derailed and sustained extensive damage.

The derailment was caused by the lead wheels of the eastbound locomotive picking the partially open normal switch point of a remote control switch. The switch falsely indicated that the points were closed in the normal position. The locomotive was remotely controlled and the Remote Control Operator (RCO) was unable to observe the failure of the locomotive to follow the intended route.
