***Federal Railroad Administration
Office of Safety
Headquarters Assigned
Accident Investigation Report
HQ-2008-57***

***Union Pacific (UP)
White Castle, LA
June 25, 2008***

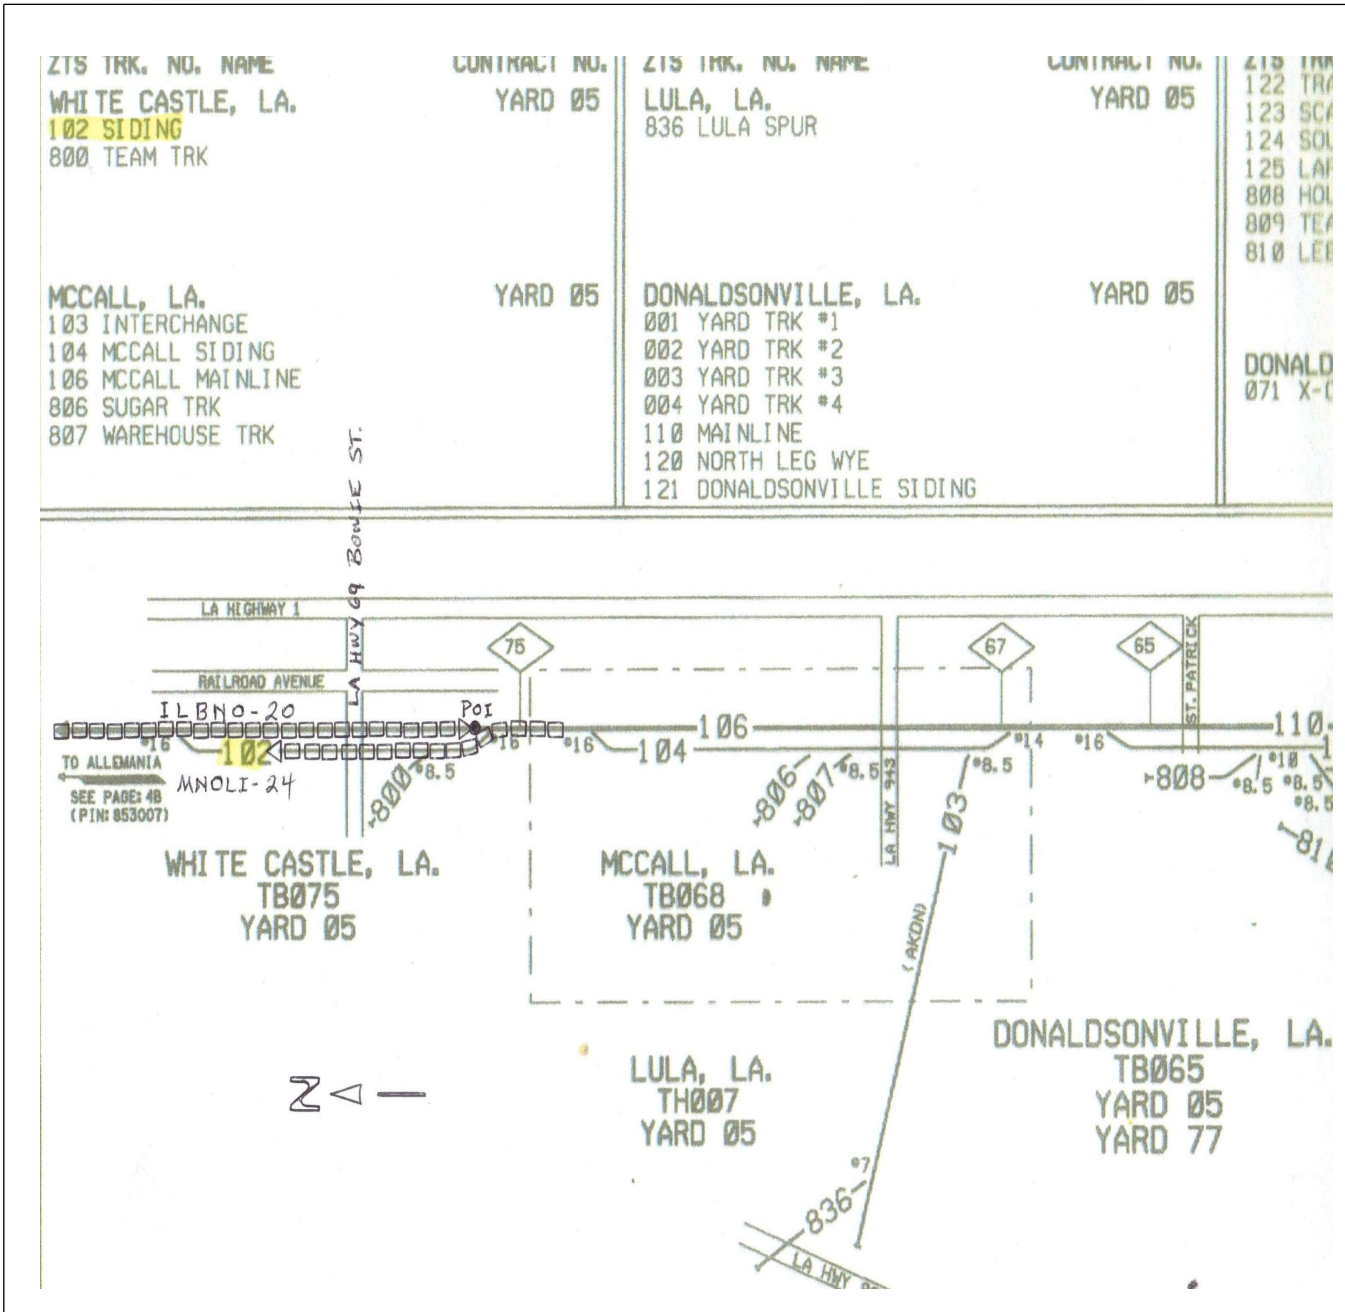
136. DRAW A SKETCH OF ACCIDENT AREA INCLUDING ALL TRACKS, SIGNALS, SWITCHES, STRUCTURES, OBJECTS, ETC., INVOLVED.

As UP Train ILBNO-20 neared the south end of White Castle Siding, the crew observed the mainline signal, at that location, to be dark [unlighted], and the rear cars of UP Train MNOLI-24 fouling the mainline. The engineer attempted to stop his train short of the signal with an emergency train air brake application. UP Train ILBNO-20 passed the clearance point of the mainline and collided with the side of UP Train MNOLI-24 at 3:46am.

The lead locomotive of UP Train ILBNO-20 and the 66-67-68th cars of UP Train MNOLI-24 derailed. The 69th and 70th of UP Train MNOLI-24 were damaged, but did not derail. Estimated overall damage to the two trains and track structure was estimated at \$251,744.
