***Federal Railroad Administration  
Office of Safety  
Headquarters Assigned  
Accident Investigation Report  
HQ-2008-73***

***Union Pacific (UP)  
Tucson, AZ  
September 6, 2008***

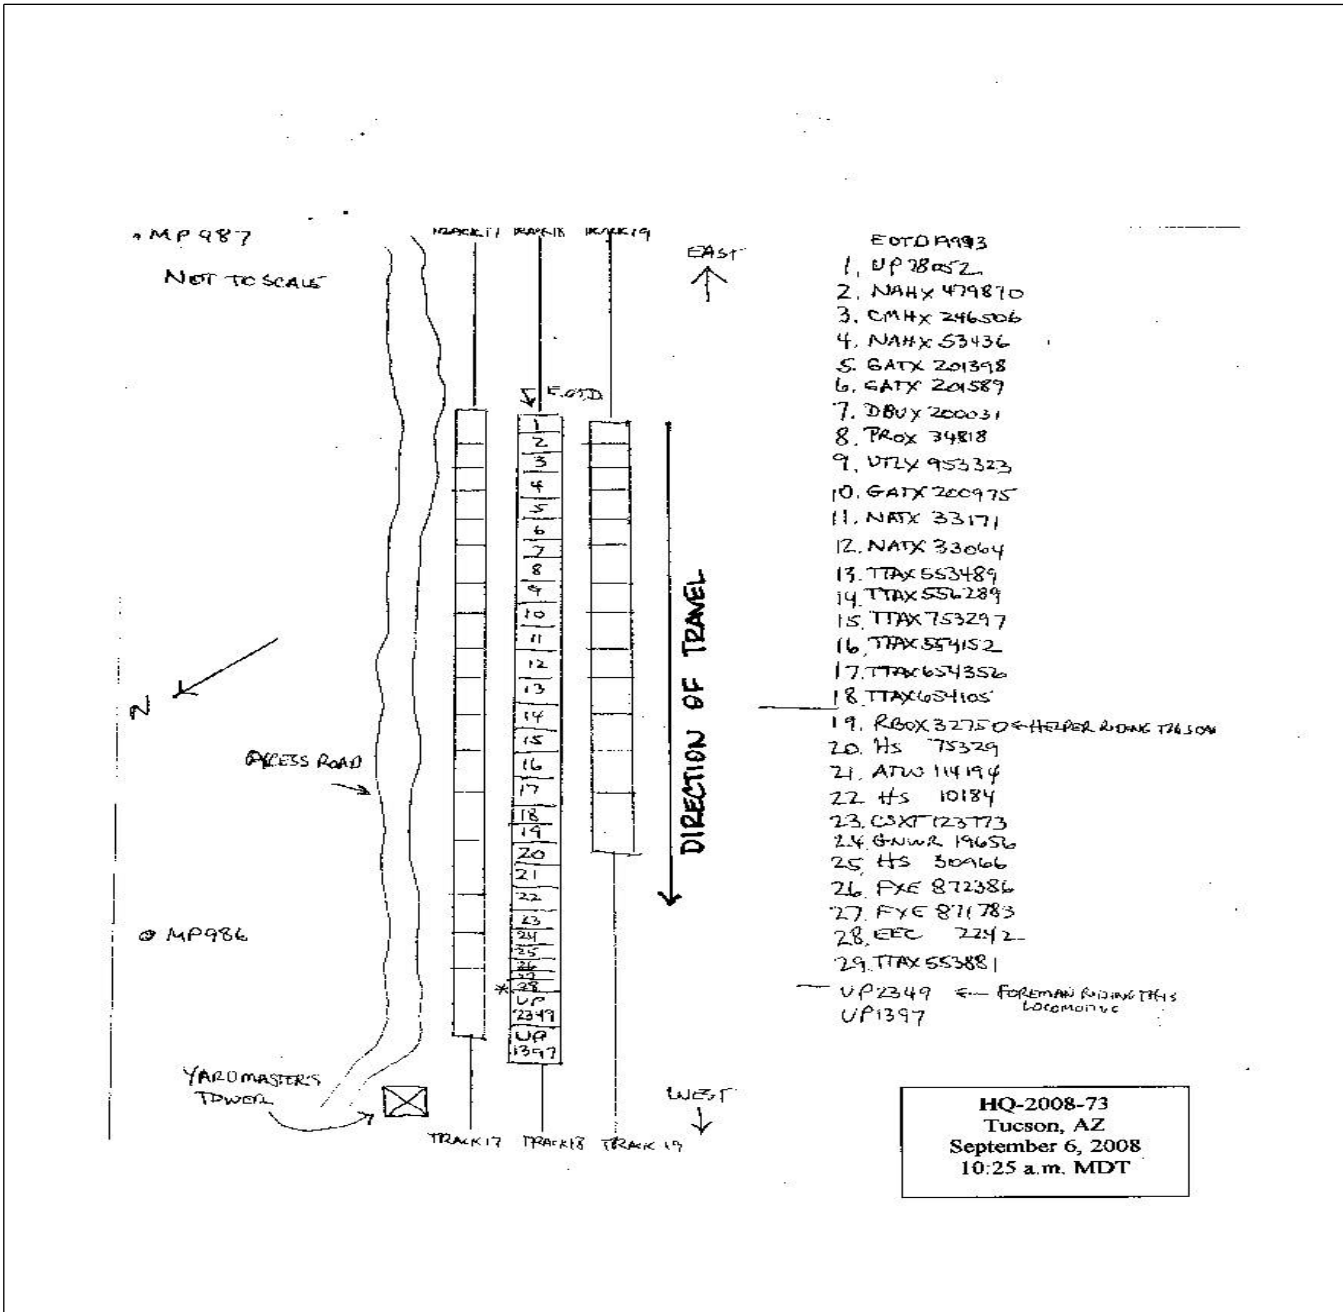
136. DRAW A SKETCH OF ACCIDENT AREA INCLUDING ALL TRACKS, SIGNALS, SWITCHES, STRUCTURES, OBJECTS, ETC., INVOLVED.

On September 6, 2008 at approximately 10:25 a.m. MDT, 18 unattended freight cars rolled west out of Track 18 in Union Pacific's (UP) Tucson, Arizona rail yard. The 18 cars struck the rear car of an 11-car switching movement of UP Switching Job YTU10R-06, an Remote Control Operator (RCO) assignment, which had just cut away from the 18 unattended freight cars, and was making a westward movement in the same track.

Shortly after UP Switching Job YTU10R-06 pulled away from the remaining 18 cars in the track, the cars began to roll west because the single hand brake that had been applied was not sufficient enough to hold the cut of rail cars. After rolling for approximately 1,000 feet, the cars struck the rear car, RBOX 32750, and caused a hard coupling into the car. The impact forced the train to be pushed westward approximately 277 feet in 22 seconds, accelerating it to a speed of 16 mph before it came to stop. The train came to a stop when the "man down" feature of the remote control device was activated when both crew members were thrown to the ground. The tilt mechanism functioned as intended and an emergency application of the emergency air brakes occurred. The crew members sustained multiple cuts, abrasions, and contusions due to the fall.
