Federal Railroad Administration Office of Safety Headquarters Assigned Accident Investigation Report HQ-2008-76

Norfolk Southern (NS) McIntosh, AL September 30, 2008

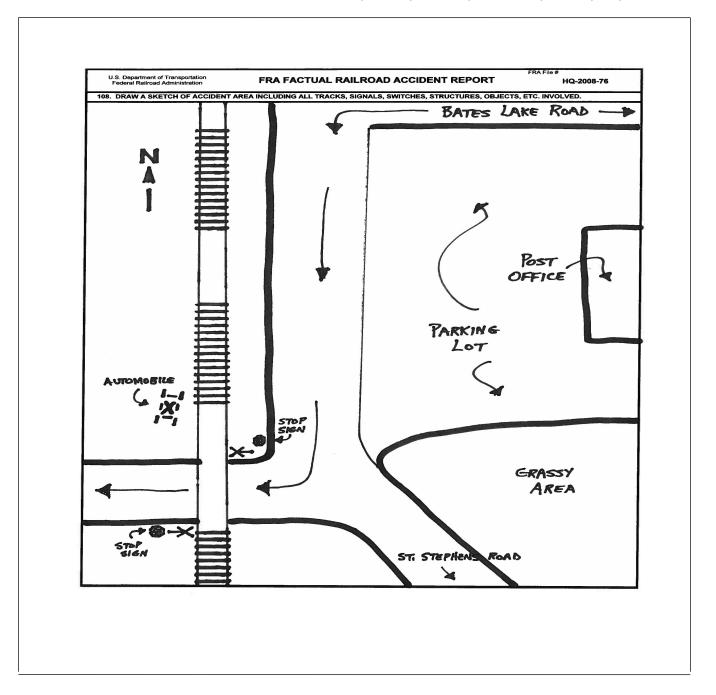
136. DRAW A SKETCH OF ACCIDENT AREA INCLUDING ALL TRACKS, SIGNALS, SWITCHES, STRUCTURES, OBJECTS, ETC., INVOLVED.

Highway-rail grade crossing DOT No. 727 760 C is equipped with railroad crossing signs (cross-bucks) and stop signs. There are no active warning devices or advance railroad crossing pavement markings. From the east, Bates Lake Road approaches the railroad right-of-way straight on, then makes a left 90 degree turn to the south paralleling the tracks for 120 feet, then makes a right 90 degree turn to the west over the crossing and straight on for approximately 1/4 mile to Highway 43. The cross-bucks and stop sign, on the east side of the crossing, are positioned with the cross-bucks parallel with the tracks and 25 feet from the center of the crossing. The stop sign faces northward towards the traffic flow coming from the east on Bates Lake Road and is positioned next to the cross-bucks.

Adjacent to the railroad right-of-way, on the east side, is the U.S. Post Office for Malcolm, AL. The building sits back approximately 100 feet (facing west) with its parking lot in front spanning 120 feet across and parallel with the tracks. When exiting the post office parking lot to the west to cross the tracks, the stop sign for the crossing is not facing directly at the vehicles, but faces northward as explained above. The crossbucks are facing the oncoming traffic straight on. The cross-bucks and stop sign, on the west side of the right of-way, do face the oncoming traffic.
