***Federal Railroad Administration
Office of Safety
Headquarters Assigned
Accident Investigation Report
HQ-2008-79***

***Kansas City Southern (KCS)
Jackson, MS
October 23, 2008***

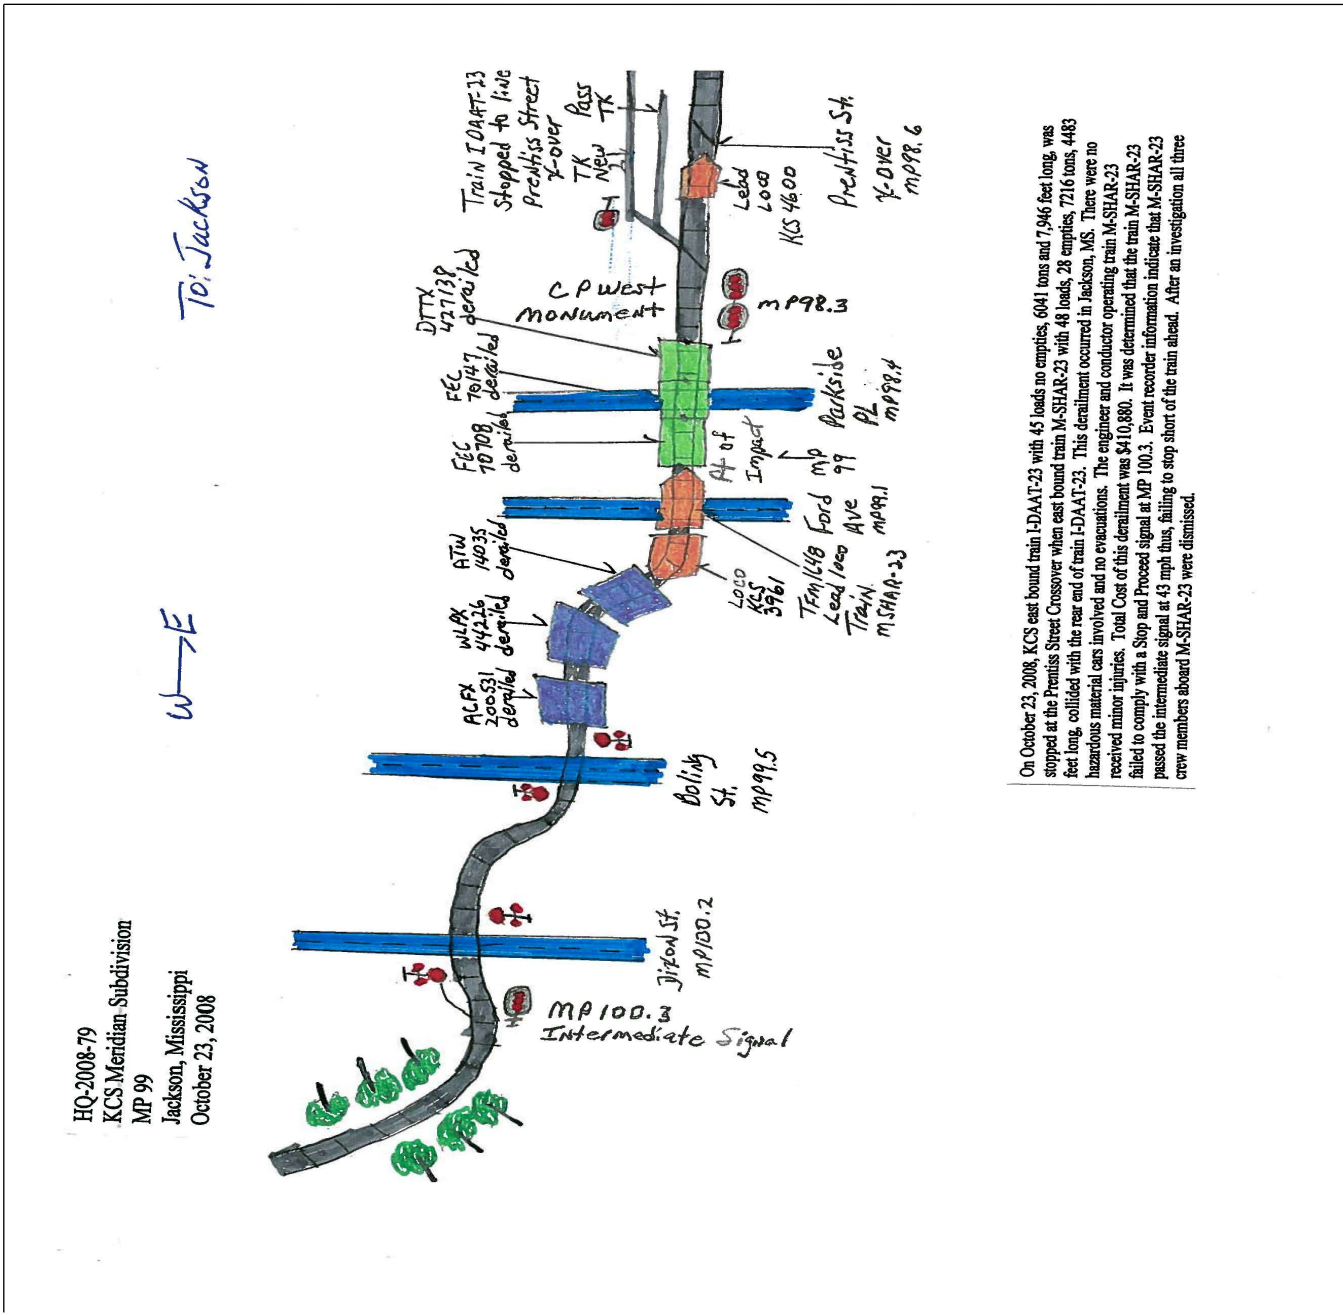
136. DRAW A SKETCH OF ACCIDENT AREA INCLUDING ALL TRACKS, SIGNALS, SWITCHES, STRUCTURES, OBJECTS, ETC., INVOLVED.

On October 23, 2008, KCS east bound train I-DAAT-23 with 45 loads no empties, 6041 tons and 7,946 feet long, was stopped at the Prentiss Street Crossover when east bound train M-SHAR-23 with 48 loads, 28 empties, 7216 tons, 4483 feet long, collided with the rear end of train I-DAAT-23. This derailment occurred in Jackson, MS. There were no hazardous material cars involved and no evacuations. The engineer and conductor operating train M-SHAR-23 received minor injuries. Total Cost of this derailment was \$410,880. It was determined that the train M-SHAR-23 failed to comply with a Stop and Proceed signal at MP 100.3. Event recorder information indicate that M-SHAR-23 passed the intermediate signal at 43 mph thus, failing to stop short of the train ahead. After an investigation all three crew members aboard M-SHAR-23 were dismissed.
